# Ravenglass

## Flood Investigation Report 30

**Flood Event 30<sup>th</sup> August 2012**

This flood investigation report has been produced by Cumbria County Council as a Lead Local Flood Authority under Section 19 of the Flood and Water Management Act 2010.

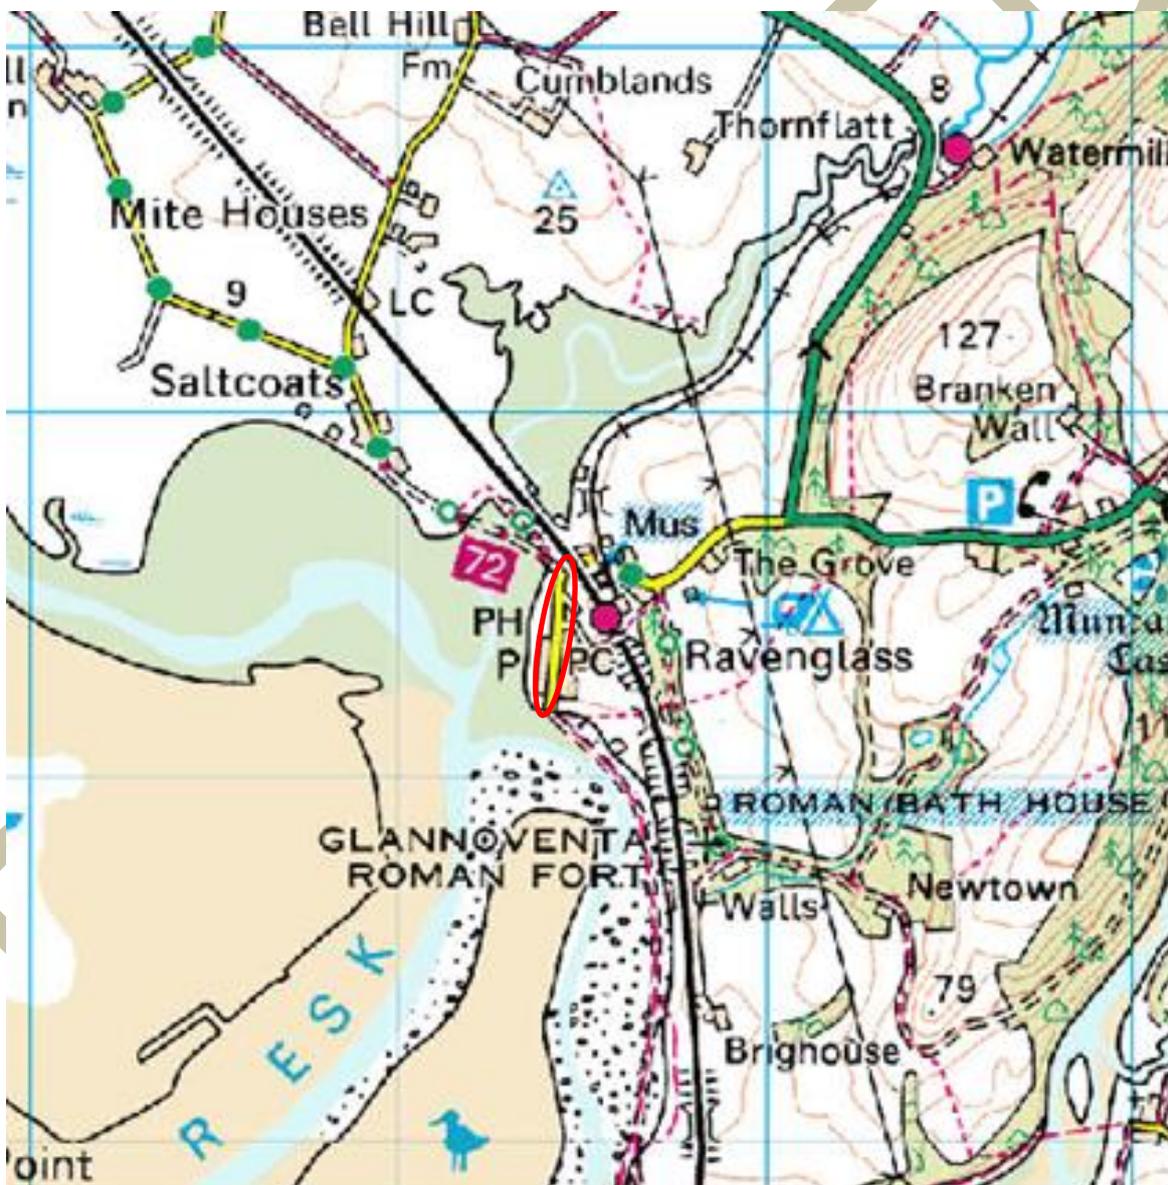
Figures 1 & 4 illustrate the locations affected by flooding during the heavy rain that occurred on the 30<sup>th</sup> August 2012. An important road in the village is Main Street which starts at the flood gates onto the beach at the southern end of the village and ends at the junction with A595 at the top of the hill above the village. There were two separate flooded areas referred to as Main Street North and Main Street South in this report. 13 properties suffered from internal flooding throughout the village.

Figure 1. Location of flood effected areas in Ravenglass.

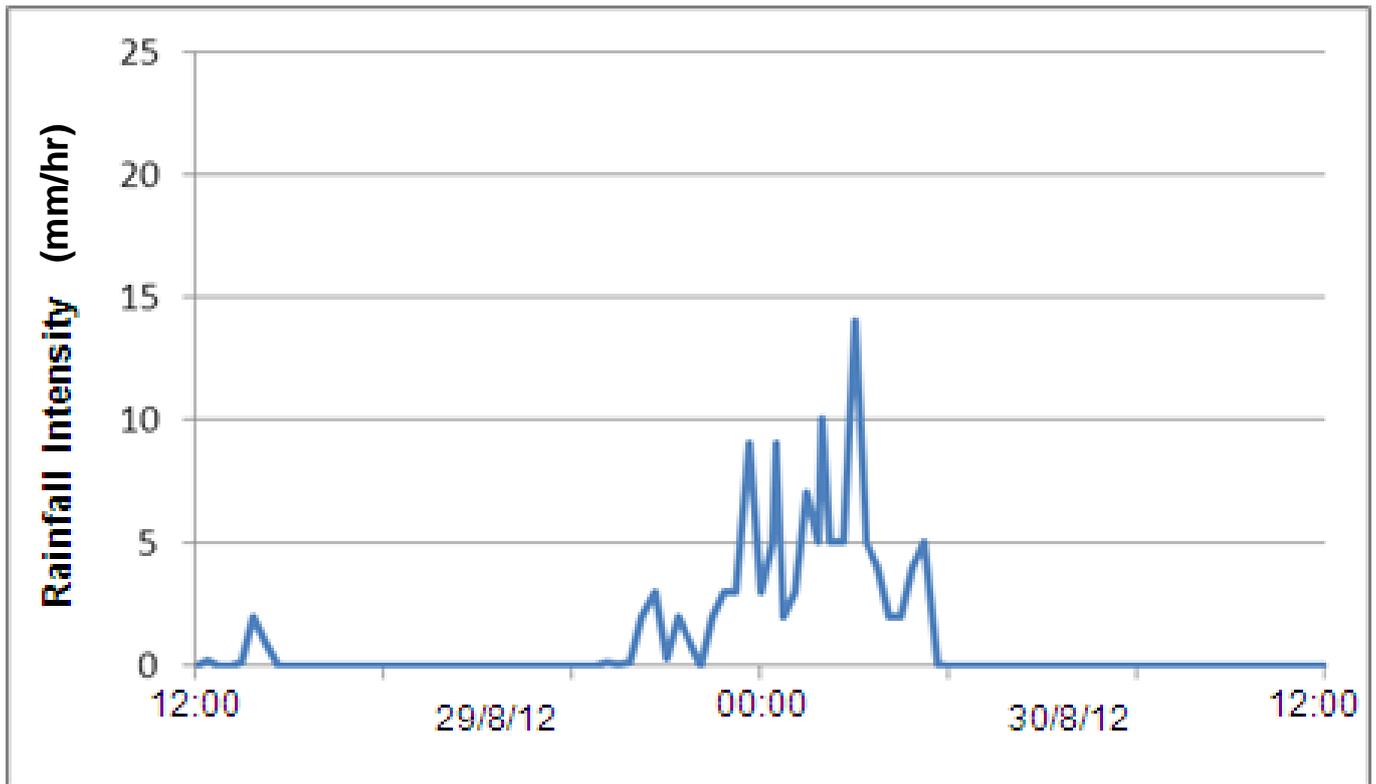
According to radar data taken from a weather information provider, peak rainfall was 14mm/hr and occurred at about 02:00am. Drizzle started at 8:45pm and storm conditions started at 23:45pm. The storm finally subsided at 3:45am with 25mm total rainfall in seven hours.

Figure 2. Rainfall data from 29-30 August 2012 taken from radar data for Ravenglass.

Heavy rain figures for Drigg rain gauge <http://wow.metoffice.gov.uk/>, which is 3.6km away, suggest the storm may have been even heavier than the radar figures indicate. The rain gauge shows 34mm fell throughout the storm at Drigg. The average total rainfall for the whole of August is 92mm (1981-2010) at St Bees Head.

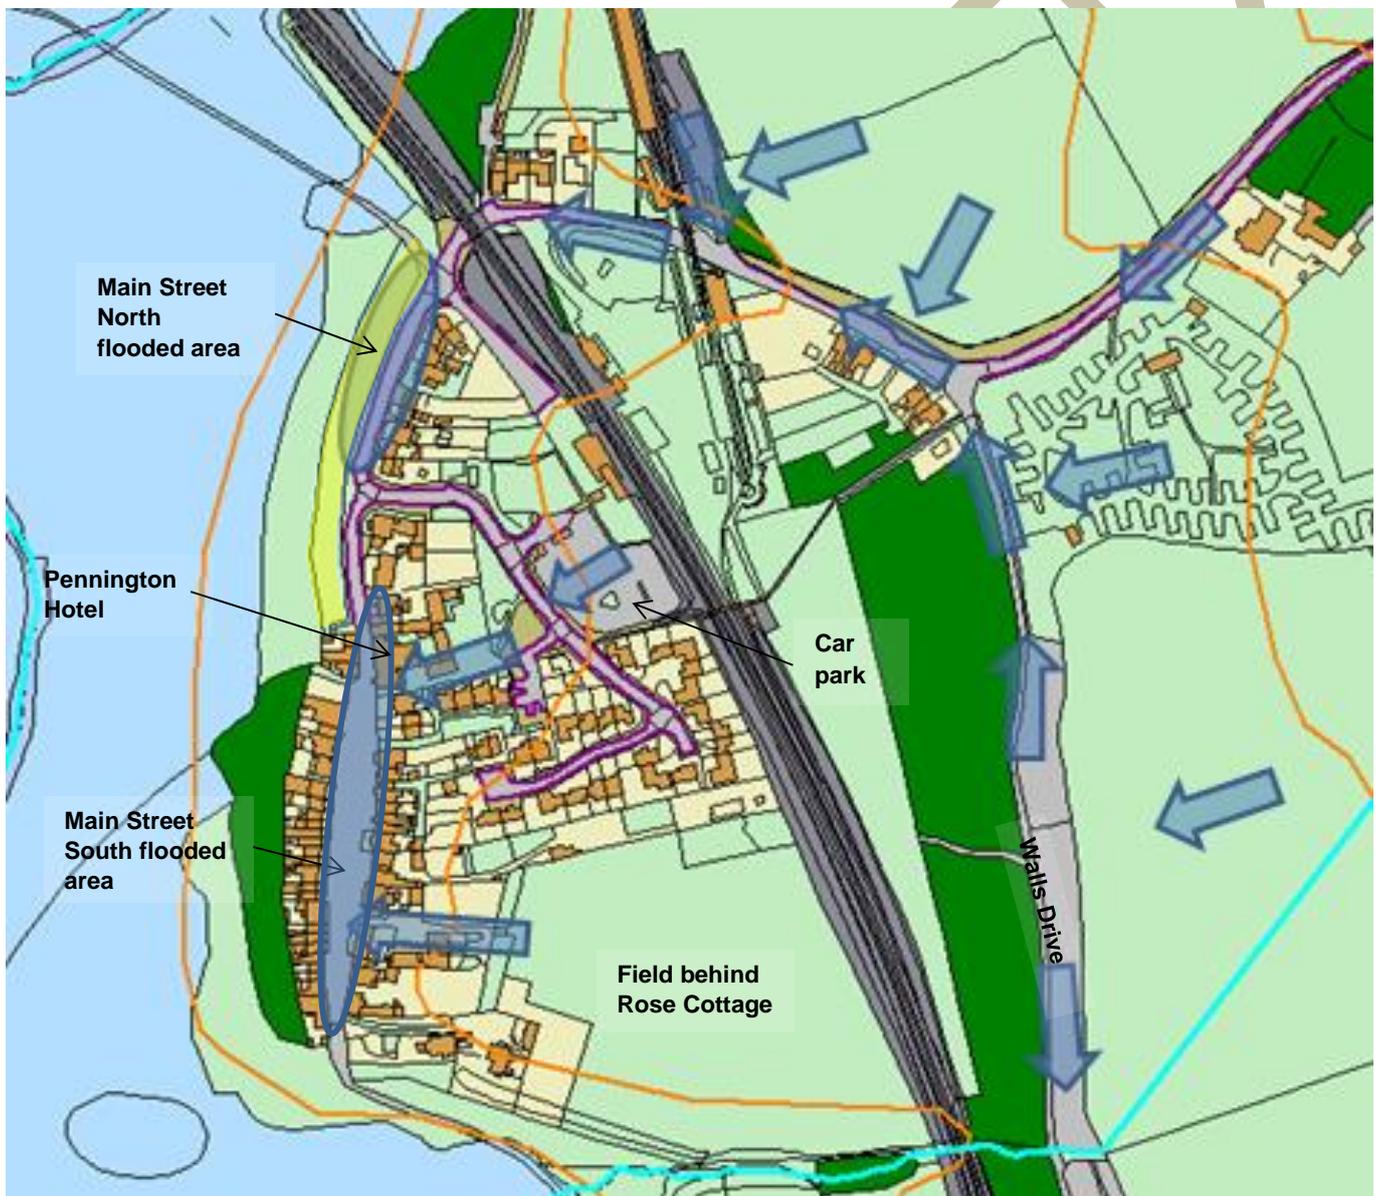
Water reached Main Street North after flowing down the road into the village. Ground infiltration rate would have been reduced because the fields were saturated after the wet summer preceding the event. Water poured out of the fields directly onto the road into the village and onto Walls Drive which also brought the water to the road into the village. The road channelled the water down to Main Street North. The flow of water exceeded the capacity of the road gullies and it pooled on the highway under the Cumbria Coast Line rail bridge. The build-up of water was the main cause of flood damage on 30/8/12.

**Figure 4. Surface water flow routes (arrows) and main flooded areas (oval). Some water was held back by a sea defence embankment (yellow). Key locations named in the report are identified.**

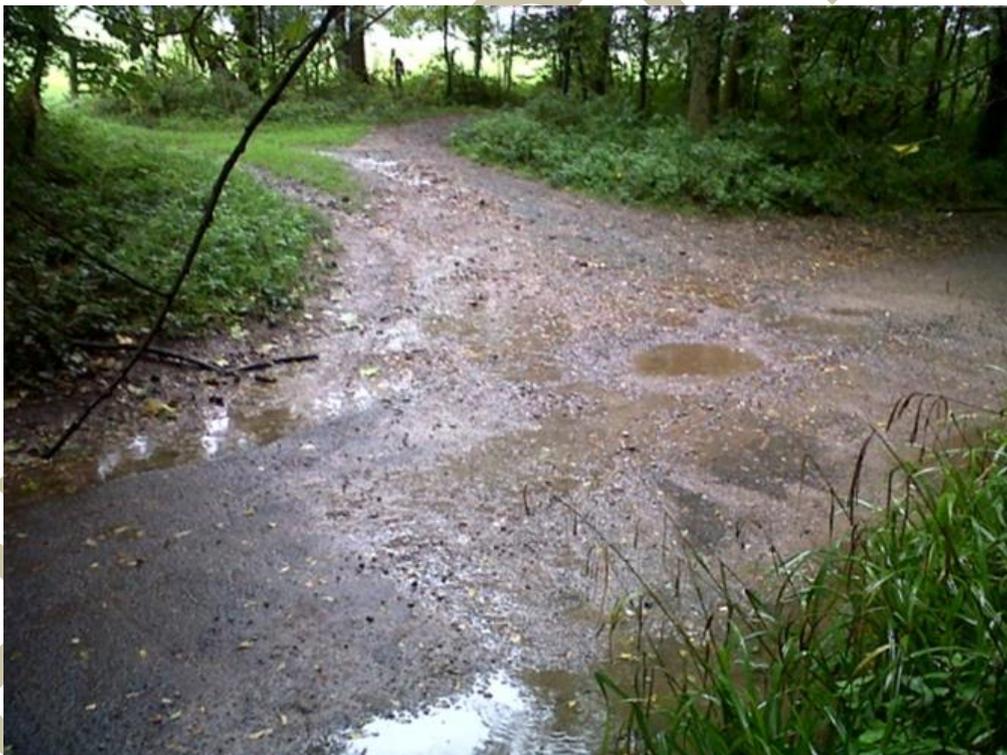
Flood waters ran down the road into the village with flows from the fields on both sides. There was significant runoff from Walls Drive which rises to the south. Runoff from the other side of the rise makes its way south where there is a beck flowing around the southern side of the village.

Figure 5. Surface water flowing onto Walls Drive from the fields above.

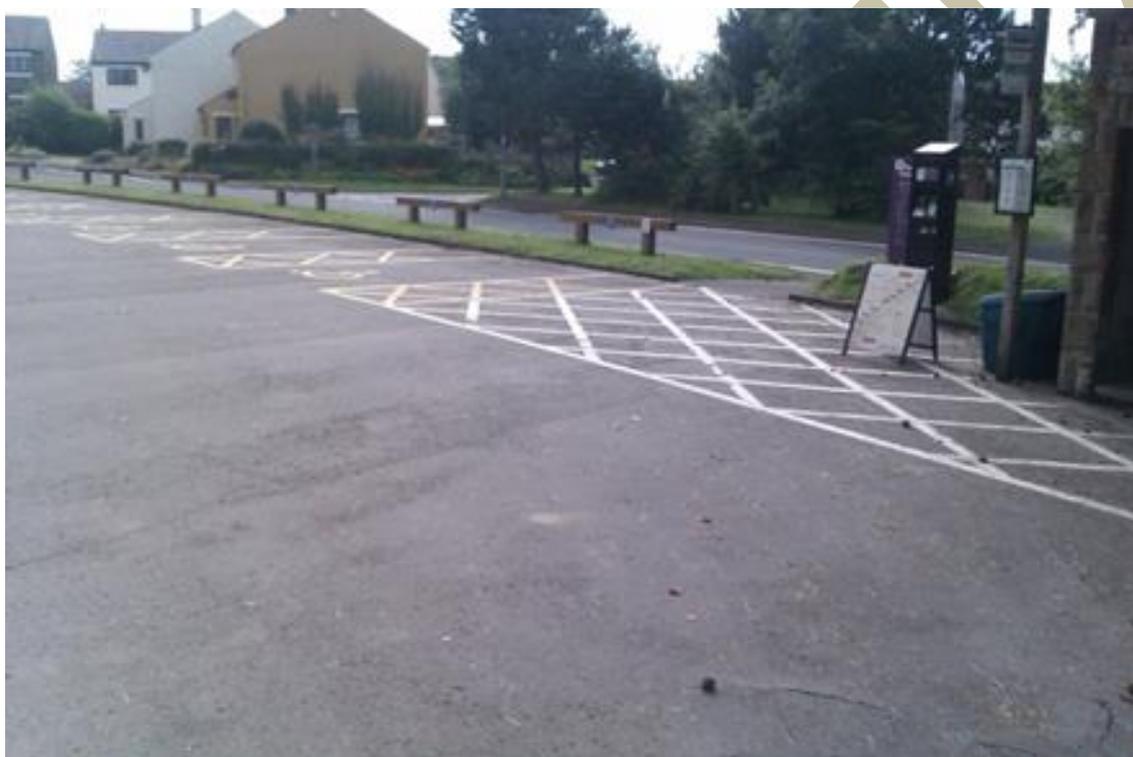
Surface water from the village car park flowed through the car park entrance and over a dropped kerb on the lower west side provided for a footpath route. The profile of the adjacent road, Croftlands Drive, directed flood water down the alley next to the Pennington Hotel and onto Main Street South. A further source of surface water was the field to the south of the village from which runoff flowed down a track and through rear gardens to Main Street South, flooding Lorne Cottage.

**Figure 6. Impermeable surface of the car park and the dropped kerb which provided a flow route for flood water.**

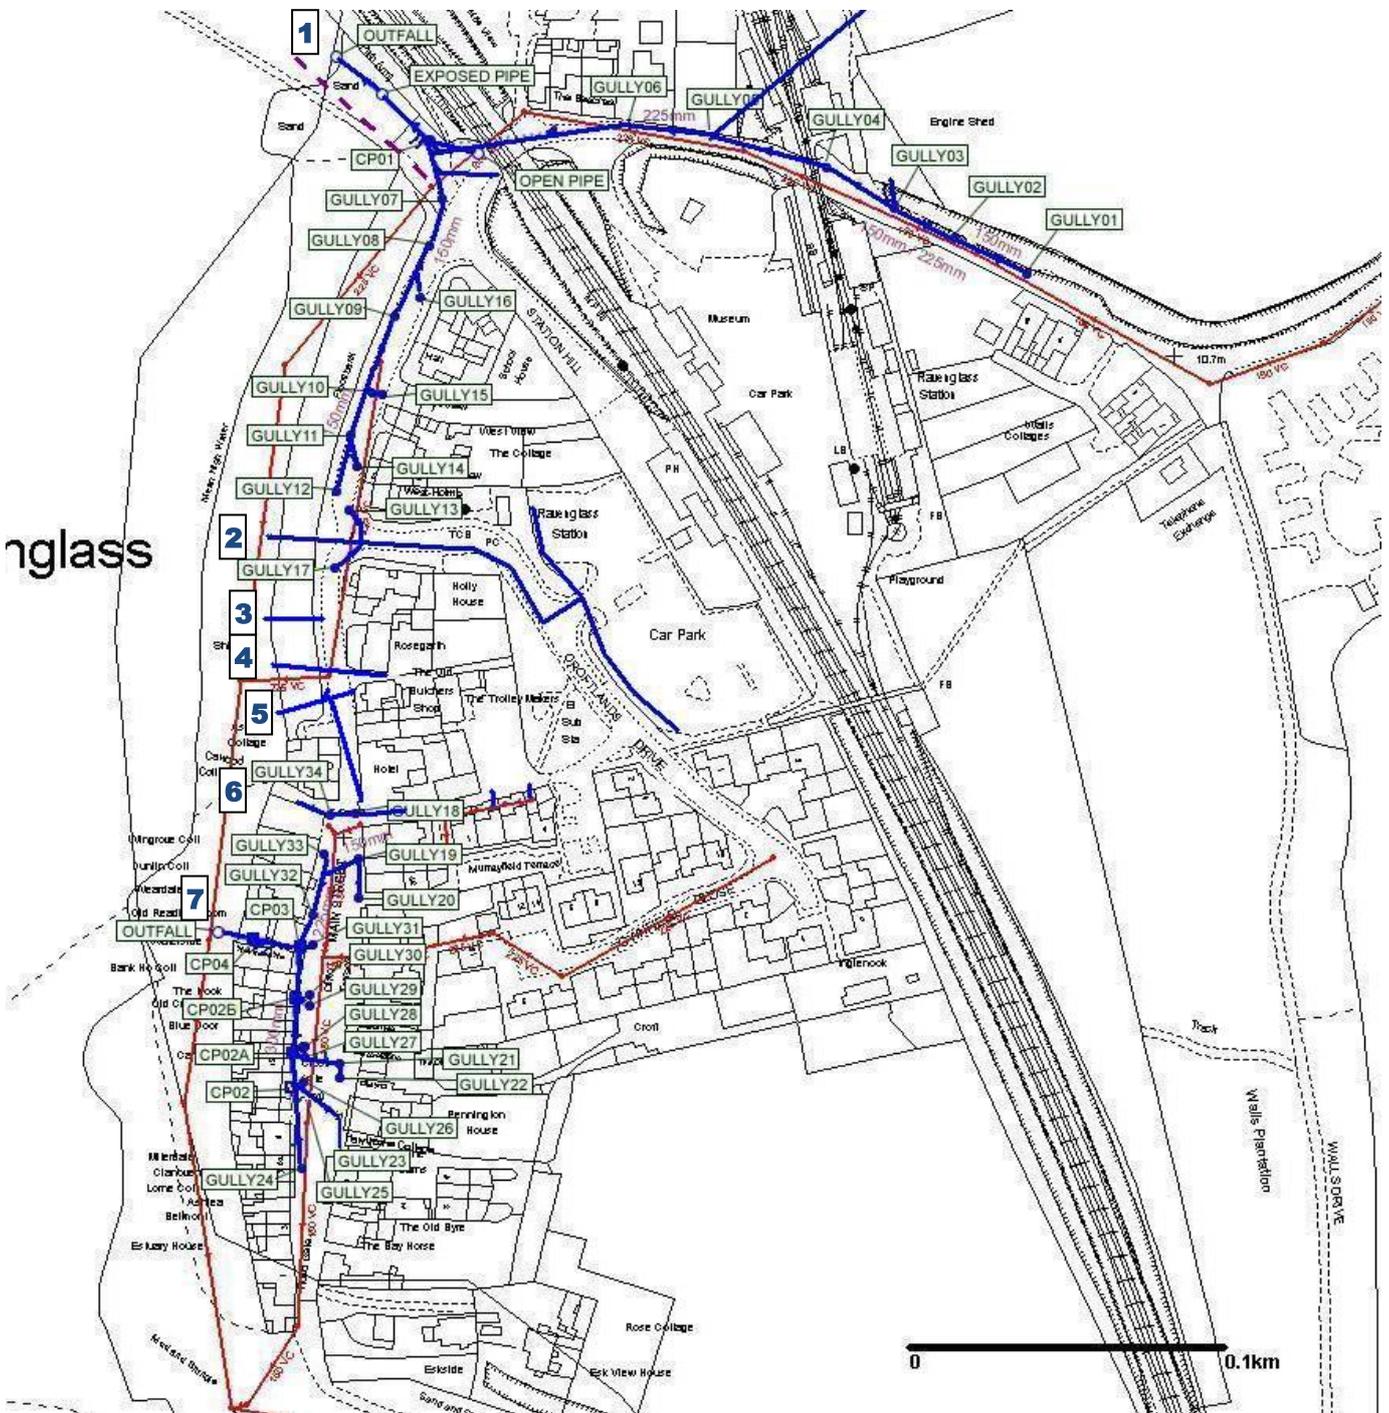
Highway drainage is only designed to carry the flows from the highway surfaces and not land outside these areas. Figure 7 shows the mapped surface water system and shows there are seven outfalls and therefore seven separate systems plus the combined sewer.

The northernmost system all converges on one point, labelled CP01 in Figure 7. This is a manhole found to be buried under the sea defence embankment. Two stone culverts connect to this manhole and carry the road drainage from Main Street North and from the road into the village.

The spout hole from the road surface also leads to the same buried manhole. The outlet for this manhole is a stone culvert but reduces to a 225mm diameter pipe. A pipe this size would be more than capable of conveying the water from the road surfaces but not excessive runoff from the surrounding fields.

Figure 7. Piped surface water drainage system in Ravenglass. Blue lines are surface water only, mainly highway drainage. Red lines are the United Utilities combined sewers. The dashed purple line is the pipe on stilts that can be seen near the surface in the estuary, which is the old highways surface water outfall. Each outfall has been numbered 1 to 7 from north to south.

A considerable amount of debris was removed from the highway drainage in the road into the village, and a collapse was found in one location. This was between the two railway bridges and seems to have caused subsidence on the road which allows water to seep out onto the surface. A gully alongside the southern abutment to the rail bridge had also collapsed. Any water that could not flow in the highway drainage would have run over the surface instead and would have discharged to the buried manhole under the sea defence embankment via the spout hole instead of the highway drains. The 225mm diameter sea outfall pipe was found to be compromised 15m downstream from the buried manhole by a collapse.

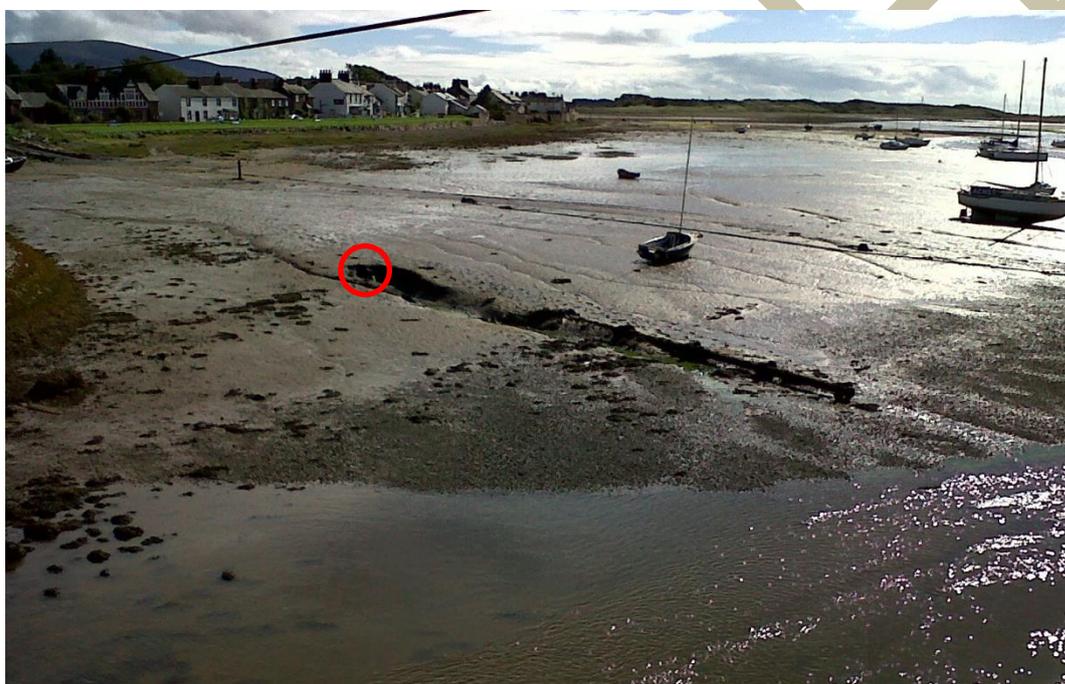
The highway system outfall is visible from the footpath alongside the railway bridge and the pipe portal lies within the estuarine sands (red circle in Figure 8). Water from this pipe has scoured out the sand forming a channel. The pipe may have extended further out into the river channel but has progressively retreated as the scour channel has moved further backwards towards the shore.

**Figure 8. Outfall of northernmost surface water system (Outfall 1 in Figure 7).**

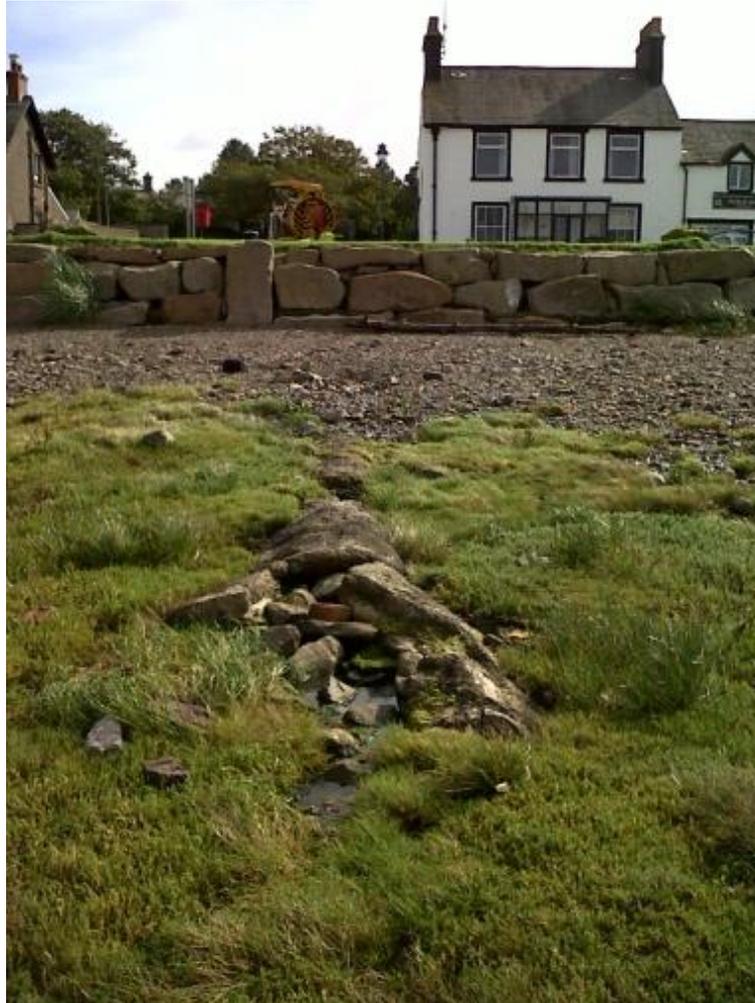
The next system is from the village car park, owned by the Lake District National Park Authority which is responsible for maintenance of the associated drainage. The gullies in the car park were found to be full of debris and a bus shelter has been constructed over one of the gullies. This meant that the flood water stayed on the surface and was able to flow over the dropped kerb (see Fig. 6). The piped system from the car park joins the highway drainage system in Croftlands Drive and the outlet to the shore is through the flood defence embankment adjacent to the road junction where Croftlands Drive meets Main Street (Outfall 2 in Figure 7). This outfall was not visible until the road gullies were jetted above and water blew out the shingle in front of the pipe. The outfall is a broken clay pipe underneath shingle; the pipe is full of beach material as it is open in a few places.

**Figure 9. Broken pipe on beach carrying car park drainage (Outfall 2 in Figure 7).**

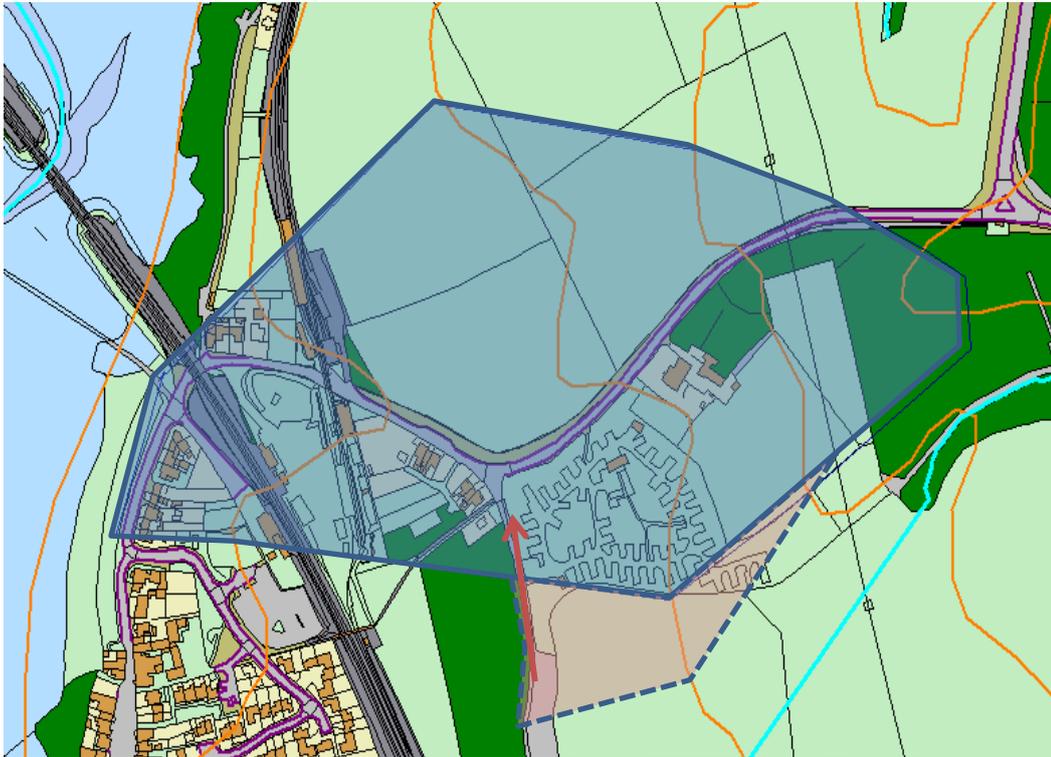
Figure 10. Catchment area affecting Main Street North.

Water follows the topography and all the surface water runoff from the 14ha catchment, shaded blue in Figure 10, flows through the Main Street North flooded area at some point on its way to the sea. The water flows onto the road into the village from both sides and an examination of the contours (orange lines) shows that there is a natural flow route into the village which is occupied by the road.

The catchment boundary crosses Walls Drive but the catchment divide is further south. The water that reaches Walls Drive between the blue catchment boundary shown in Figure 10 and the crest (shaded red) would naturally flow towards the car park and the Pennington Hotel area. Walls Drive diverts this water northward (red arrow) adding another 1.5ha (shaded red) to the Main Street North catchment which is 11% of the total.

To reduce flooding from Walls Drive by up to 11%, as much water as possible should be diverted southwards to the beck that bypasses the village instead of northwards to Main Street. The ground levels do not make this an easily achievable solution. Another option would be to divert some of the water west, straight down the slope but this would require the construction of a totally new drainage system which would have to cross the railway and the village centre, possibly connecting with the car park system.

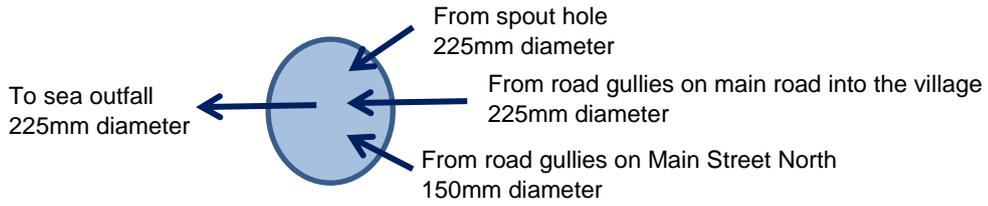
It is unlikely that the buried manhole under the sea defence embankment can operate effectively under flood conditions because when all the pipes are working at full bore, there is 2.5 times more cross-sectional area of pipework entering the manhole compared to the combined cross-sectional area discharging from it. One circular pipe to the outfall would need

to be 350mm diameter to provide the same cross-sectional area as the pipework that enters the manhole.

**Figure 11. Schematic of inlet and outlet pipes at the buried manhole.**
