Braithwaite

Section 19

Flood Investigation Report

Coledale Beck, Braithwaite, Cumbria

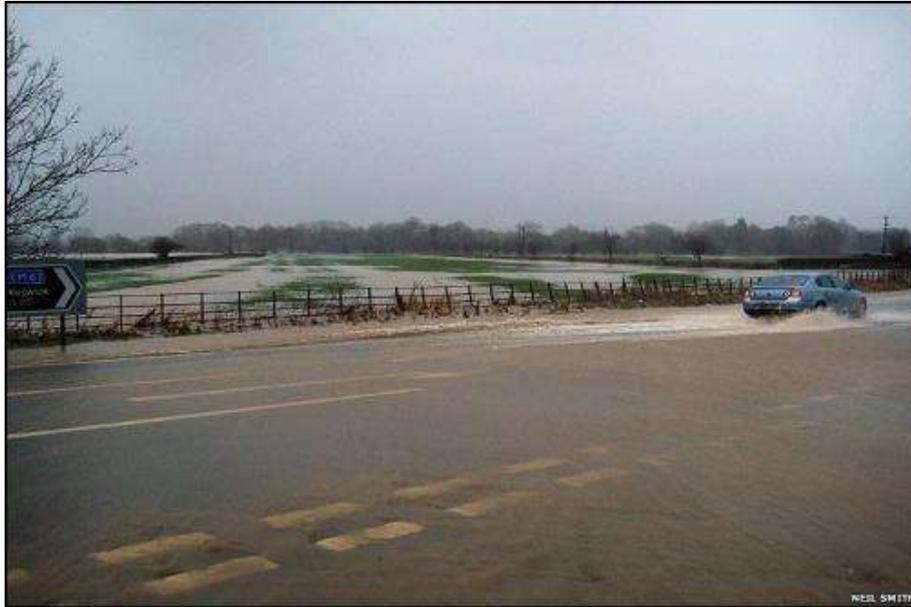
Photograph 1: Floodwater from the Coledale Beck on the A66 during the November 2009 flooding

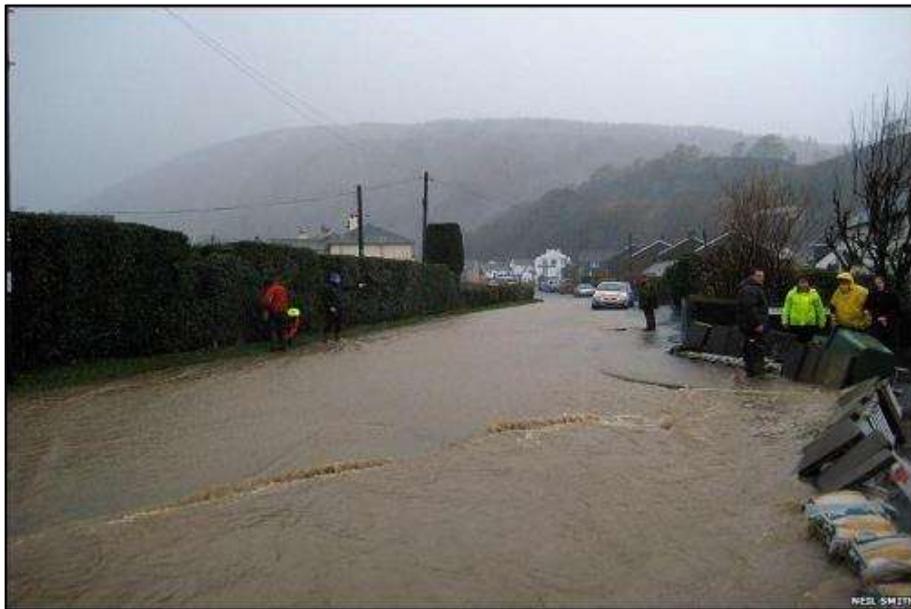
Photograph 2: Looking north on the B5292 from the A66 junction during the November 2009 flooding

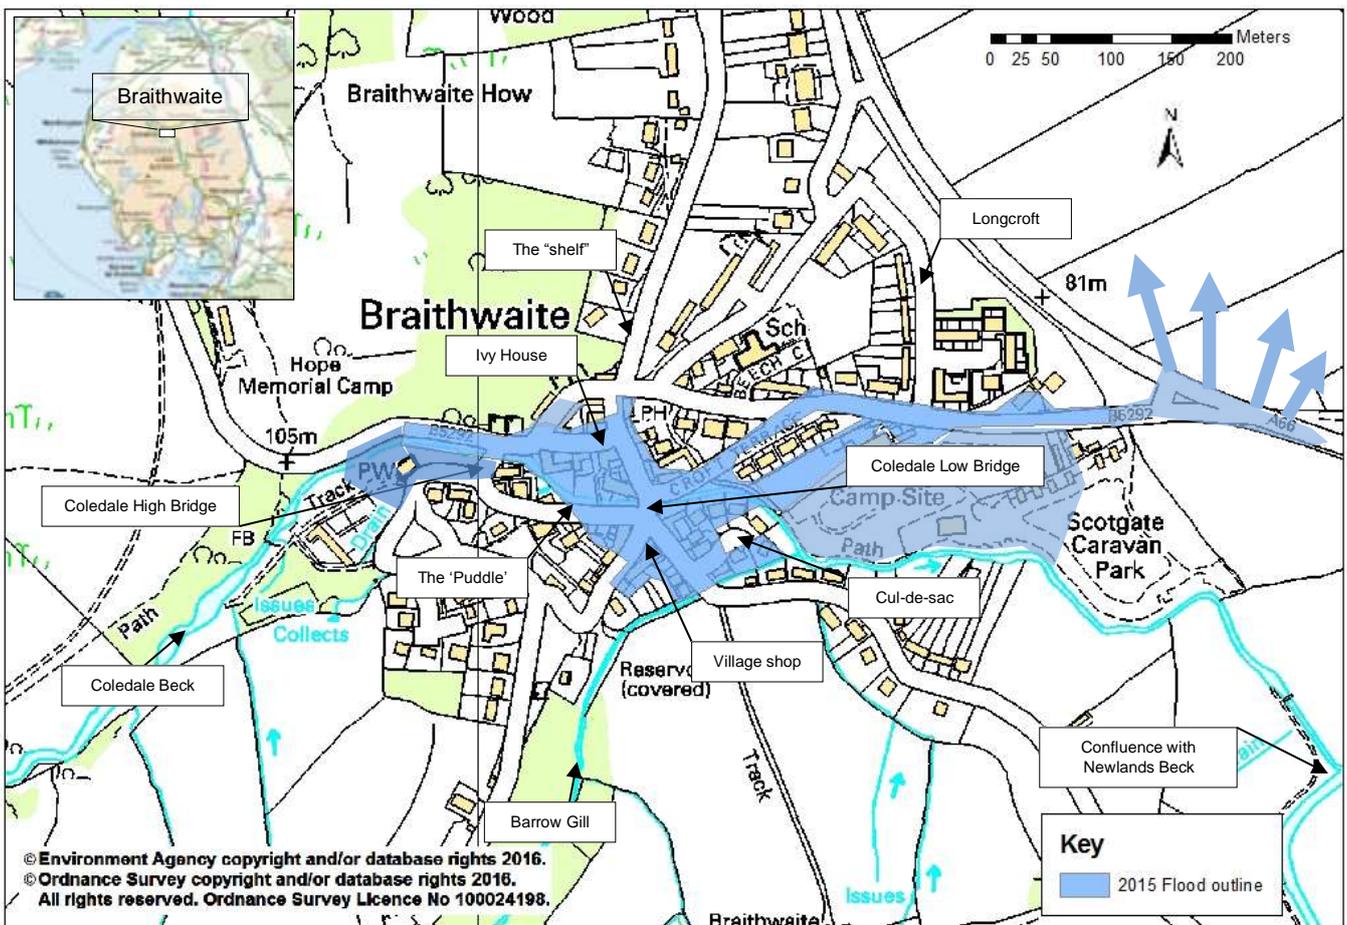
The flooding incident also damaged the two access bridges within Braithwaite, temporarily preventing all access and egress between the western and eastern sides of the village. The flood defence embankment on the Coledale Beck was also overtopped, with sections washed away during the flooding incident.

Figure 3: Extent of River (Fluvial) Flooding* in Braithwaite on the 5th December 2015

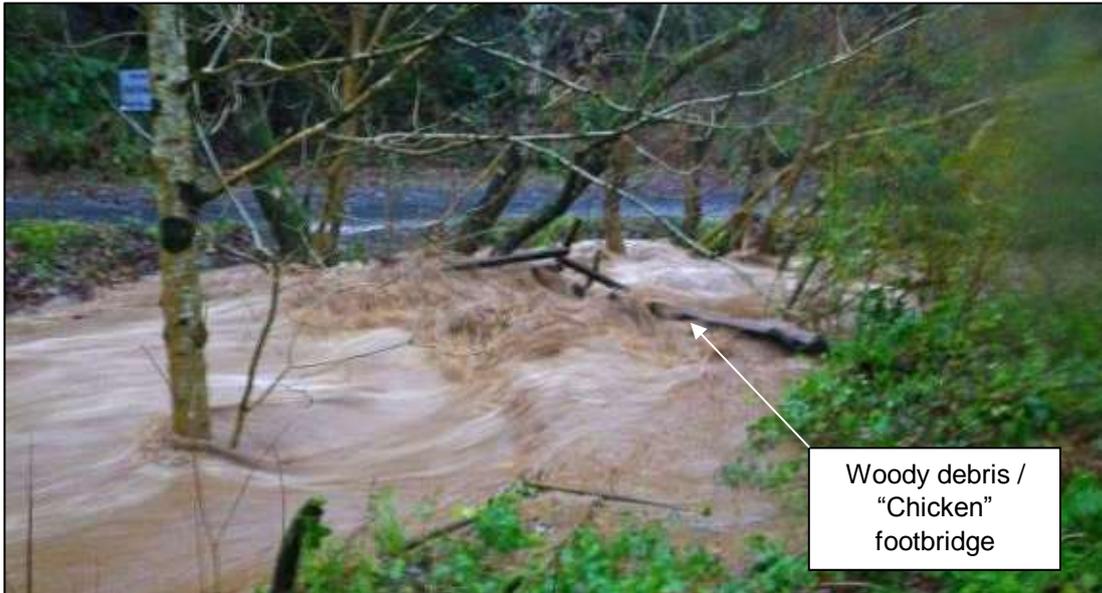
Photograph 7: Looking across the Coledale Beck from the right bank of the watercourse, upstream of the Coledale High Bridge

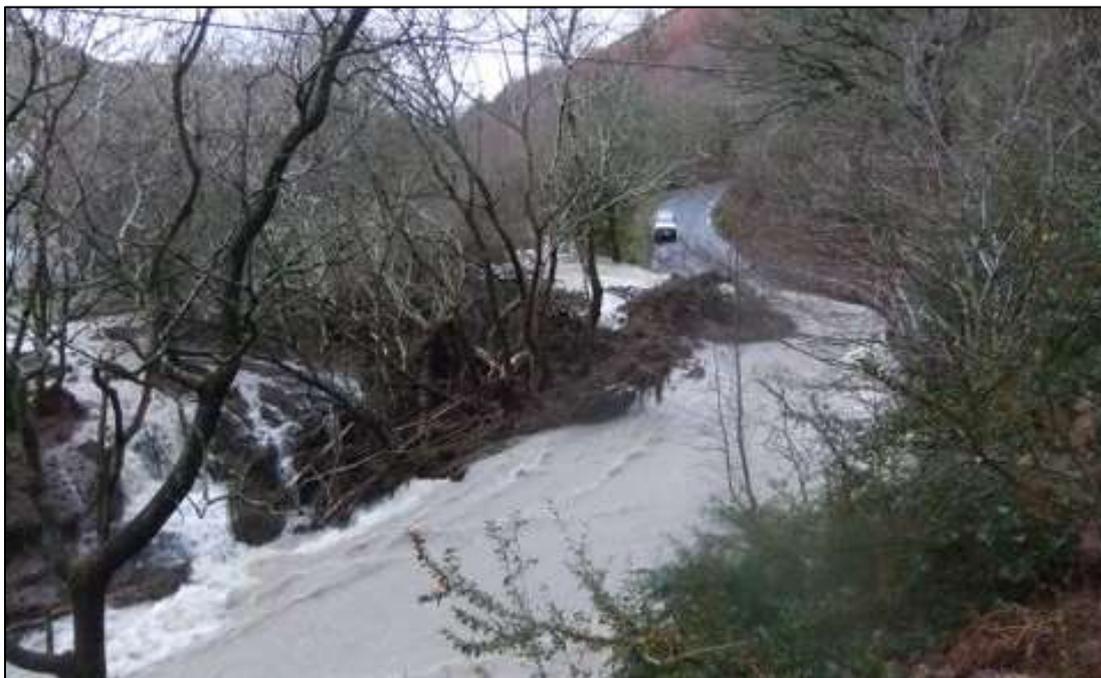
Photograph 8: Looking upstream at the main blockage above the High Coledale Bridge

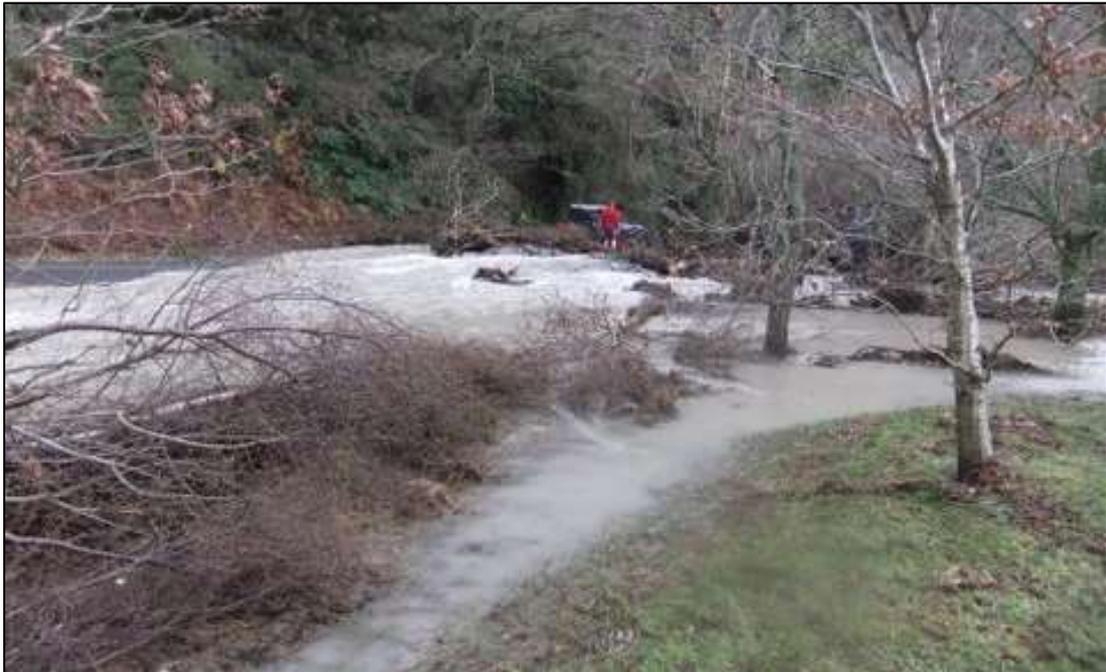
Photograph 9: Looking downstream at the main blockage above the High Coledale Bridge

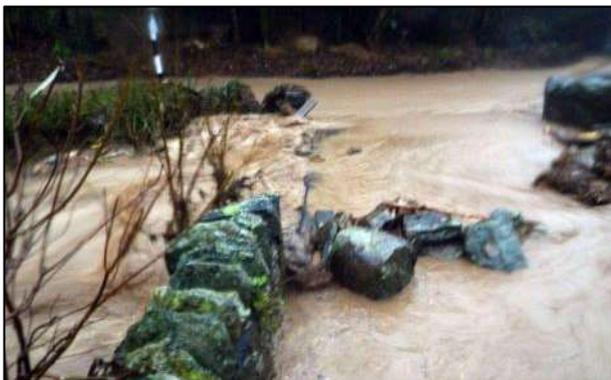
The Coledale High Bridge became blocked with tree debris despite being cleared twice earlier that morning by local residents. As flood levels rose, water poured through the parapet of the Coledale High Bridge before it eventually failed, **Photograph 10**. Some of the flood flows which overtopped the access bridge subsequently re-joined the river channel, **Photograph 11**, whilst the remainder was routed along the B5292 into Braithwaite.

Photograph 10: Damage and overtopping of the Coledale High Bridge over the Coledale Beck

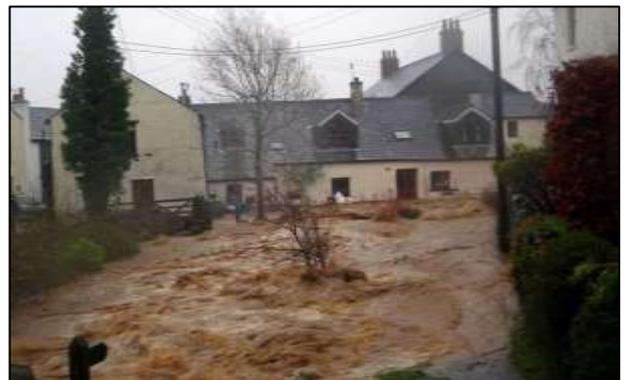
Photograph 11: Looking downstream on the Coledale Beck towards Brook Cottage, prior to the parapet failure.

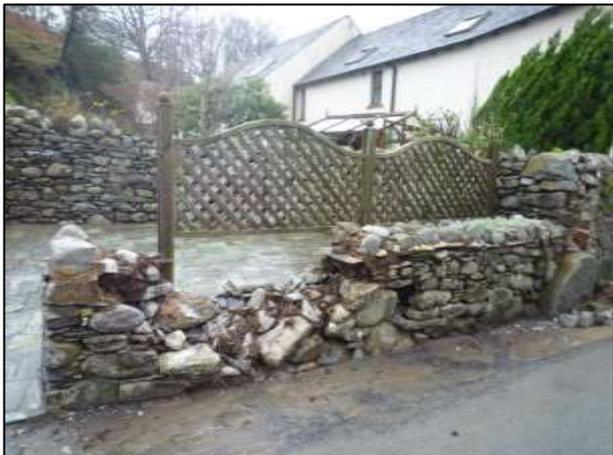
to the Ivy House Hotel, **Photographs 12 and 13**. This also routed floodwater through the properties and private car park behind Peter House at this location. Parked cars were carried away by the floodwater.

Photograph 12: Flood damage to an adjacent wall on the flowpath near the Ivy House Hotel

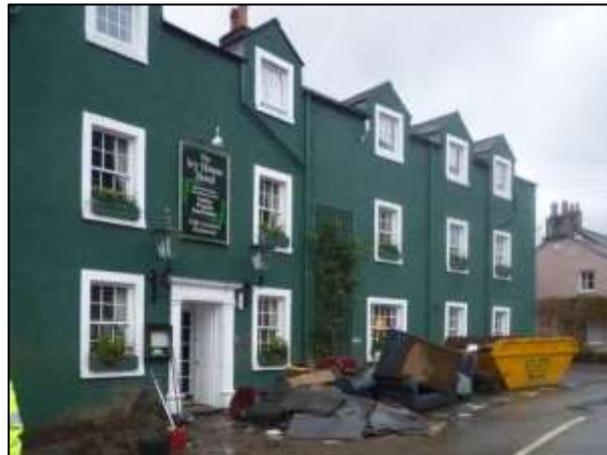
Photograph 13: Flood damage at the Ivy House Hotel

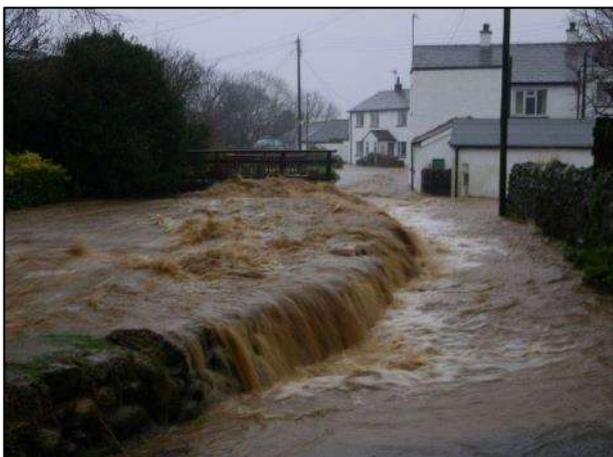
The foot bridges impacted on the Coledale Low Bridge and became caught within the opening, creating a blockage. **Photograph 14** and **Photograph 15** also show how during the flooding incident the water level in the Coledale Beck overtopped the crest level of the embankment on the right bank of the watercourse upstream of the Coledale Low Bridge. The severity of the flooding also damaged the embankment.

Photograph 14: Looking downstream at the footbridges on the Coledale Beck

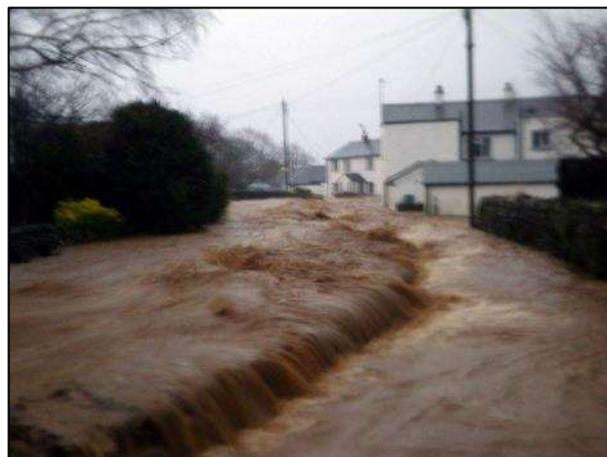
Photograph 15: Looking downstream at the where the footbridges were located

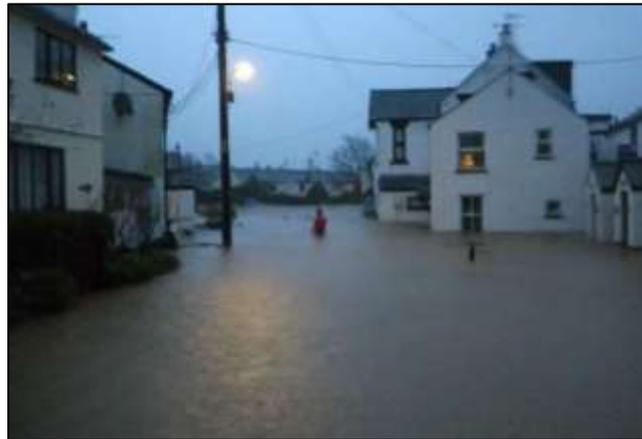
Photograph 16: Flooding at the Braithwaite Village Shop, looking east towards the Coledale Beck

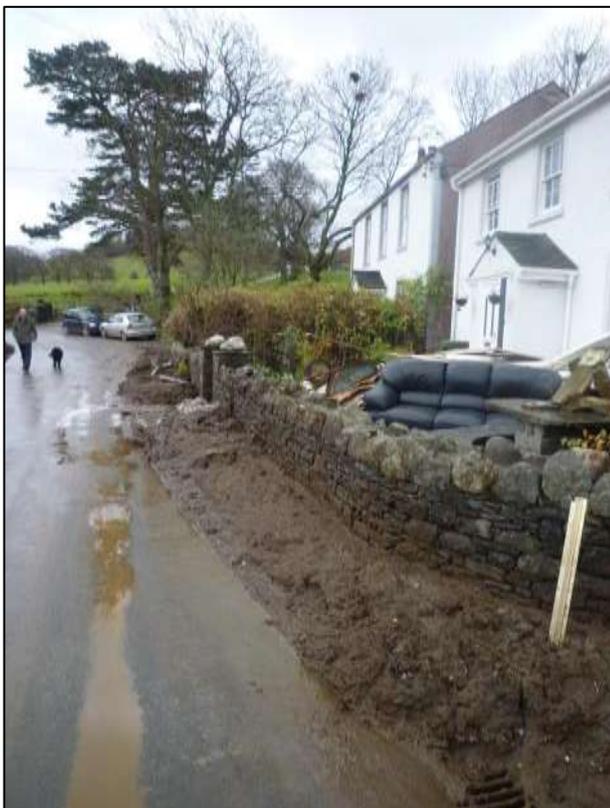
Photograph 17: Property flooding and debris near Coledale Low Bridge

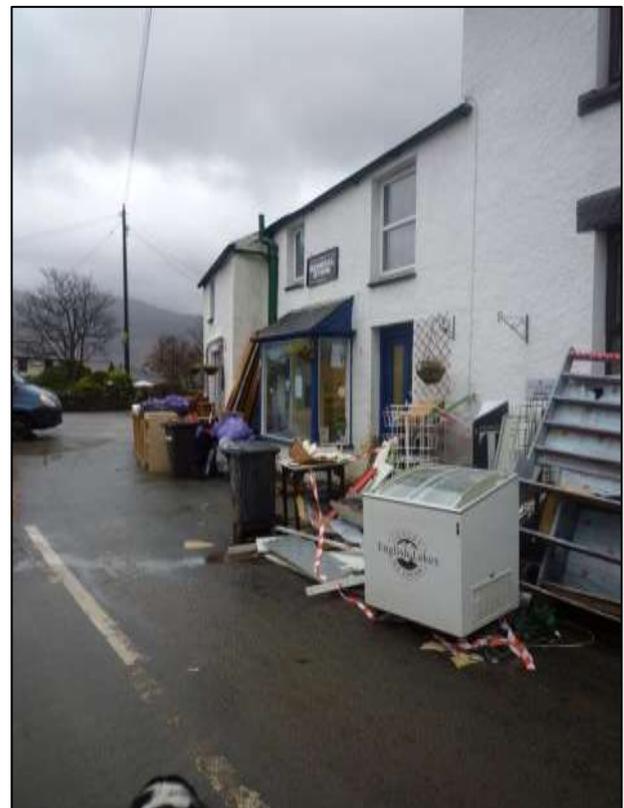
Photograph 18: Flood damage at the Braithwaite Village Shop next to Coledale Low Bridge

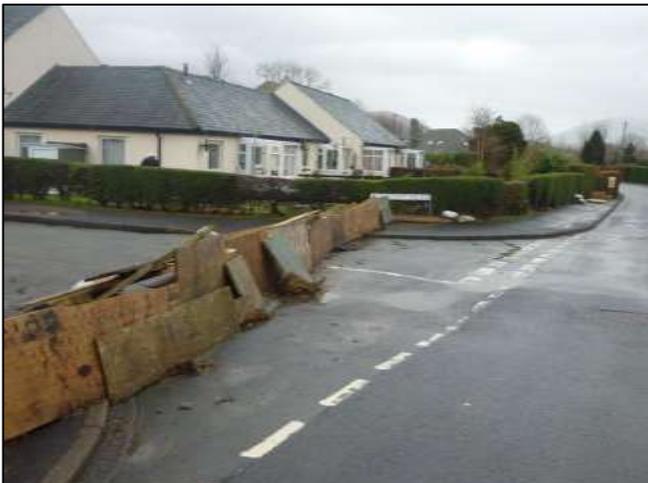
Photograph 19: Improvised flood barricades across the entrance to Longcroft

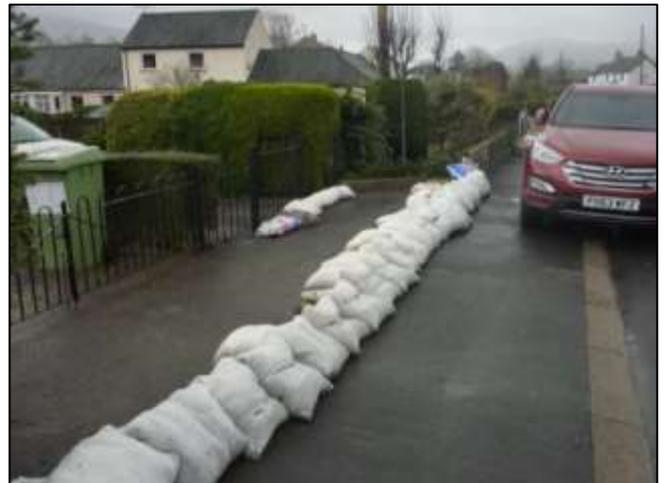
Photograph 20: Sandbags defending residential property on the B5292

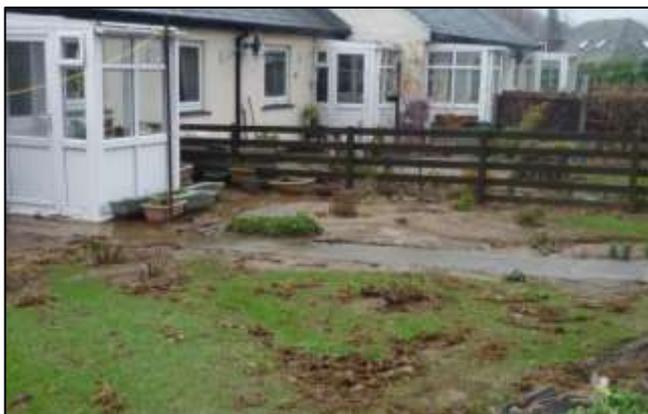
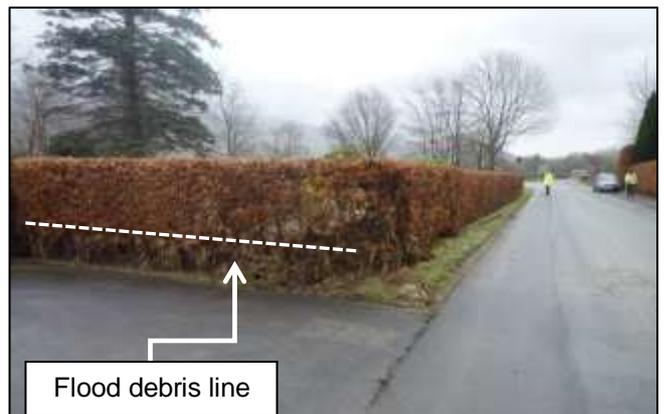
Photograph 21: Flooding damage at the corner of Longcroft

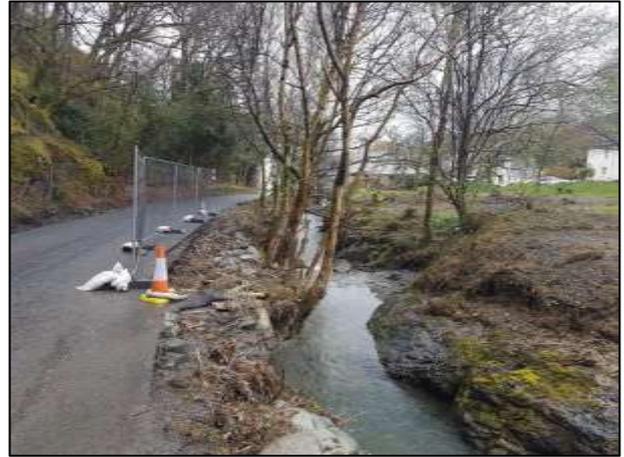
Photograph 24: Scour and undermining of the B5292 immediately north of Braithwaite

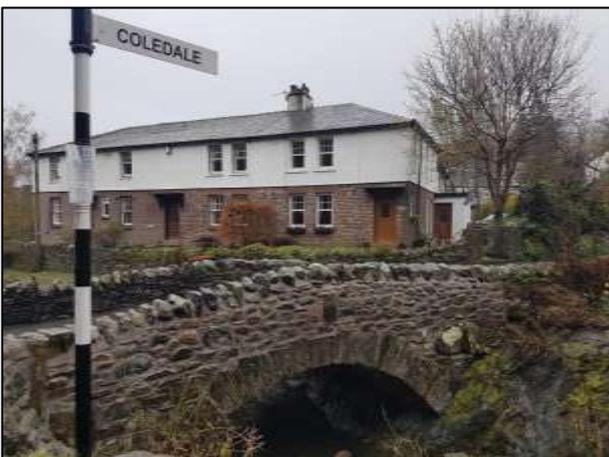
Further downstream, the parapet on the Upper Coledale Bridge was observed as having been recently repaired, **Photograph 25**. The opening under the bridge was observed as being constrained and a potential throttle to flood flows due to its low opening and effective capacity. Immediately downstream of this sandbags were present on the crest of the left bank of the Coledale Beck, **Photograph 26**. These temporary measures were deployed on the 26th December 2015 when Storm Frank brought further rainfall and elevated water levels across Cumbria. Further flooding was experienced by Brook Cottage.

Photograph 25: Refurbished parapet over the High Coledale Bridge

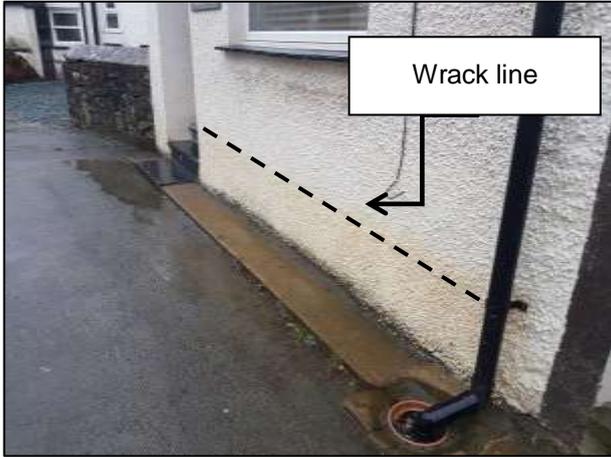
High water (wrack) lines were observed as being approximately a foot and a half above property thresholds in this area, **Photograph 27**. The flood defence embankment located immediately upstream of the Coledale Lower Bridge showed signs of temporary repair undertaken following the 5 December 2015 flooding event, **Photograph 28**.

Photograph 27: Wrack marks on property near the Ivy House Hotel

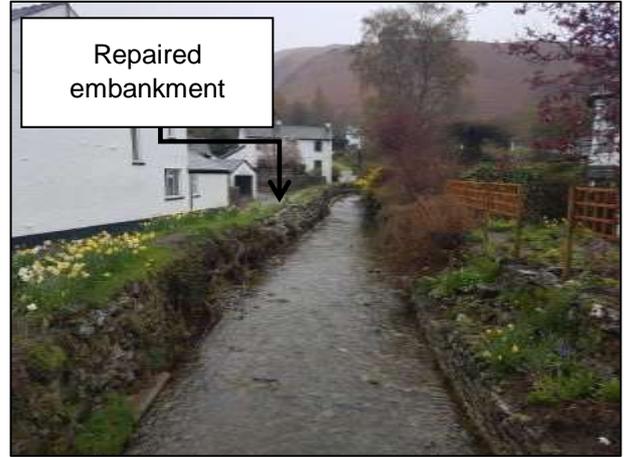
Photograph 28: Flood defence embankment on the right bank of the Coledale Beck

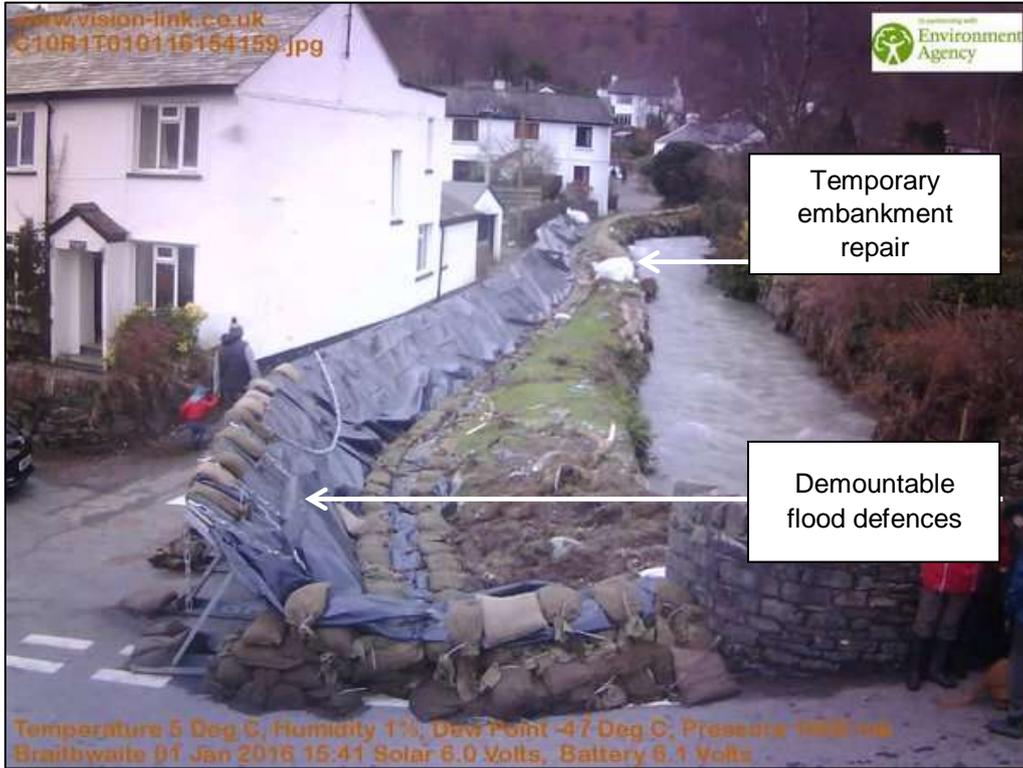
Photograph 31: Infilled flood defence embankment and demountable defences on the right bank of the Coledale Beck (looking upstream)

- Cumbria County Council cordoned off the Coledale Upper Bridge, **Photograph 30**.
- The damage to the flood defence embankment on the right bank of the Coledale was temporarily filled in. Demountable defences were later deployed on the 26th December by Army Engineers working with the Environment Agency. Both measures can be seen in **Photograph 31**.

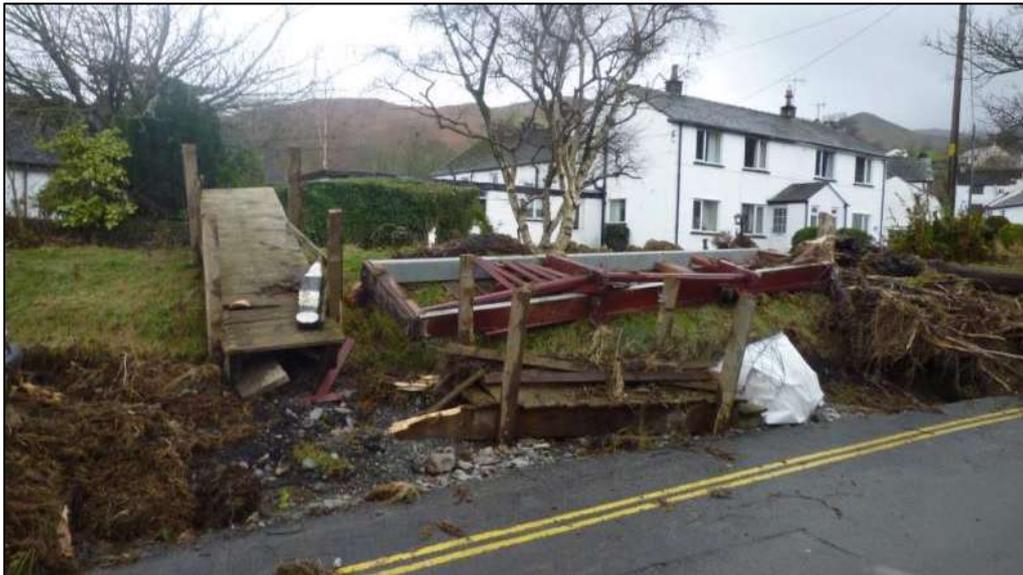
Photograph 32: Remains of the two footbridges which were removed from the Coledale Beck lower bridge

- Debris and other material was removed from the Coledale Beck and areas within the village, including the footbridges which were washed away during the flooding incident, **Photograph 32**.

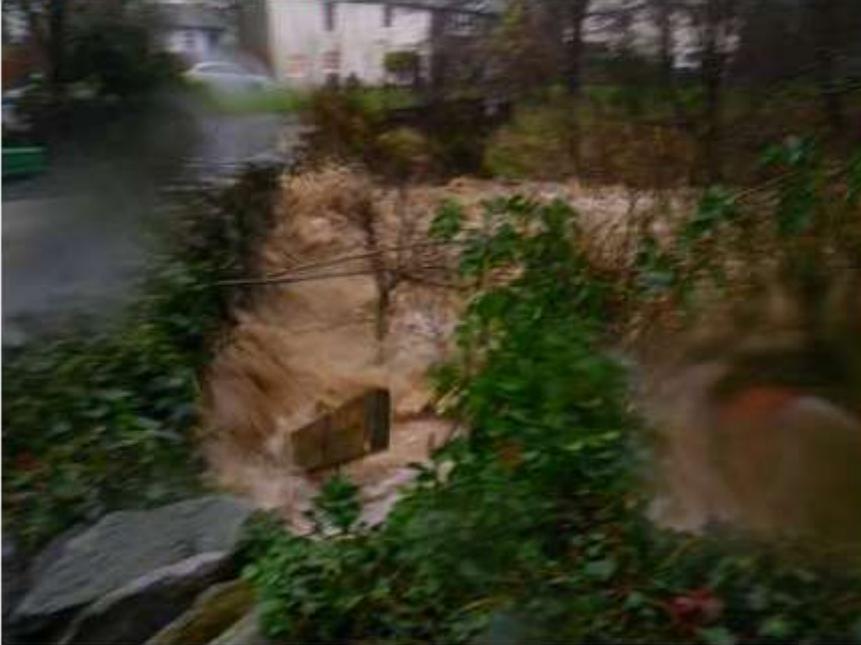
41. 14:57 Water at top of High Bridge, parapet under stress

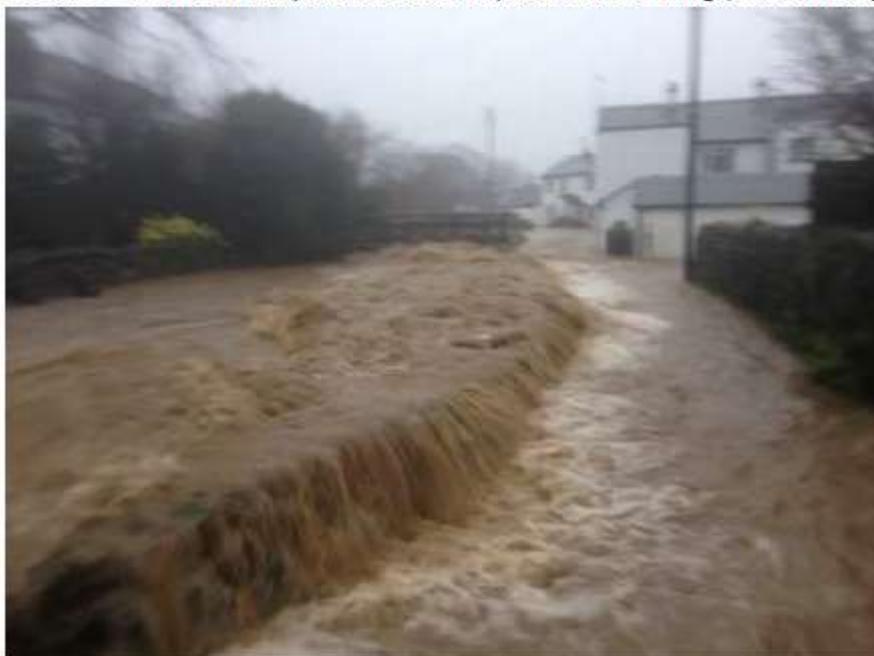
44. 15:14 – Upstream parapet shown as collapsed

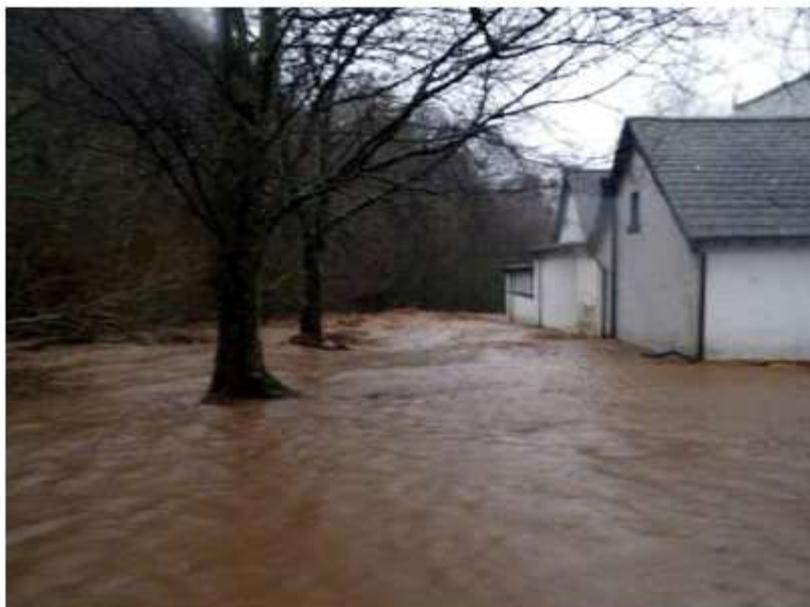
46. 15:38 All wooden upstream of Low Bridge are shown as down and totally blocking Low Bridge and forcing more water out of the beck
