Section 19 Flood Investigation Report Ellen Grove, Maryport

Flood Event Saturday 15th October 2022

Cumberland Council as a Lead Local Flood Authority under Section 19 of the Flood and Water Management Act 2010 have produced this flood investigation report.

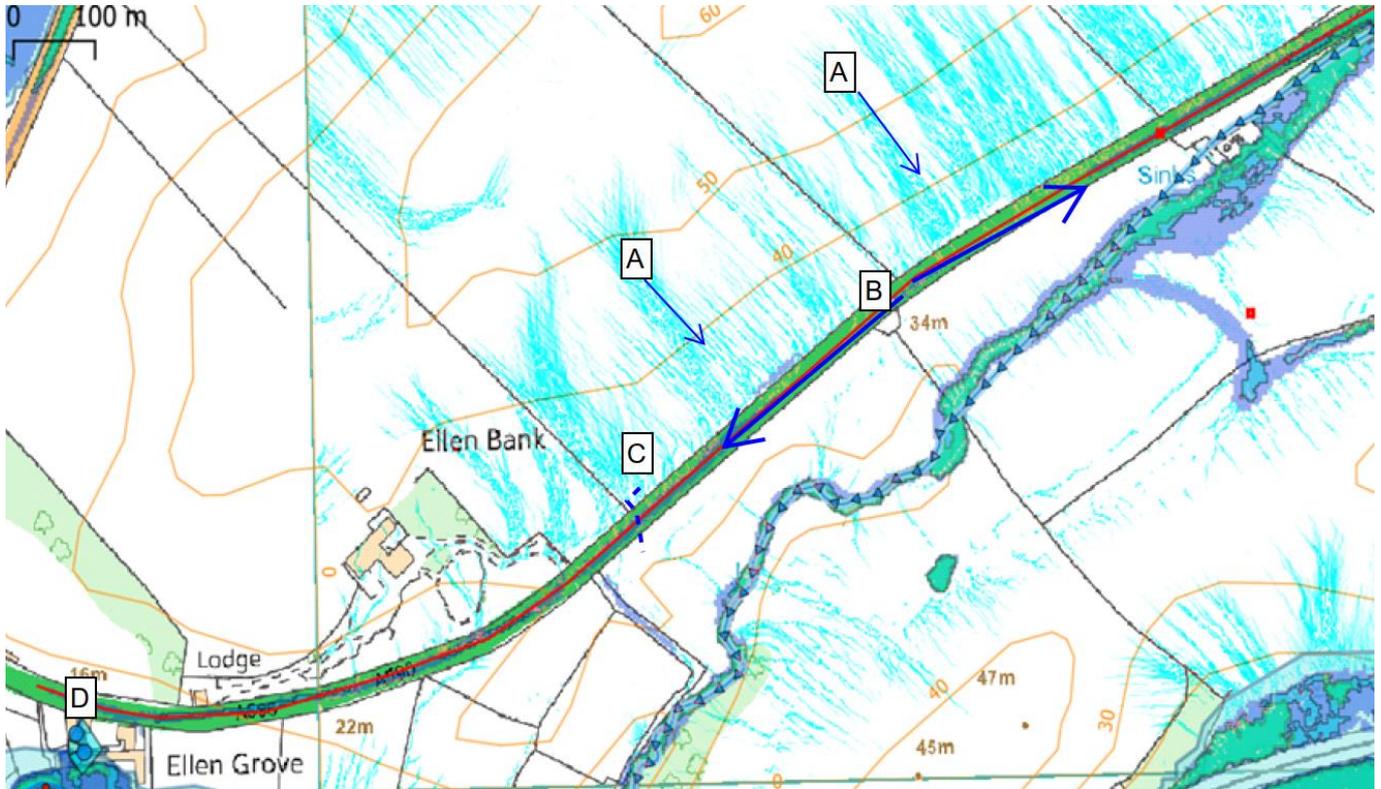
The fields at the top of the hill (A) are ploughed perpendicular with the road and water ran through these furrows through the hedgerow and out of the field entrance (B). There was no ditch in the field to stop this water, so it ran straight out and over the verge onto the road and footway. Silt that had been picked up as part of this run off was deposited onto the carriageway and into the drainage system.

The outfall close to Ellen Bank (C) was obstructed in the field by pieces of large debris and blockages at choke points along the watercourse also prevented the water to discharge at full capacity. Water that could not get into the two drainage systems up-stream then bypassed the gullies and collected in the dip in the carriageway at Ellen Grove (D). It then over-topped the kerb face and into the property it was also pushed by the tidal motion of passing vehicles.

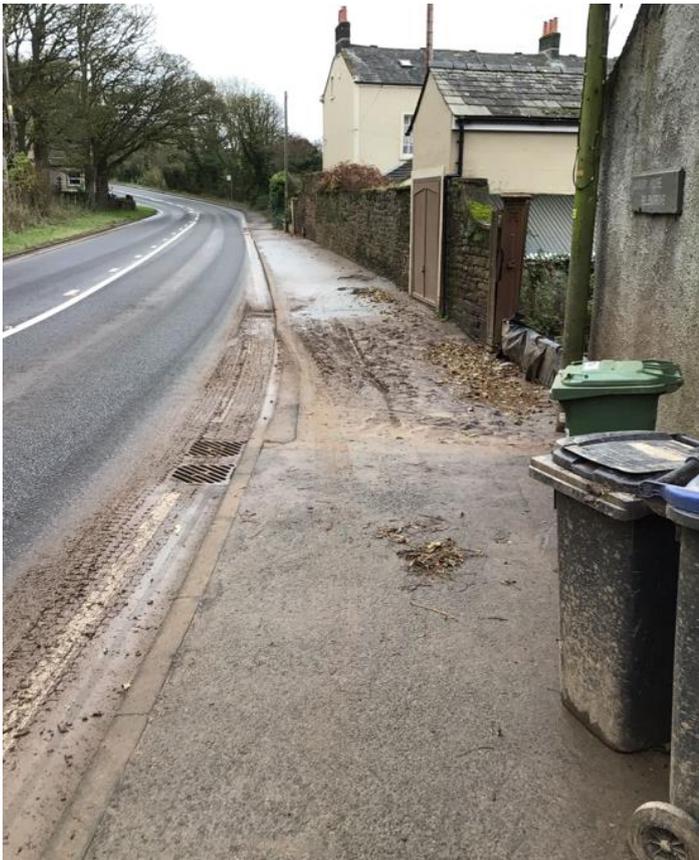
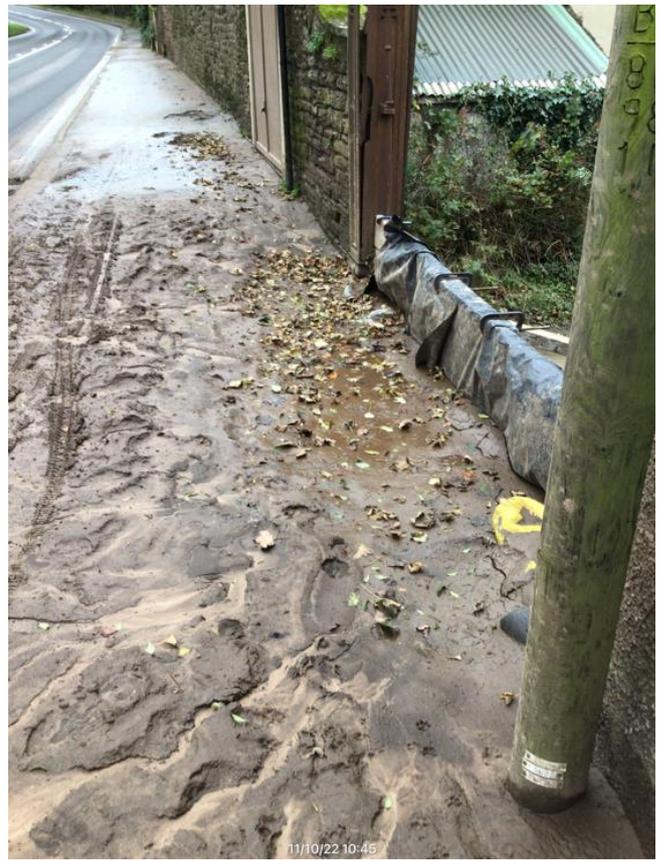
Photographs of the silt deposits at the driveway to the affected properties

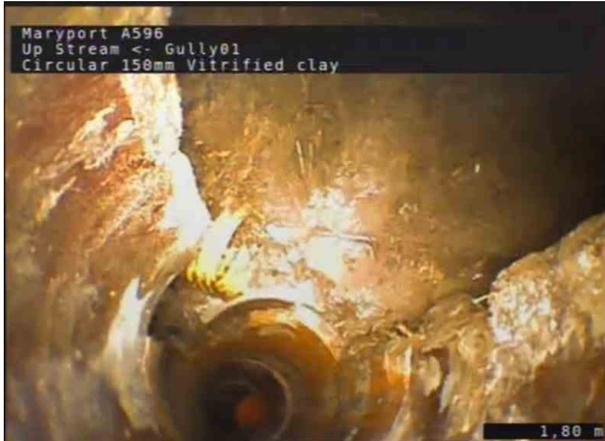
1, 00:00:39, 1.80 m
General remark, Possible buried chamber or void

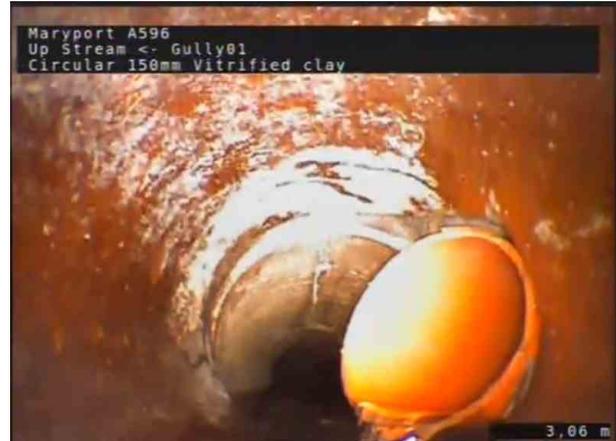
2, 00:01:20, 3.06 m
Connection defective, position incorrect and intruding at 4 o'clock, 100mm dia, intrusion: 50%

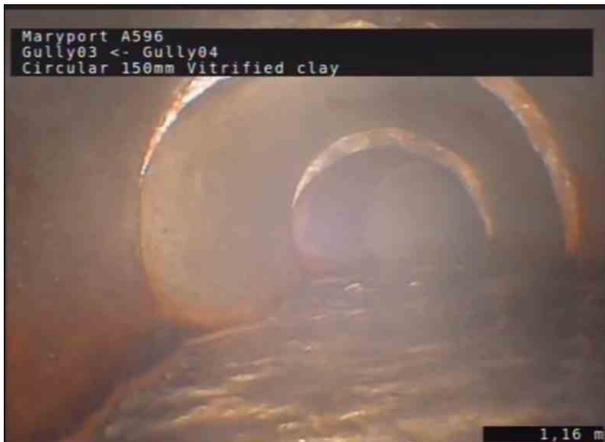
1, 00:00:33, 1.12 m
Attached deposits, encrustation from 4 o'clock to 8 o'clock,
30% cross-sectional area loss, start

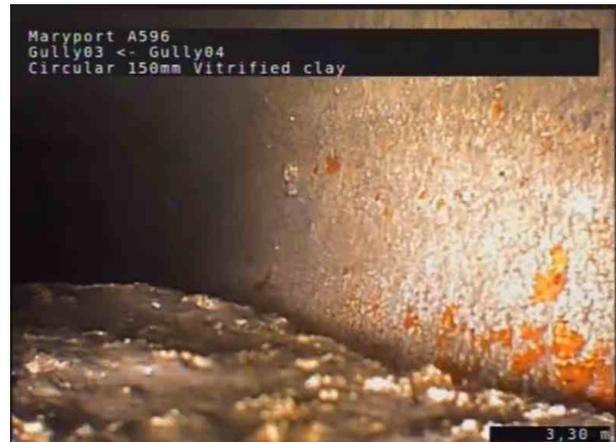
2, 00:00:44, 3.31 m
Other obstacles, other object in invert from 3 o'clock to 9
o'clock, 30% cross-sectional area loss, Loose grout

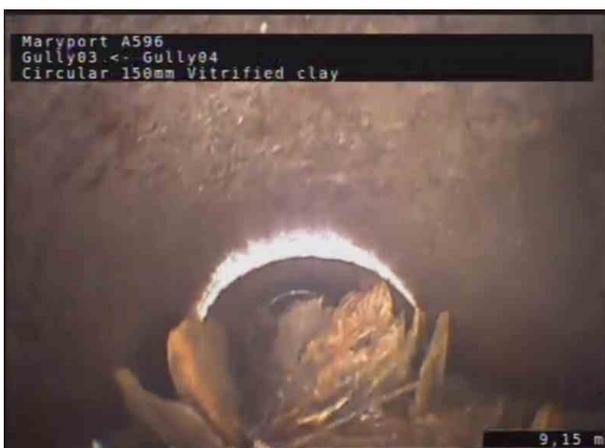
3, 00:01:22, 9.15 m
Settled deposits, other, 75% cross-sectional area loss, Loose
grout

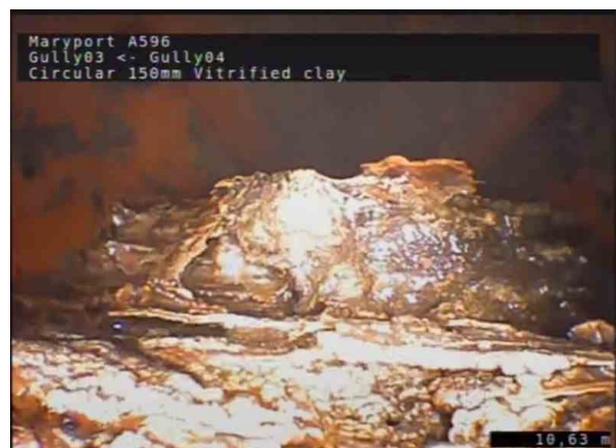
4, 00:01:45, 10.68 m
Attached deposits, encrustation from 3 o'clock to 9 o'clock,
50% cross-sectional area loss, Grout

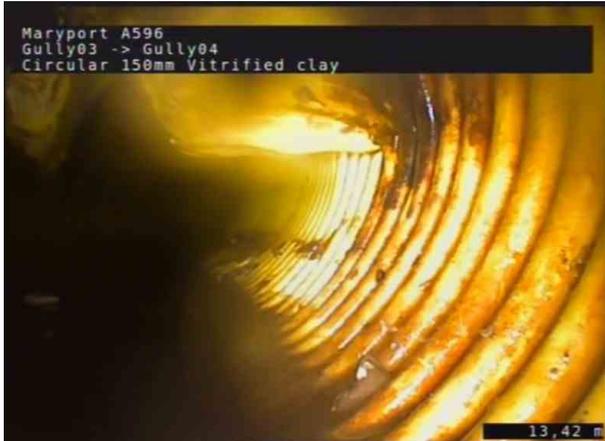
1, 00:02:19, 13.51 m
Deformed sewer or drain, 45%

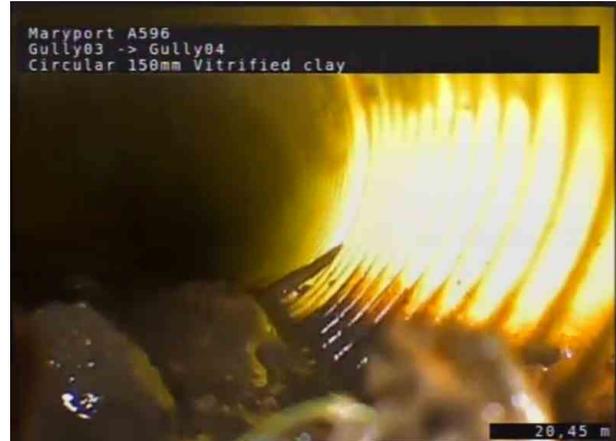
2, 00:03:07, 20.16 m
Settled deposits, coarse, 30% cross-sectional area loss

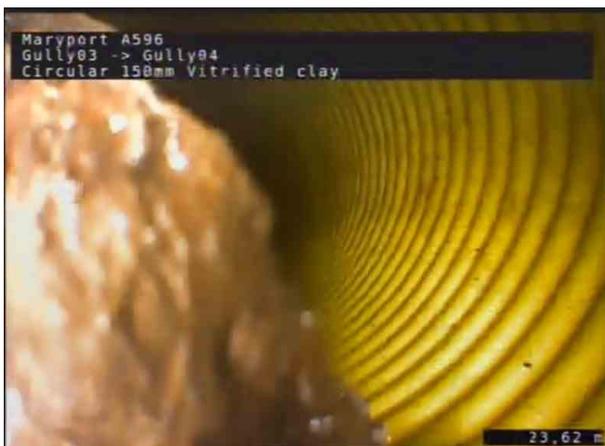
3, 00:03:21, 23.62 m
Settled deposits, coarse, 30% cross-sectional area loss

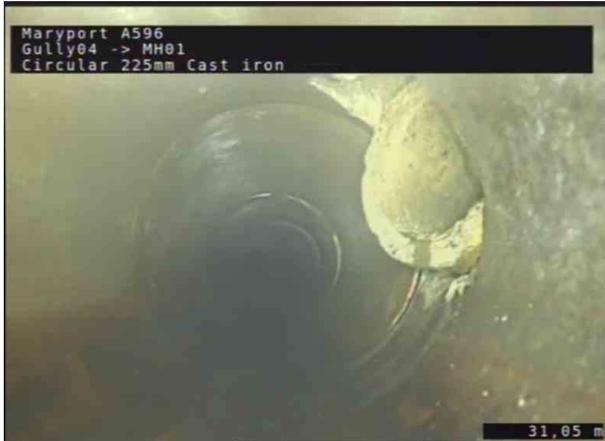
1, 00:02:42, 31.05 m
Connection defective, connecting pipe is intruding at 2 o'clock,
100mm dia, intrusion: 15%

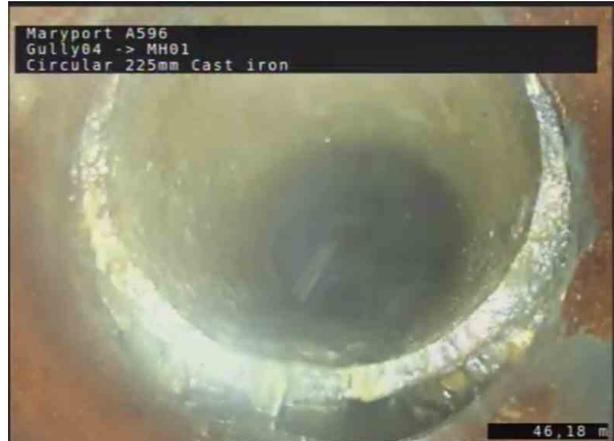
2, 00:04:01, 46.18 m
Joint displaced, medium

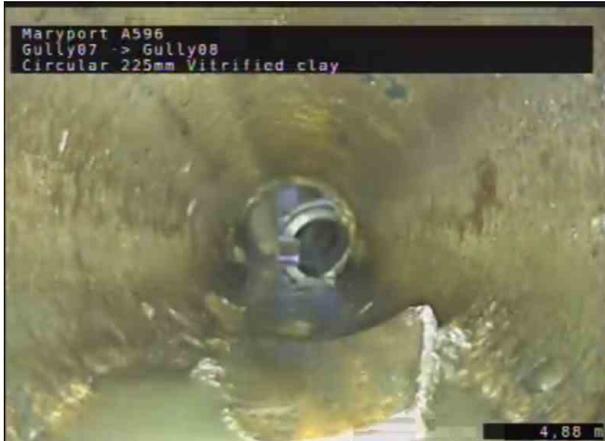
1, 00:00:40, 4.88 m
Other obstacles, pipe material in invert from 4 o'clock to 7 o'clock, 10% cross-sectional area loss

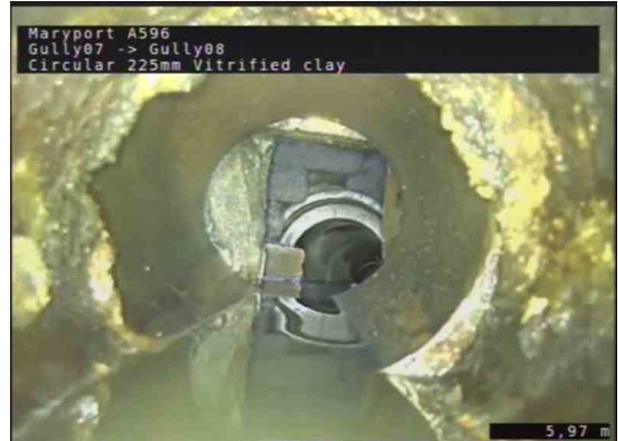
2, 00:00:47, 5.97 m
Attached deposits, encrustation from 8 o'clock to 4 o'clock, 10% cross-sectional area loss

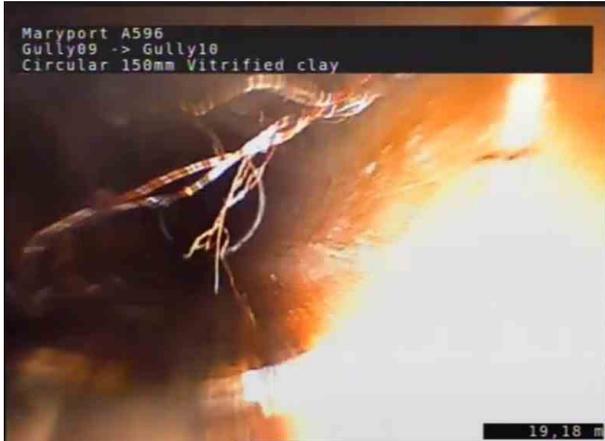
1, 00:01:37, 19.27 m
 Roots, fine at joint

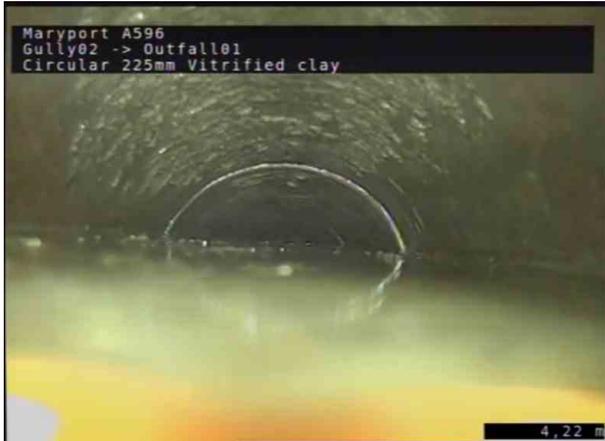
1, 00:00:42, 4.15 m
Water level, 70% of the vertical dimension

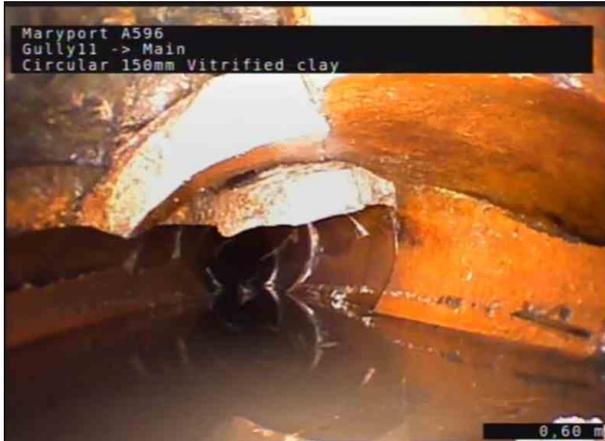
1, 00:00:11, 0.60 m
Broken pipe from 9 o'clock to 3 o'clock

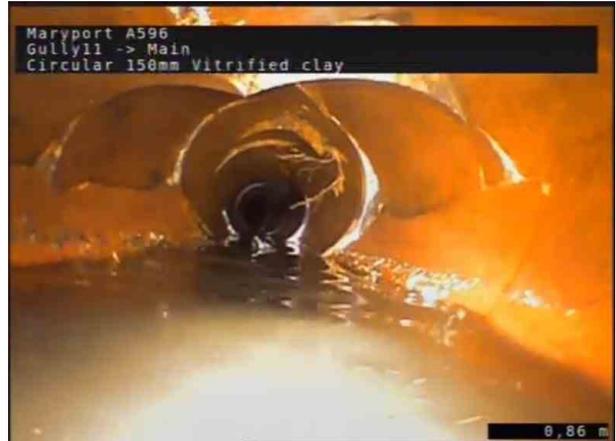
2, 00:00:18, 0.96 m
Fractures, multiple from 12 o'clock to 12 o'clock

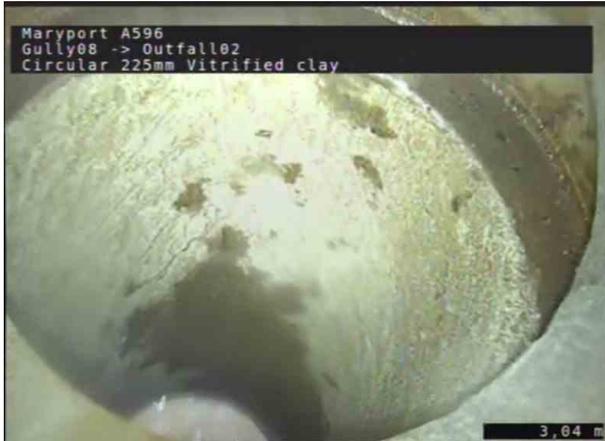
1, 00:00:22, 3.04 m
 Joint displaced, large

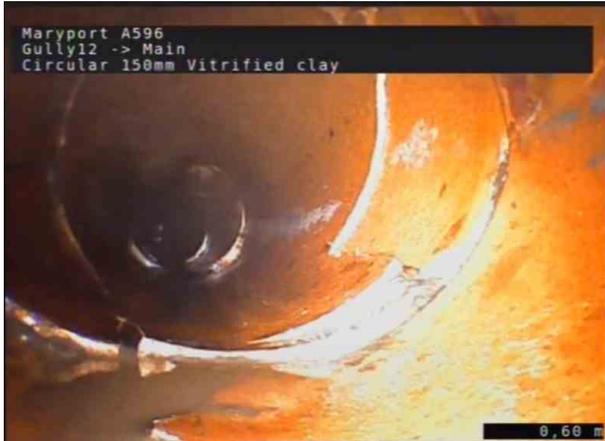
1, 00:00:14, 0.60 m
Fractures, multiple from 12 o'clock to 12 o'clock

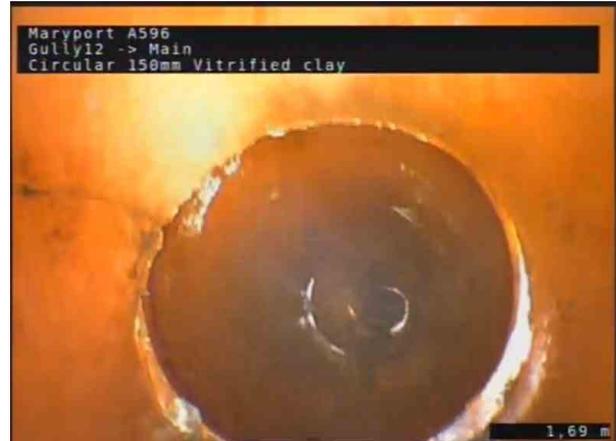
2, 00:00:28, 1.69 m
Crack, longitudinal at 10 o'clock

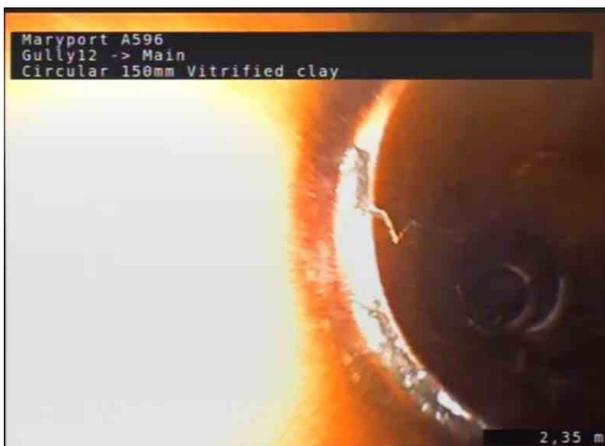
3, 00:00:33, 2.43 m
Fracture, longitudinal at 10 o'clock

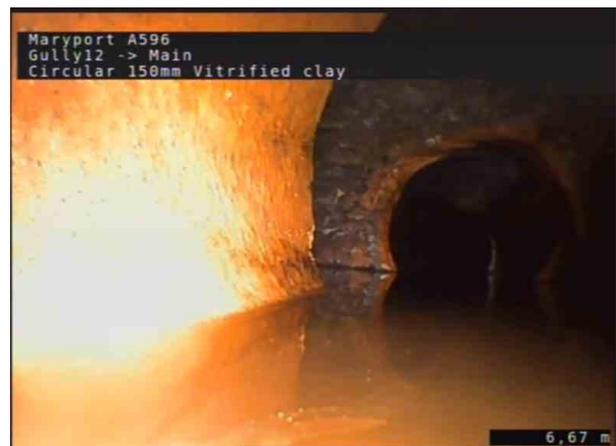
4, 00:01:10, 6.67 m
Hole in drain or sewer from 12 o'clock to 12 o'clock, Large void

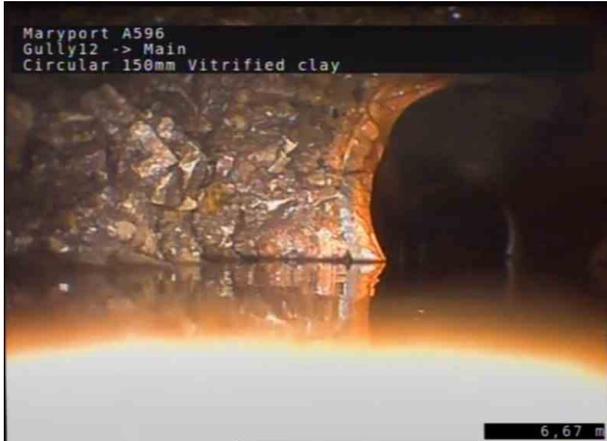
5, 00:01:17, 6.67 m
Void visible beyond defect

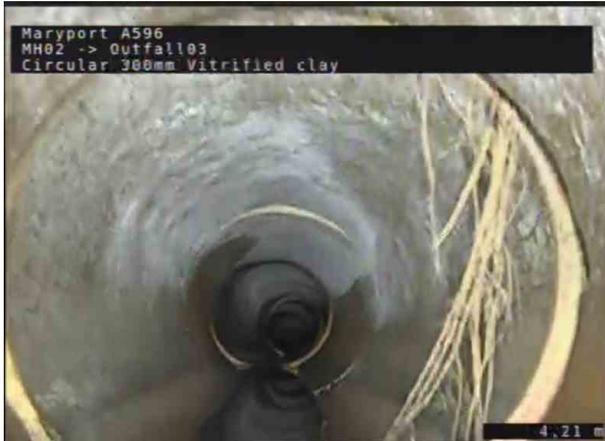
1, 00:00:36, 4.21 m
Roots, fine at joint

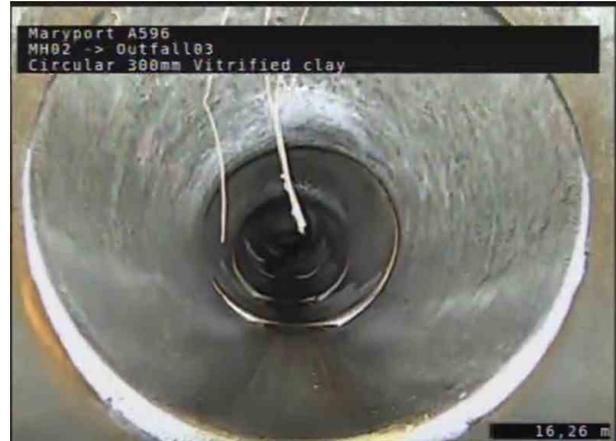
2, 00:01:27, 16.26 m
Roots, fine at joint

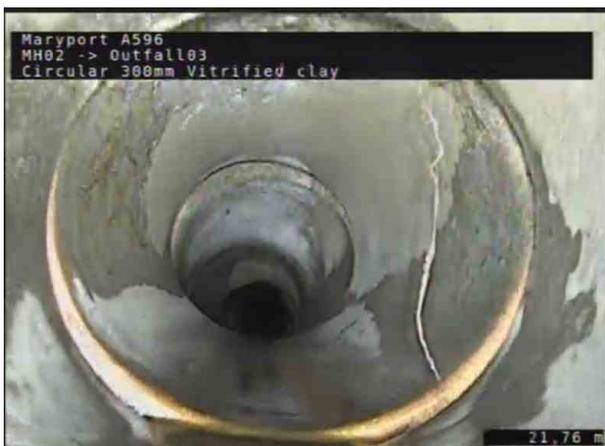
3, 00:01:46, 21.87 m
Roots, fine at joint

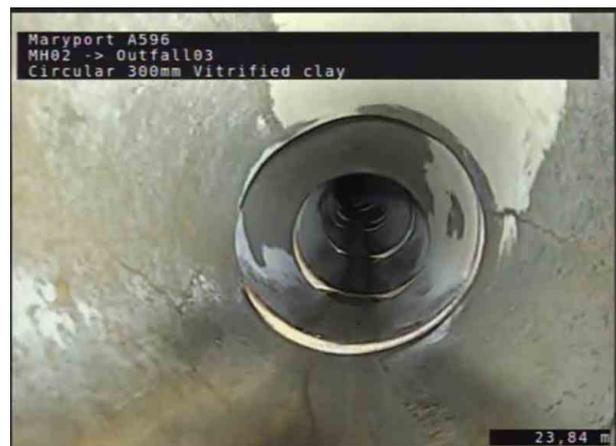
4, 00:01:54, 23.84 m
Crack, longitudinal at 3 o'clock

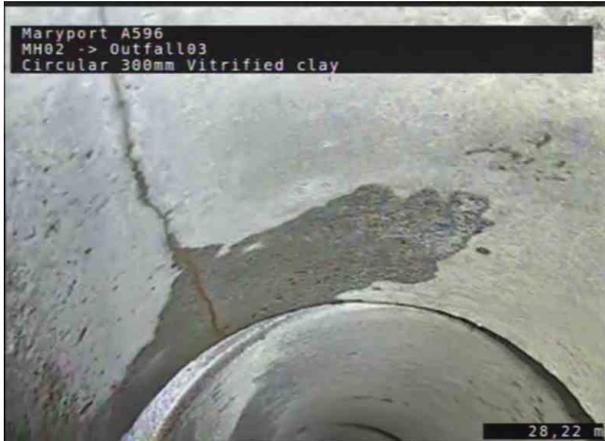
5, 00:02:16, 28.22 m
Crack, longitudinal at 8 o'clock

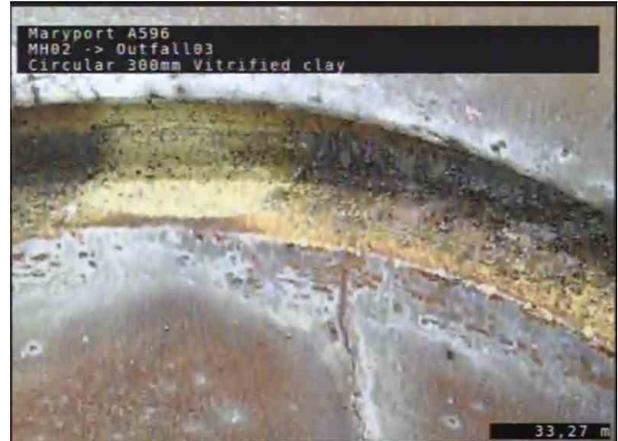
6, 00:02:49, 33.27 m
Crack, longitudinal at 4 o'clock

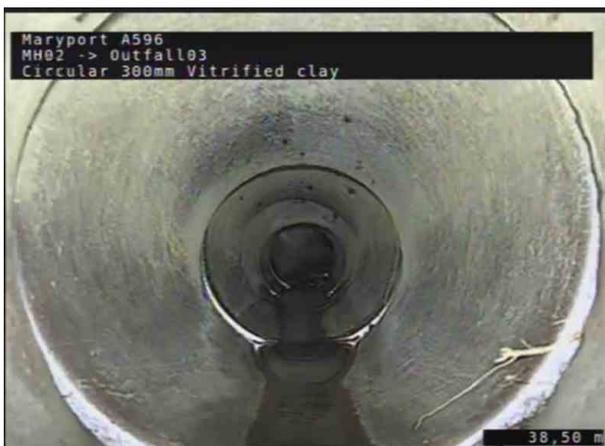
7, 00:03:19, 38.55 m
Roots, fine at joint

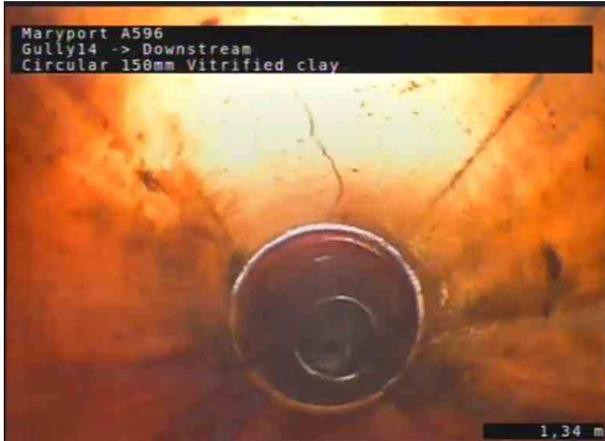
1, 00:00:19, 1.37 m
Fracture, longitudinal at 12 o'clock

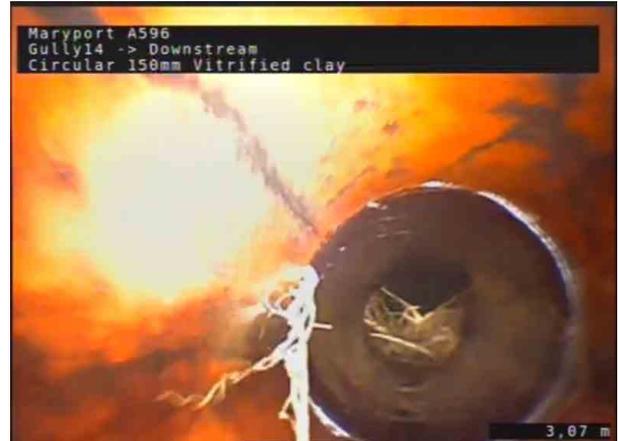
2, 00:00:29, 3.07 m
Roots, fine at joint, start

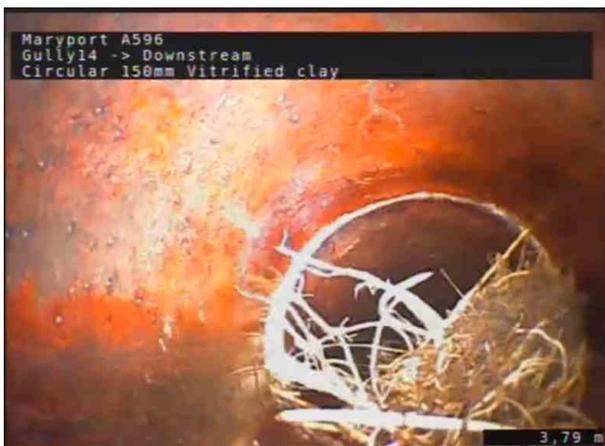
3, 00:00:33, 3.79 m
Roots, mass, 40% cross-sectional area loss

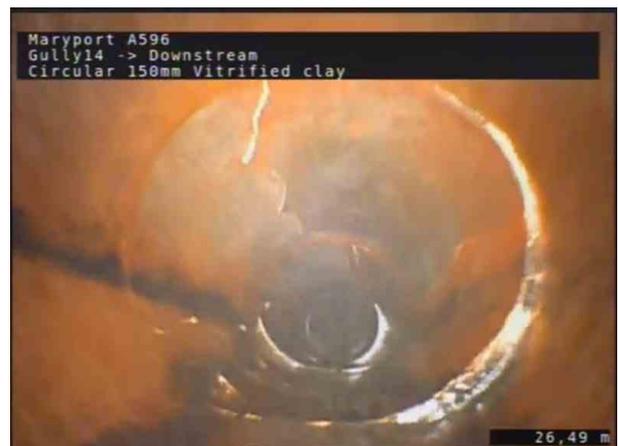
4, 00:03:32, 26.64 m
Fractures, multiple from 12 o'clock to 12 o'clock

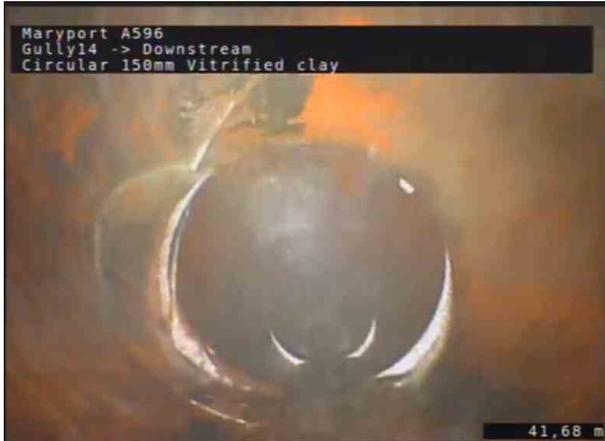
5, 00:04:40, 41.68 m
Fracture, circumferential from 12 o'clock to 12 o'clock

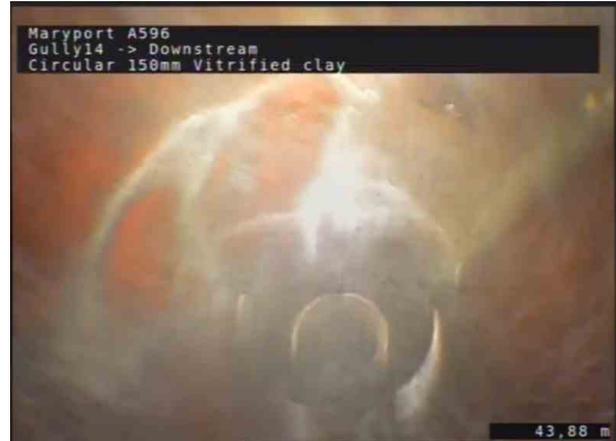
6, 00:04:48, 43.88 m
Fractures, multiple from 12 o'clock to 12 o'clock

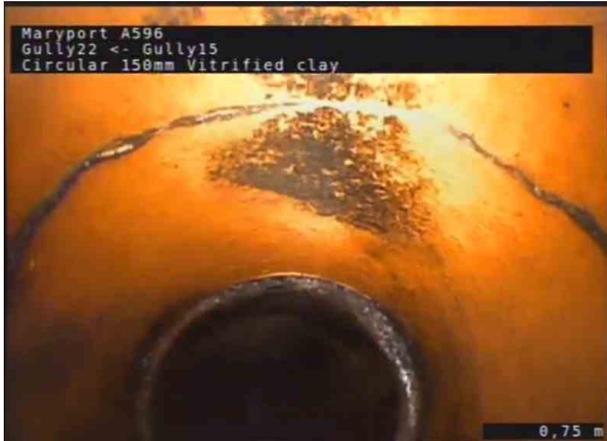
1, 00:00:14, 0.75 m
Fracture, circumferential from 9 o'clock to 3 o'clock

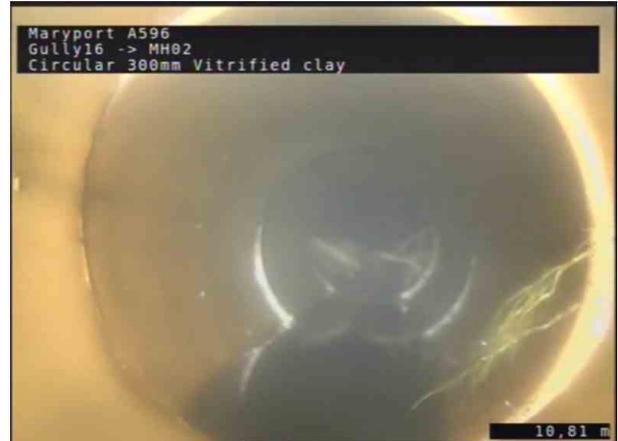
2, 00:00:49, 10.89 m
Roots, fine at joint, start

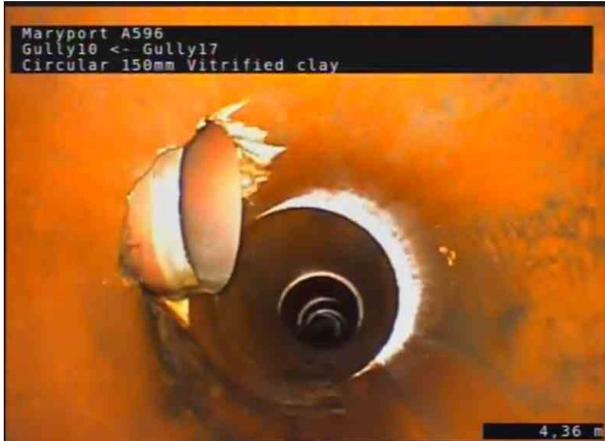
1, 00:00:33, 4.36 m
Connection defective, connecting pipe is intruding at 10 o'clock, 100mm dia, intrusion: 20%

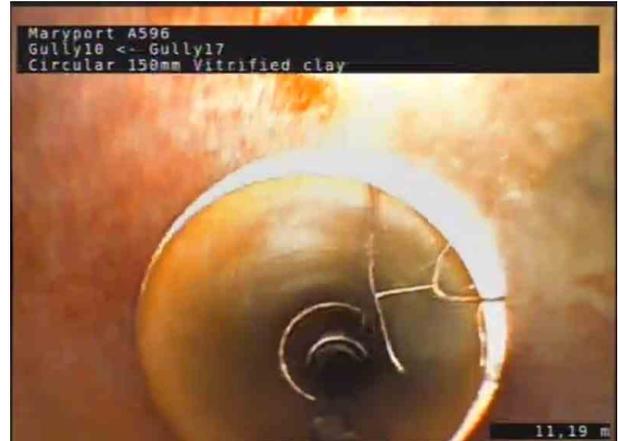
2, 00:00:57, 11.19 m
Roots, fine at joint

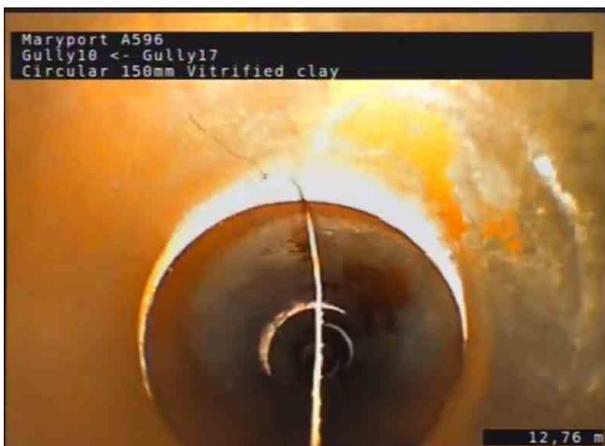
3, 00:01:03, 13.11 m
Roots, fine at joint

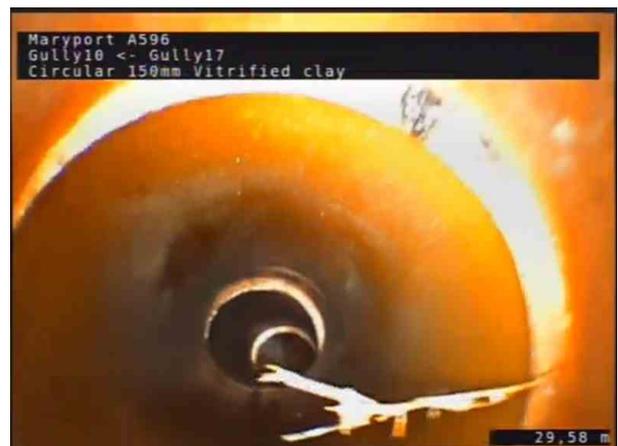
4, 00:01:52, 29.58 m
Roots, fine at joint

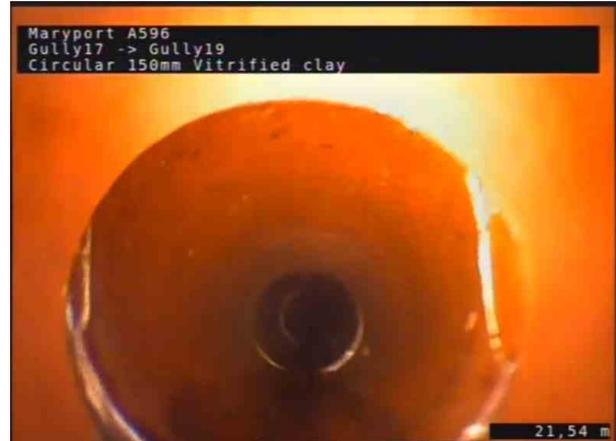
2, 00:01:54, 21.54 m
Fracture, circumferential at joint from 2 o'clock to 4 o'clock

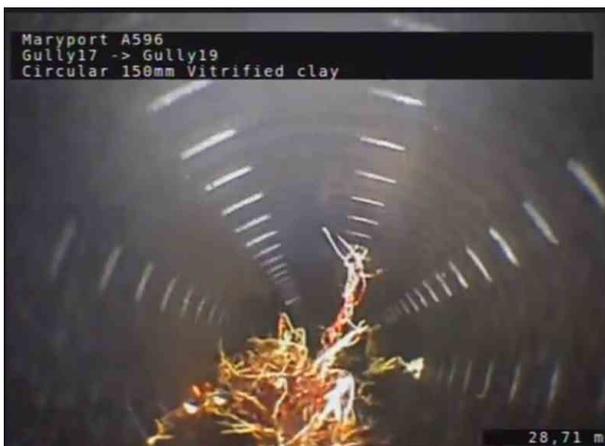
3, 00:02:17, 28.71 m
Roots, mass, 20% cross-sectional area loss

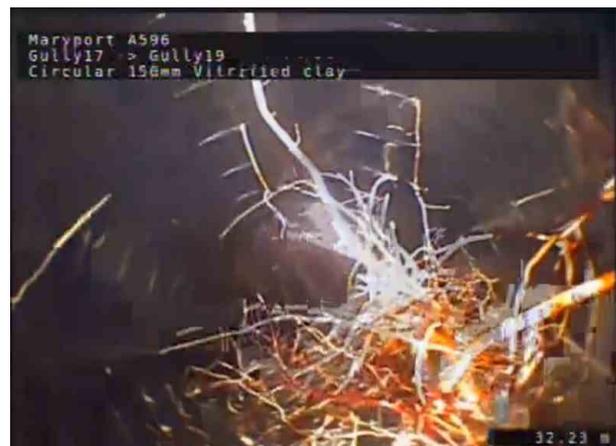
4, 00:02:39, 35.36 m
Roots, mass, 40% cross-sectional area loss, start

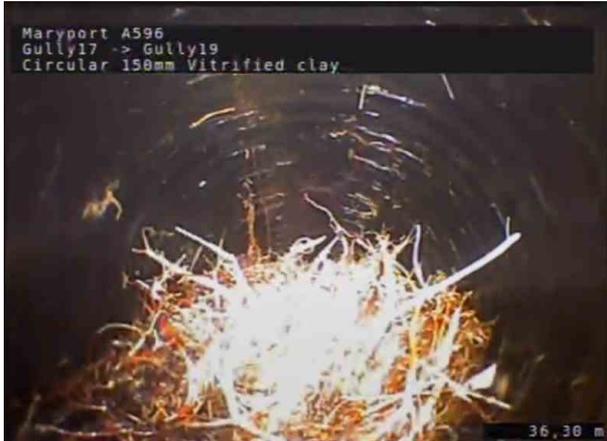
5, 00:03:19, 36.38 m
Roots, mass, 70% cross-sectional area loss

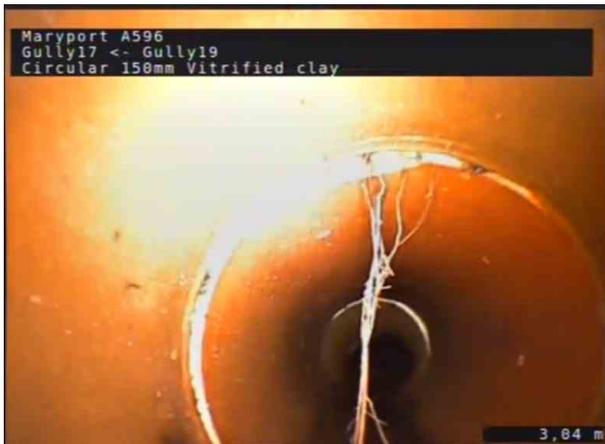
1, 00:00:29, 3.84 m
Roots, fine at joint

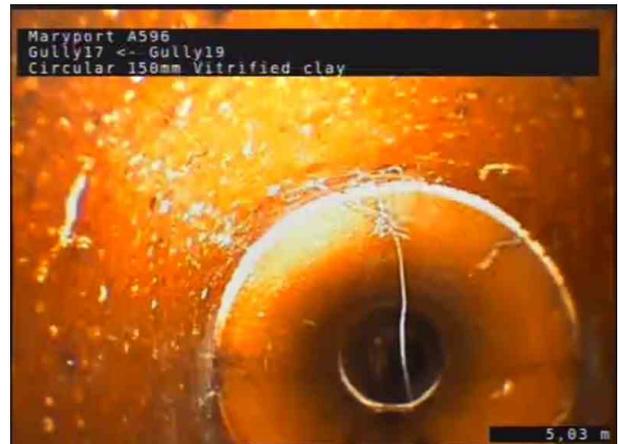
2, 00:00:33, 5.03 m
Roots, fine at joint, start

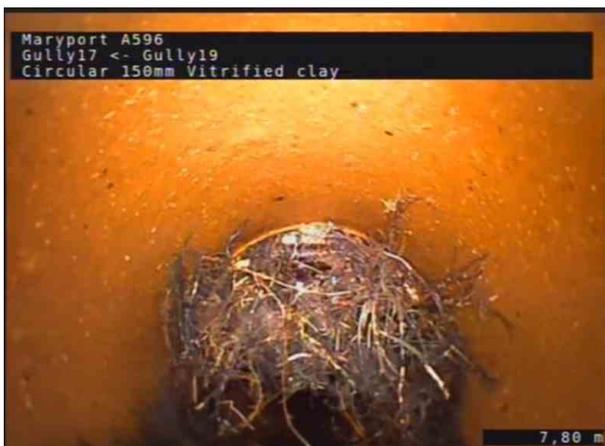
3, 00:00:48, 7.80 m
Roots, mass, 70% cross-sectional area loss

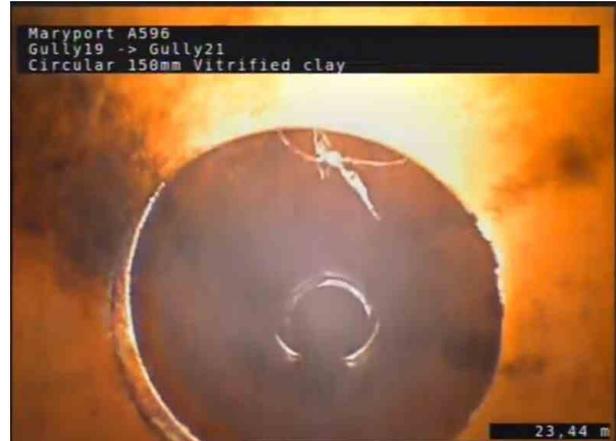
2, 00:01:30, 23.44 m
Roots, fine at joint

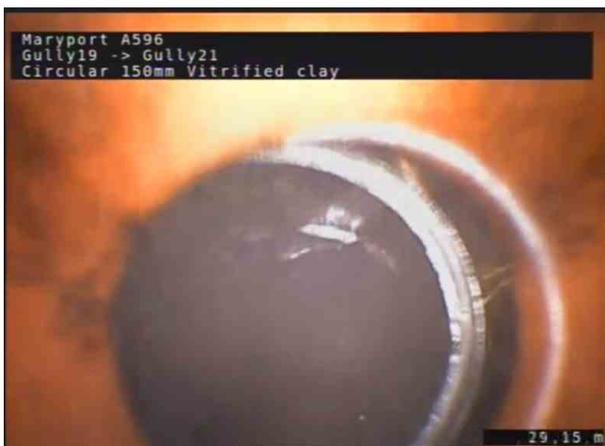
3, 00:02:04, 29.15 m
Joint displaced, large

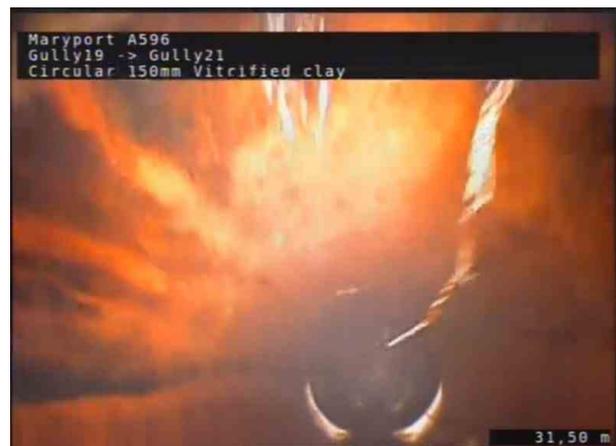
4, 00:02:22, 31.50 m
Roots, fine at joint, start

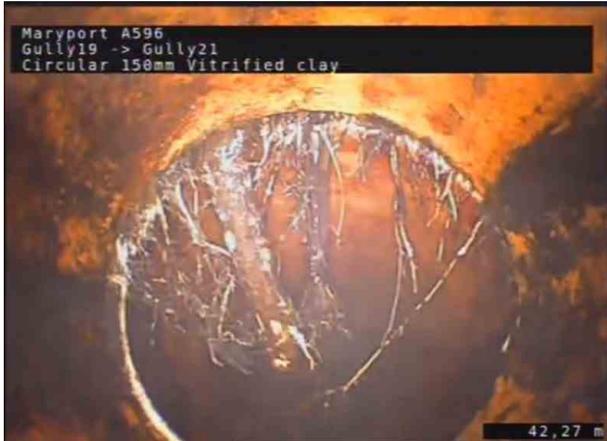
5, 00:03:18, 42.27 m
Roots, tap at joint

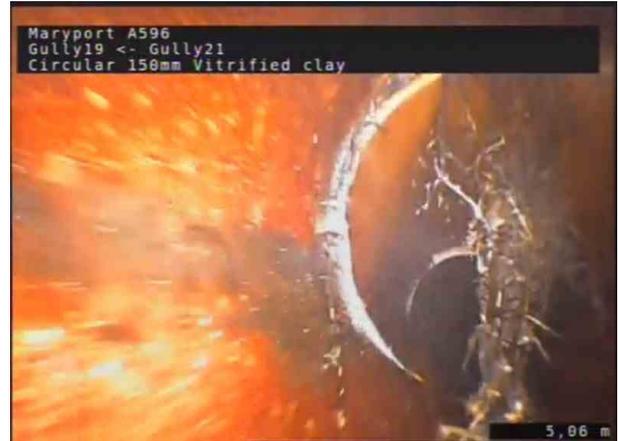
2, 00:00:49, 5.06 m
Roots, tap at joint

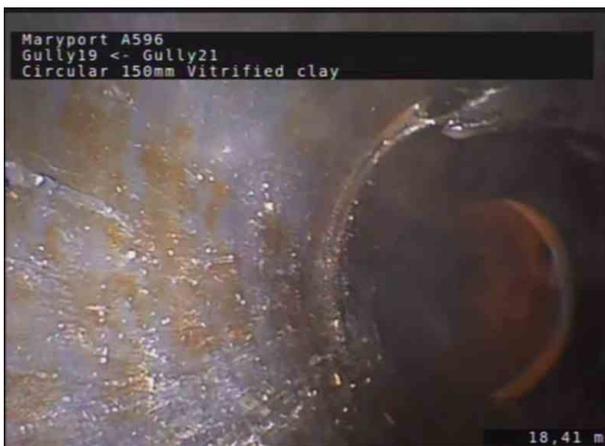
3, 00:01:40, 18.53 m
Joint displaced, large

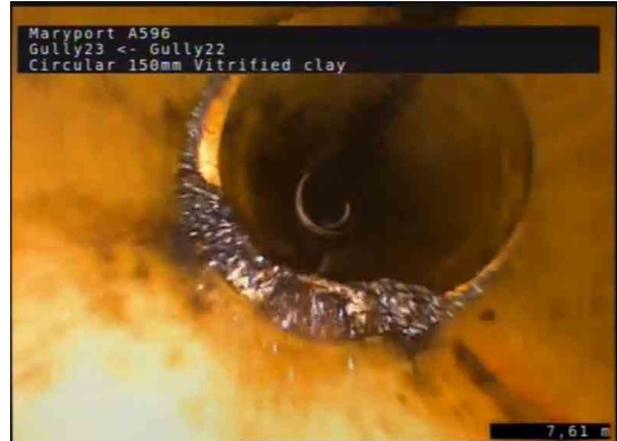
2, 00:01:21, 7.61 m
Attached deposits, encrustation at joint from 5 o'clock to 9 o'clock, 15% cross-sectional area loss

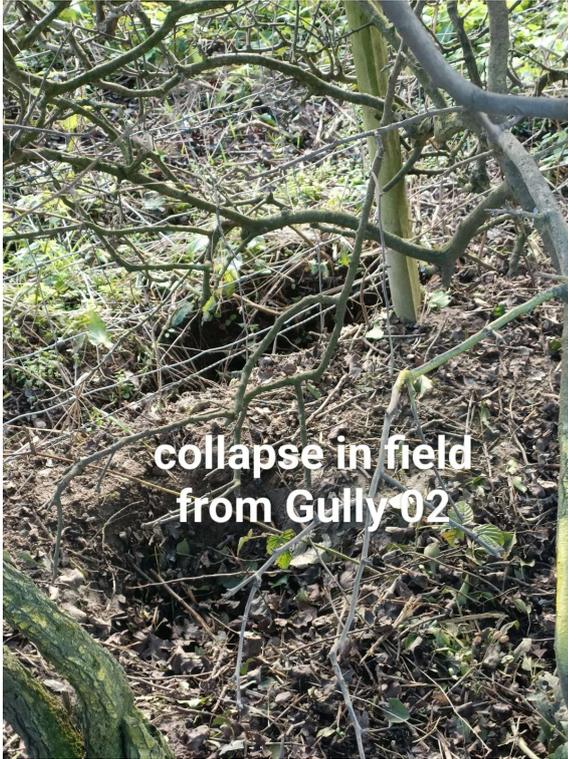
**collapse in field
from Gully 02**

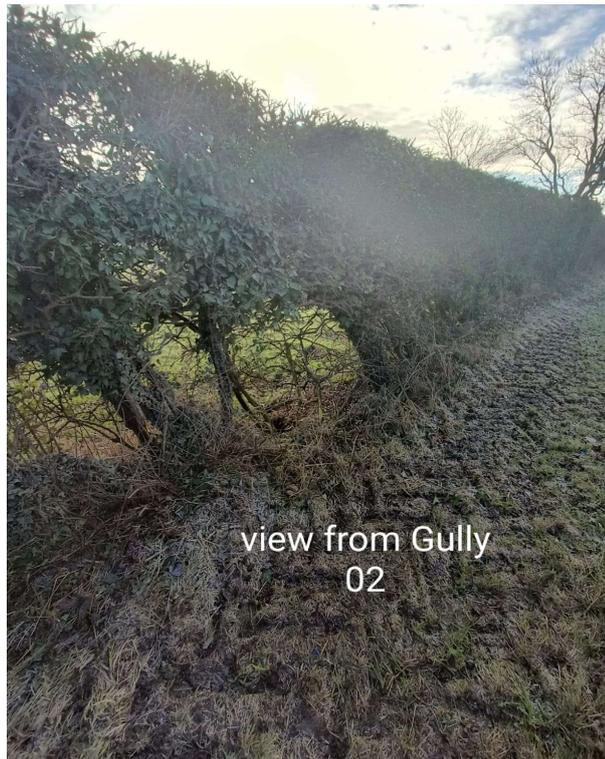
**view from Gully
02**
