Gosforth

Flood Investigation Report No.26

**Flood Event:
30th August 2012**

This flood investigation report has been produced by Cumbria County Council as a Lead Local Flood Authority under Section 19 of the Flood and Water Management Act 2010.

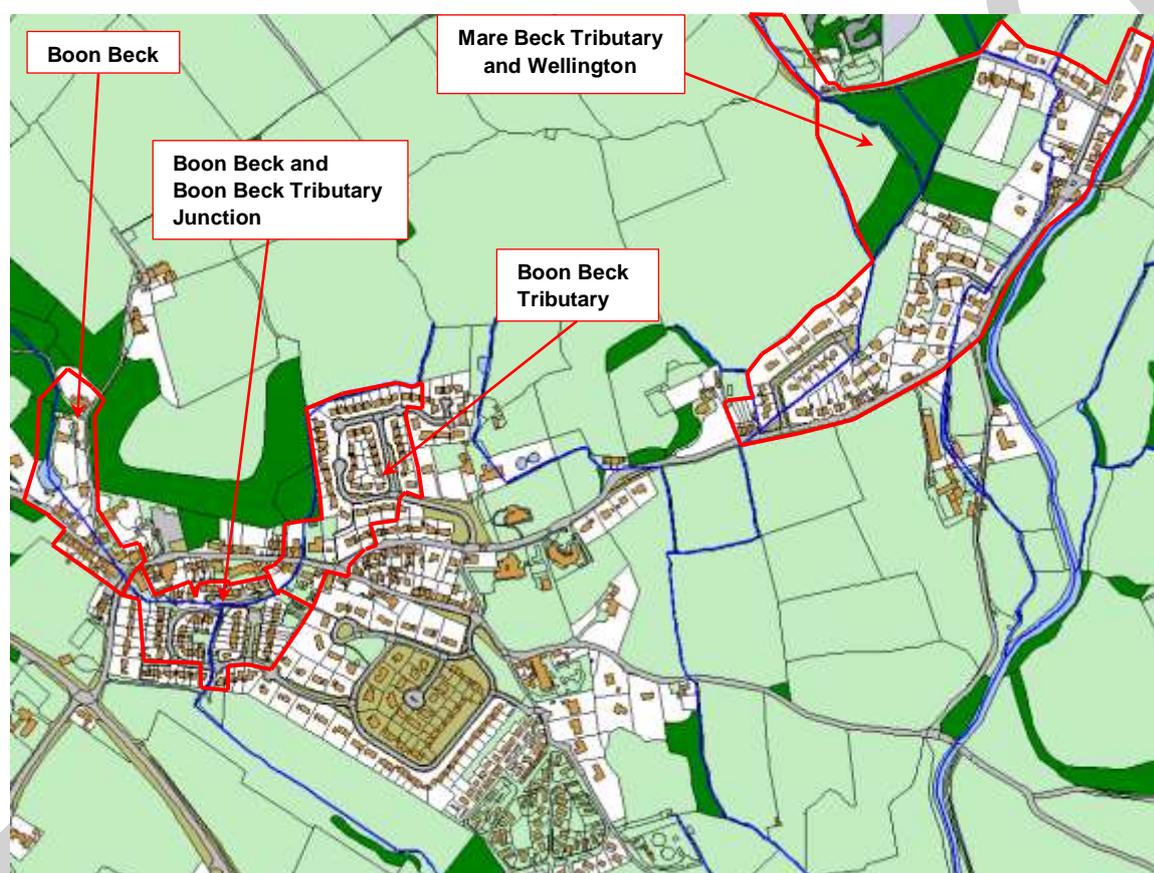
Figure 4. Flooded areas/zones

- 1.) **Boon Beck:** The areas along the route of Boon Beck, from where it overtopped above Gill Cottage to The Square.
- 2.) **Boon Beck and Boon Beck Tributary Junction:** The areas in Meadowfield around the junction of Boon Beck and its tributary.
- 3.) **Boon Beck Tributary:** The area around Denton Park and the culvert across the highway adjacent The Garage.
- 4.) **Mare Beck Tributary and Wellington:** The upper reaches of a tributary of Mare Beck, around Gillgrass Cottage, Wellington, Ellerslie Park & Terrace.

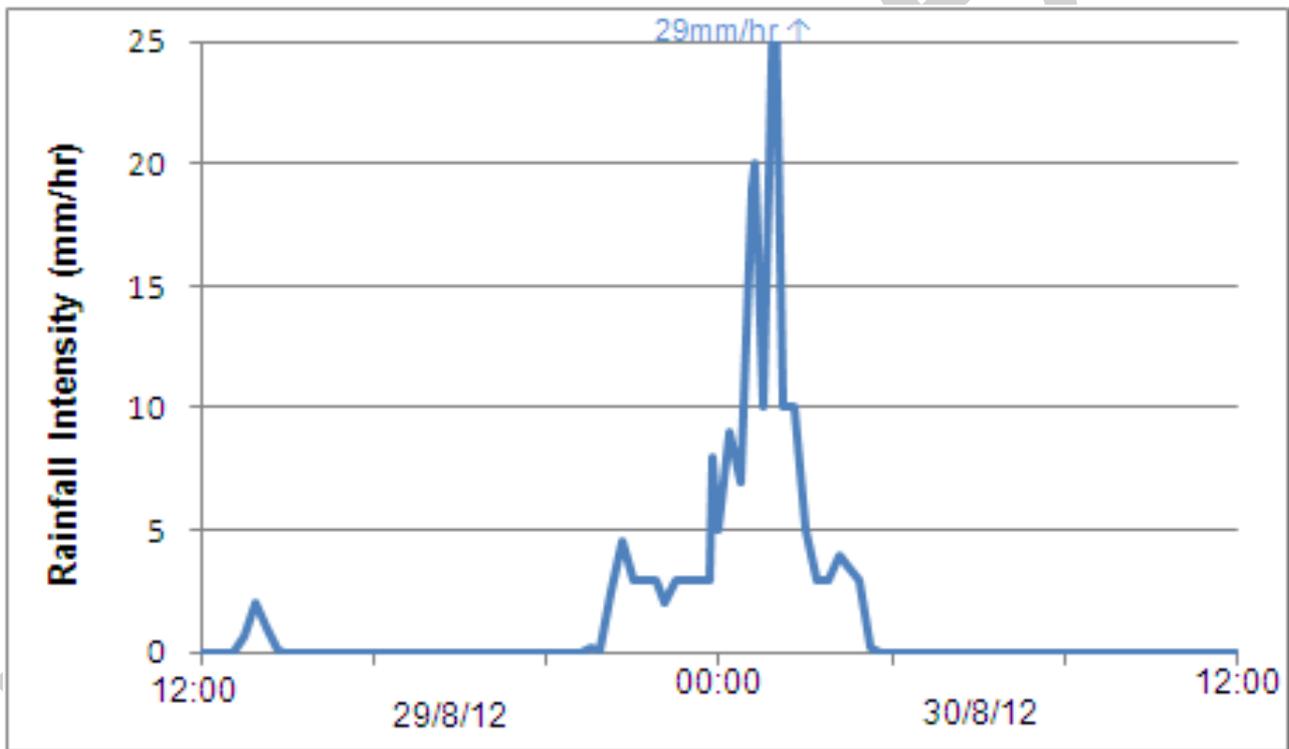
Figure 5. Rainfall Data from 29th to 30th August 2012

According to rainfall radar data, peak rainfall intensity was about 29mm/hr and occurred at about 1:15am. The rain event started at about 9:00pm and finished at about 3:30am with a total of 37mm in 6hrs 30mins.

Environment Agency data shows the storm event to have been even more severe. 58mm fell in the 24 hours from 4:30am on 29th August 2012 to 4:30am on 30th August 2012 at the rain gauge at Calder Hall. The highest 15 minute total was an extreme 15mm (60mm/hr.) at around 1:00am.

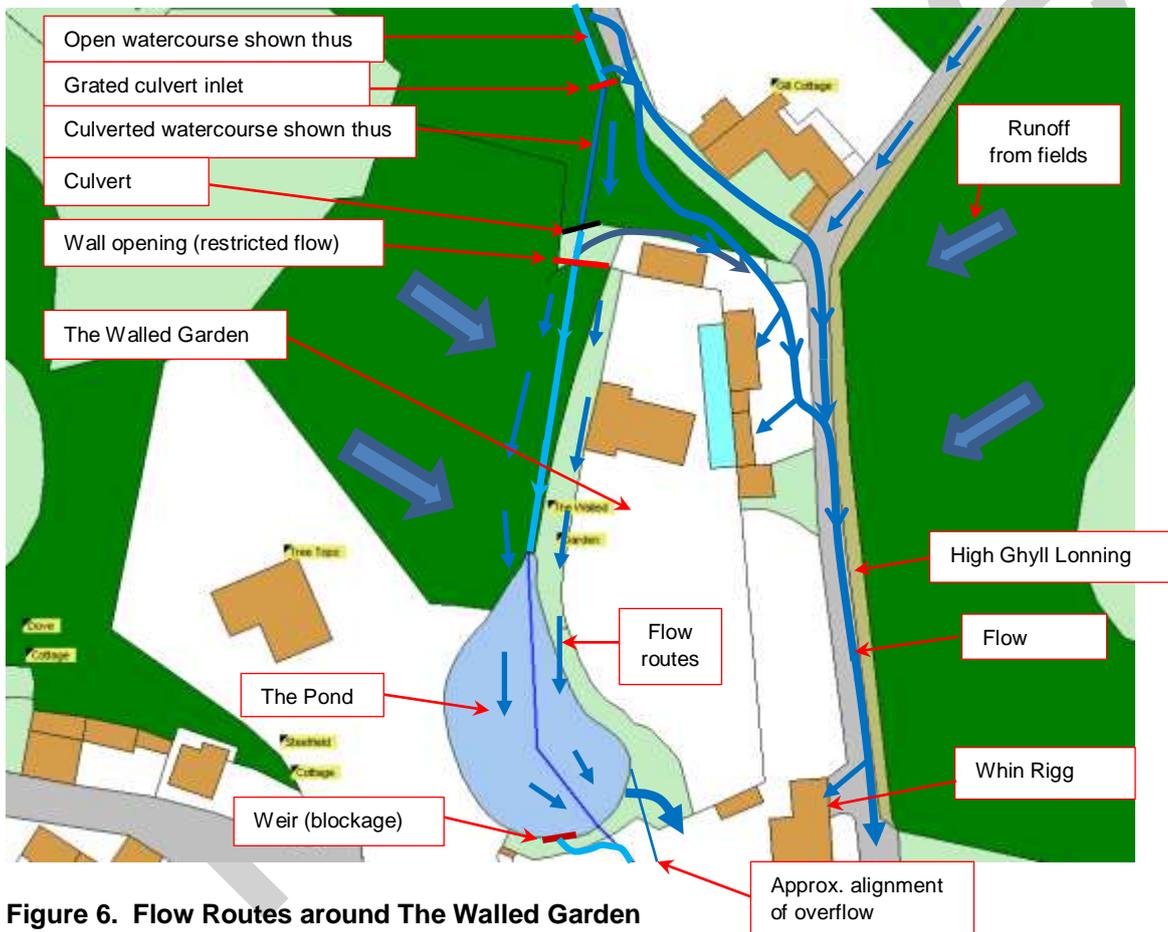
Figure 6. Flow Routes around The Walled Garden

The Ordinary Watercourse Boon Beck enters a grated culvert about 60m upstream of Gill Cottage (See Figure 6). The beck burst its banks before it had reached the blocked culvert. A CCTV survey showed that the culvert had become 50% blocked with debris. Overland flows diverged on the land above the culvert with one flow scouring the gravelled drive in front of Gill Cottage and the other in a more southerly direction. The overland flow in front of Gill cottage continued down High Ghyll Lonning.

Beyond the downstream end of the blocked culvert, the watercourse encounters The Walled Garden, which has an opening to allow normal flows. However, due to the volume of water on the day part of the flow diverted along the wall to the eastern corner of the property, flooding out buildings and then joining High Ghyll Lonning. These flows then flooded the garage of Whin Rigg on the way down to The Square.

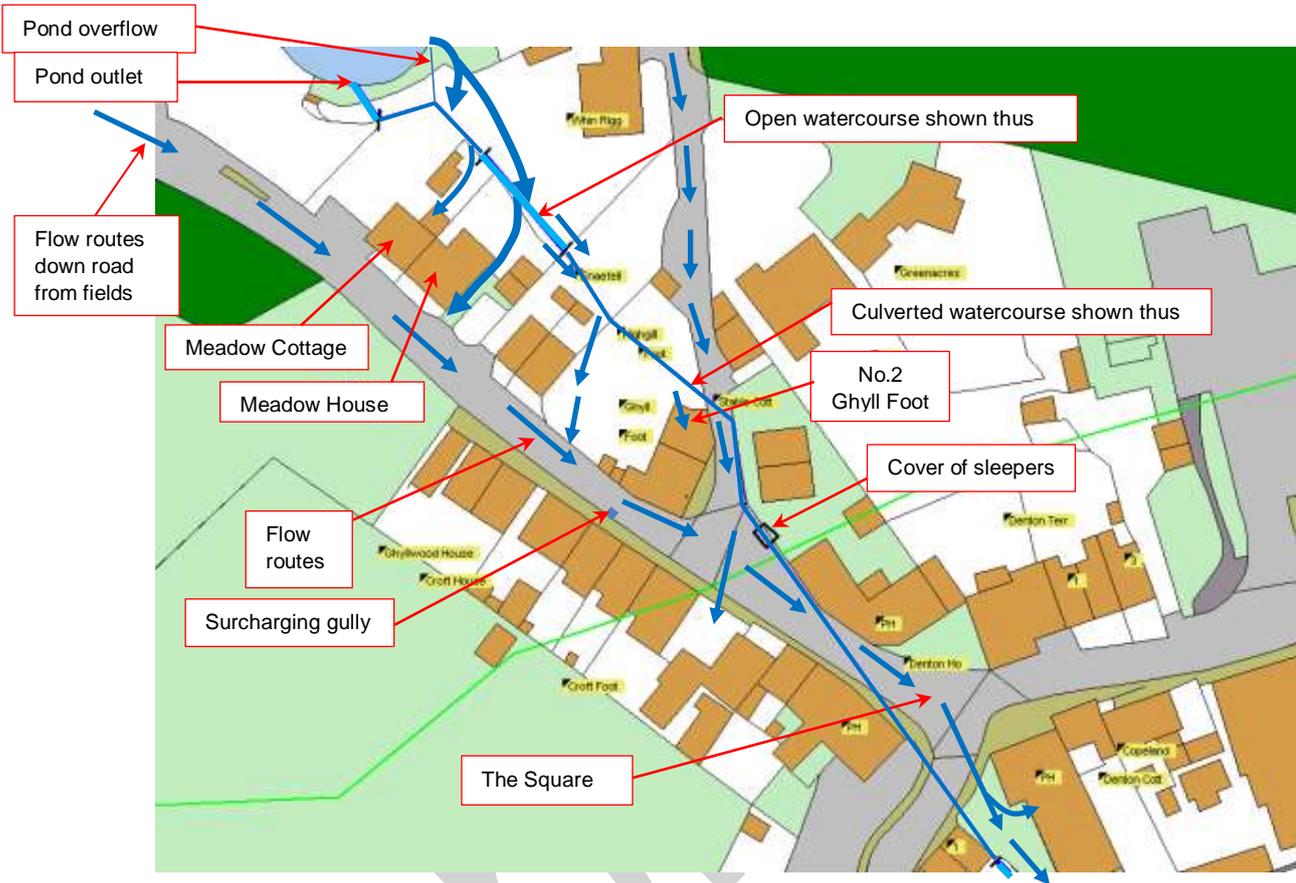
Figure 7. Flow Routes from The Pond to The Square

to a shallow artificial pond, carrying with it debris and silt. Normally this pond discharges through an adjustable weir which became blocked with garden debris, in particular a staircase, and the pond overtopped, washing away the gardens below. Also it resulted in internal flooding to Meadow House and Meadow Cottage. There is an overflow for the pond but it had collapsed and blocked. Behind Meadow House the overland flows diverged down to High Ghyll Lonning, and around Meadow House to join with floodwaters coming down the highway from the fields to the northwest of the village.

The culverted watercourse in the gardens and under High Ghyll Lonning (see Figure 17 “Culvert Details between The Pond Outfall and The Square” in Appendix 4) became blocked with garden debris and flooded No.2 Ghyllfoot. At the bottom of High Ghyll Lonning the culvert, covered with railway sleepers, surcharged. Overland flows then proceeded to The Square.

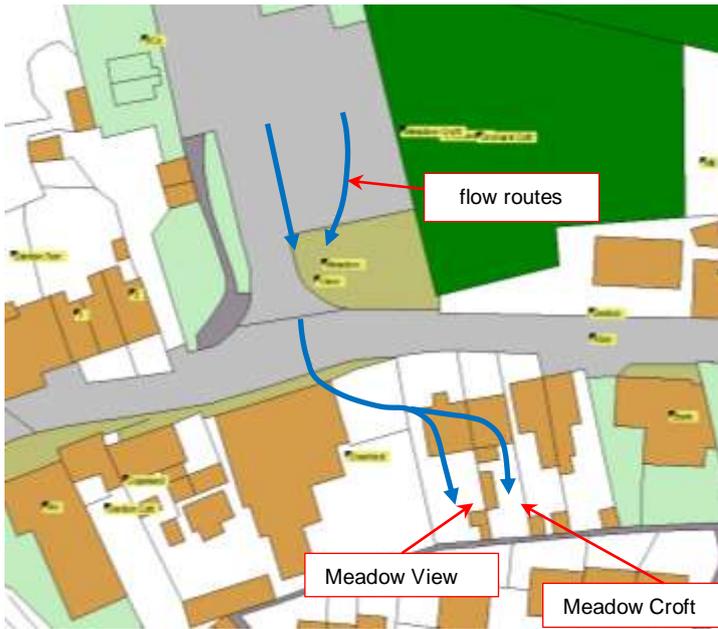
Figure 8. Flow routes from the car park

Heavy surface water runoff from the car park (see Figure 8) overwhelmed highway drainage. This flow flooded the bakery at Meadow View and Meadow Croft next door.

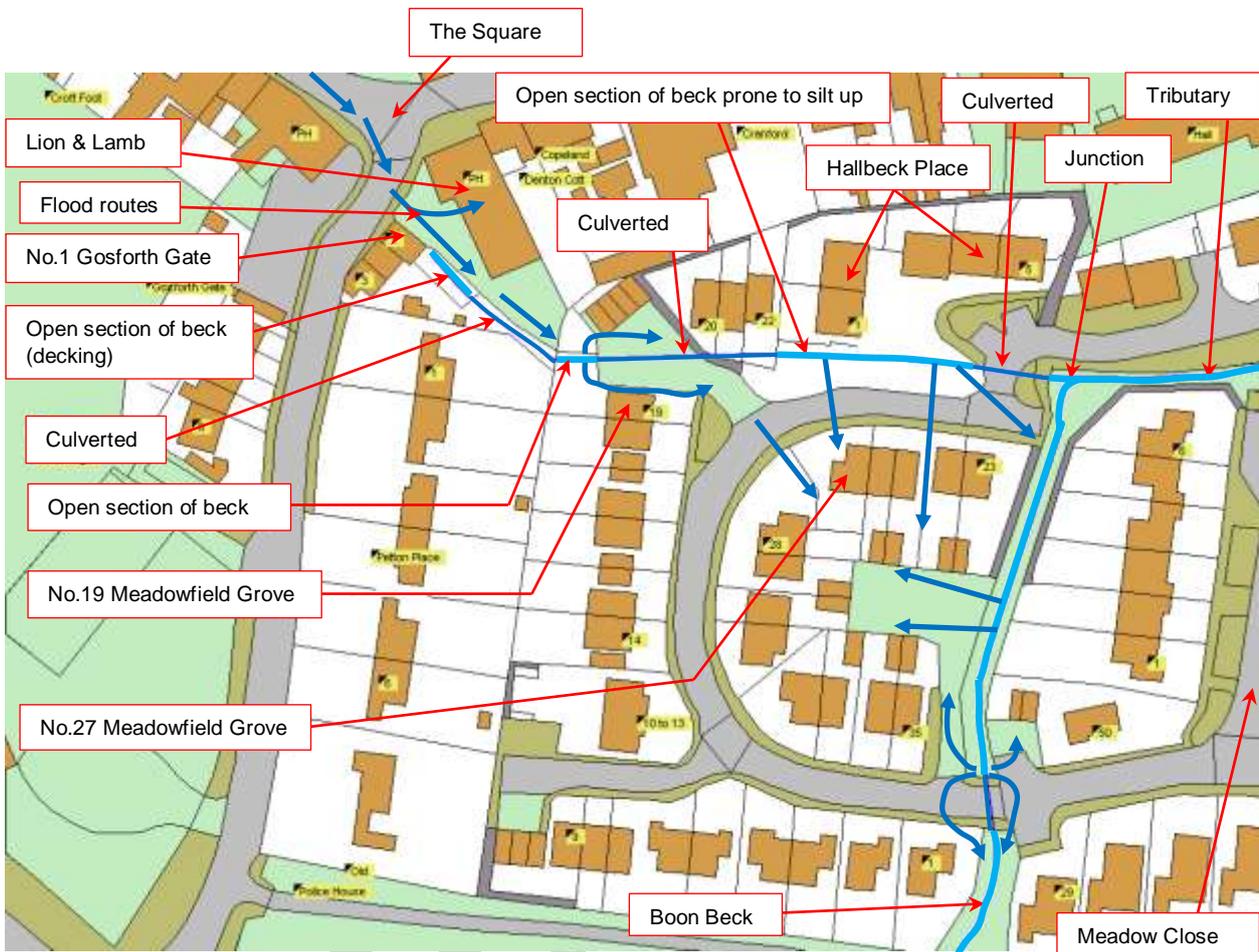
Figure 9. Flow Routes from The Square to the Tributary Junction

All of the Boon Beck floodwaters continued down the drive alongside No.1 Gosforth Gate and internally flooding the public house “The Lion & Lamb”, washing away the gravel surfacing and depositing it in the watercourse at Meadowfield Grove. The culvert pipes at Meadowfield Grove were found to be 50% full of silt, causing a surcharge which resulted in external flooding to No.19 Meadowfield Grove.

The floodwaters flowed overland down the route of the culvert where it met the open section of watercourse in front of Hallbeck Place, which had silted up over time. The watercourse burst its banks, flooding the garage of No.27 and the gardens of Nos. 23 to 27 Meadowfield Grove. The combined sewer in the back gardens of Hallbeck Place, which is owned by Home Group, surcharged when overwhelmed by surface water inundation and flooded internally Nos. 1, 2 and 3 Hallbeck Place.

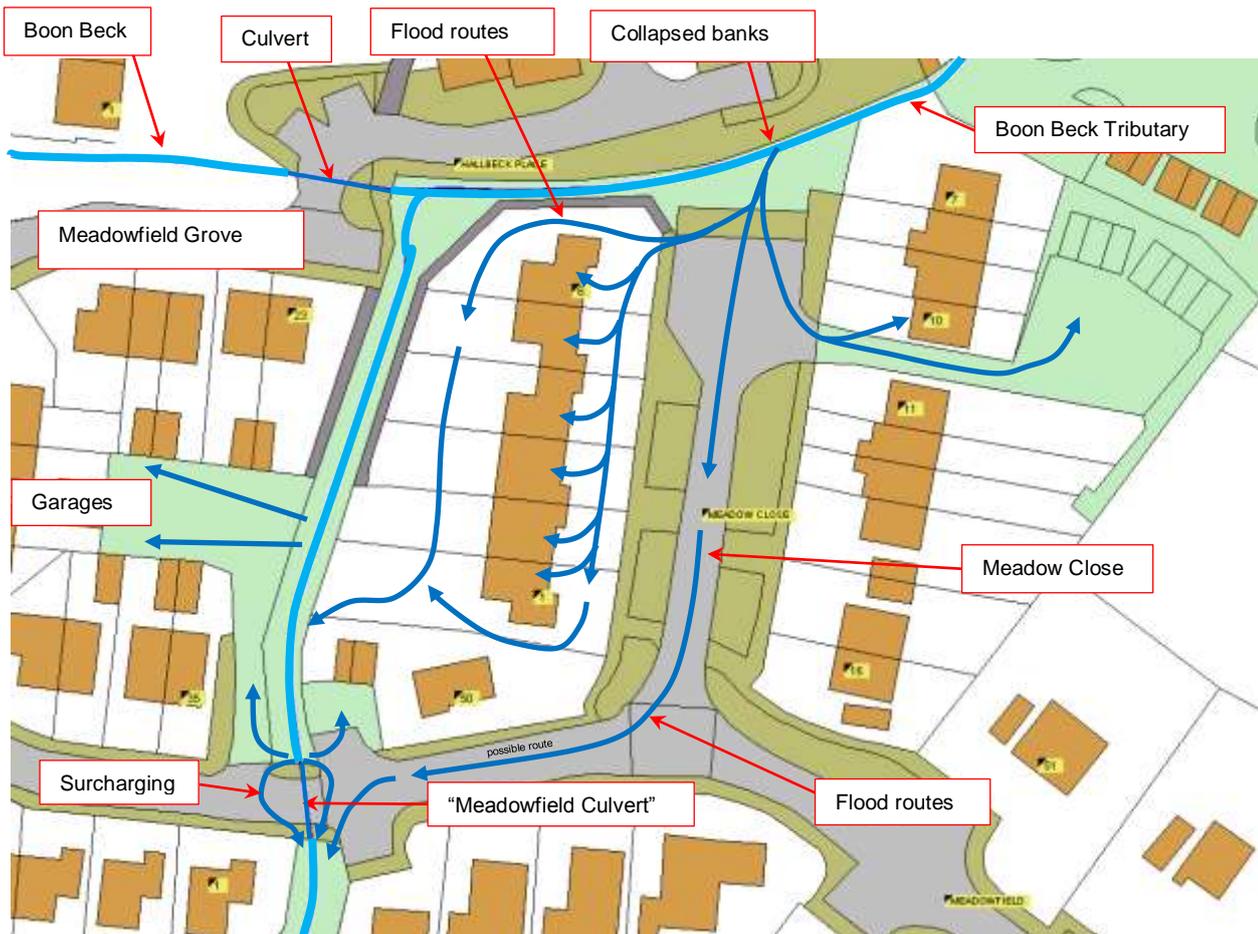
Figure 10. Flow Routes around Meadow Close

From the junction with its tributary, the beck flows in a southerly direction behind the back gardens of Meadow Close and crosses under Meadowfield Grove in a culvert called “Meadowfield Culvert” for reference in Figure 10 “Flow Routes around Meadow Close”. There was debris in this section of beck that is understood to have been washed down from upstream. During the floods this culvert surcharged and flooded the garages behind Nos.23 to 26 Meadowfield Grove.

Boon Beck tributary burst its banks above Meadow Close, flowing down the cul-de-sac to Meadowfield Grove and re-joining the beck downstream of the Meadowfield Culvert. The flow was quite deep, reaching a depth of about a metre around Nos. 1 to 6 Meadow Close, all of which were flooded internally.

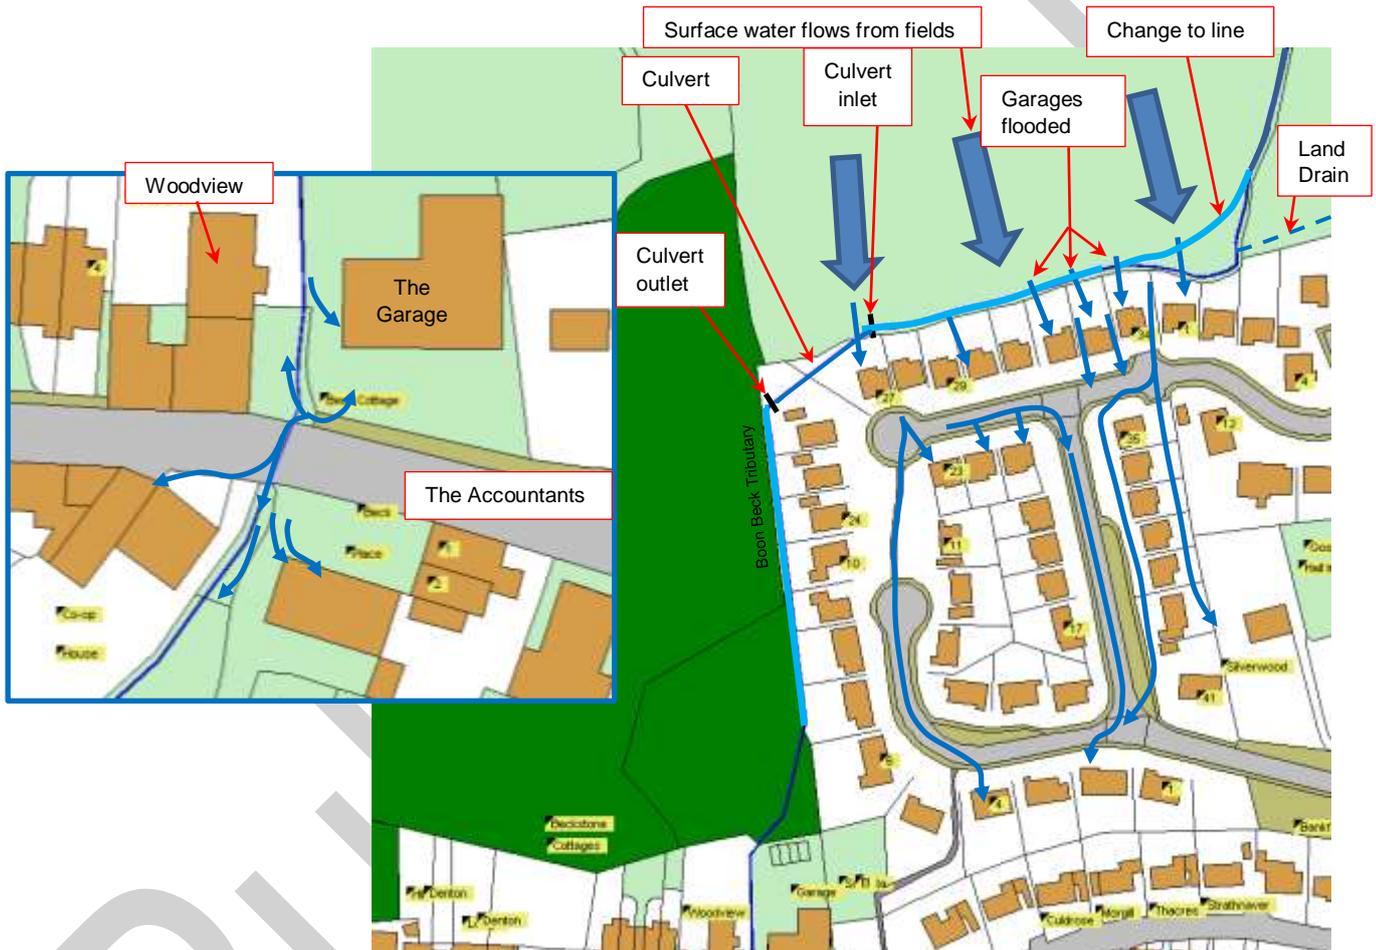
Figure 11. Flow Routes through Denton Park

A high volume of surface water flowed from the fields above Denton Park (see Figure 11). The watercourse at the rear of the properties is very narrow and full of silt, so much of the surface water flowed over the top of it into adjacent gardens. The garages of Nos. 32, 33, and 34 were flooded. Significant depths of silt were deposited and gravel drives washed away. The watercourse enters a culvert behind the back garden of No.27 Denton Park. The floodwaters continued between No.29 and No.30 and flooded the garages of Nos.21, 22 and 23. Part of the flood then flowed down the road to the east and continued round the corner, down the hill and flooded the garages of Nos. 2, 3 and 4 Denton Park. The rest of the flood waters flowed in a southerly direction, down the footpath and into the road, flooding internally No.4 Denton Park.

The floodwaters flowed across the highway due to the culvert being overwhelmed by the volume of flood water. (See inset) In this area the flooding was reported to be about 450mm deep. Sandbags prevented Co-Op House from being flooded. Internal flooding was reported at Woodview, No.2 Beck Place and The Accountants.

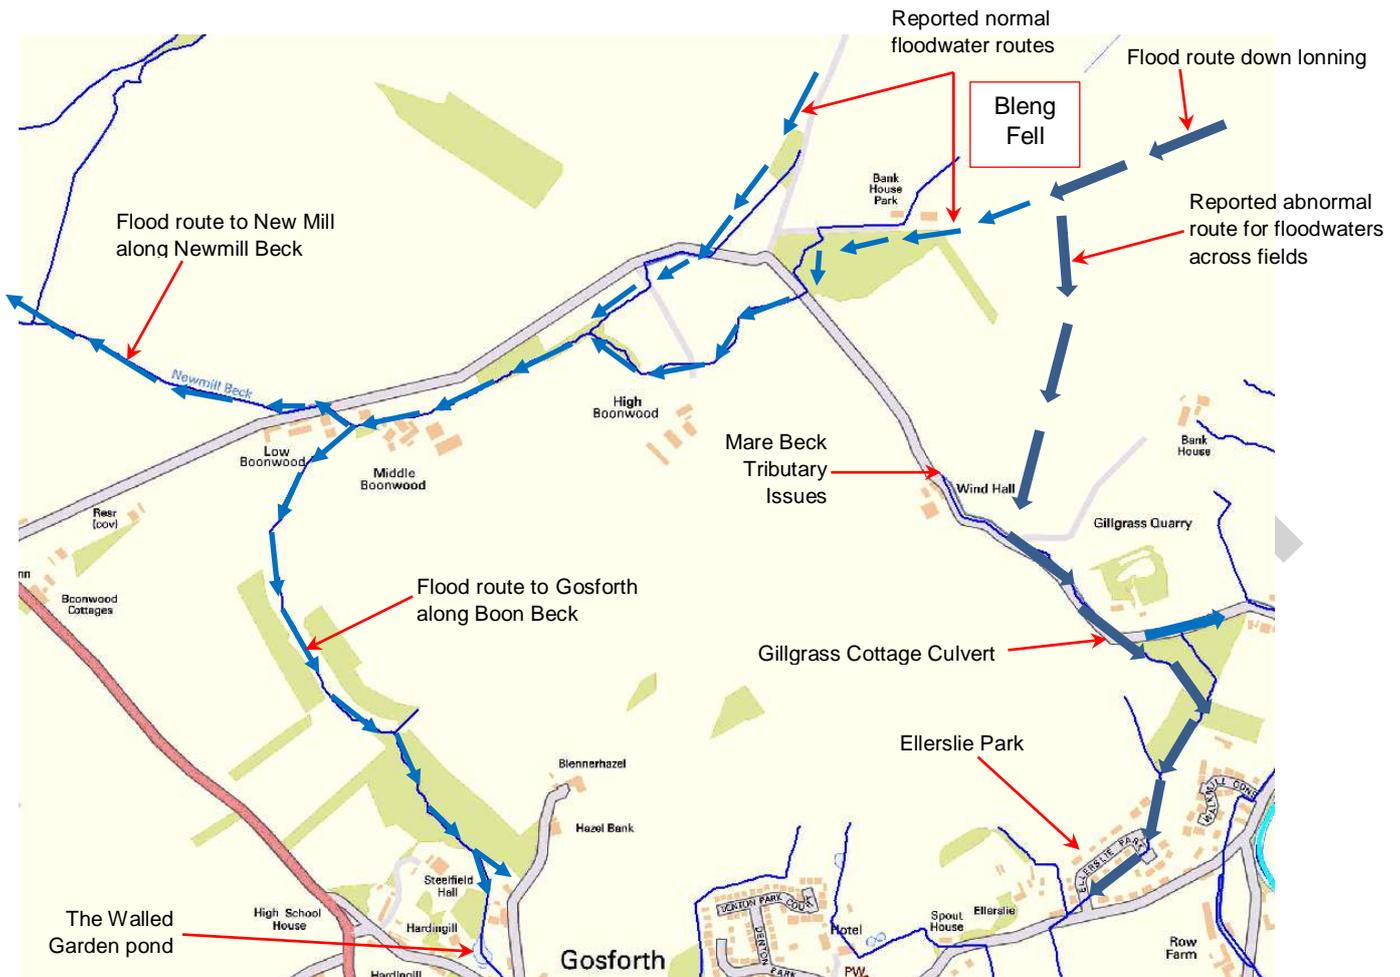
Figure 12. Abnormal flow routes from Fells

Much of the heavy flooding originated on Bleng Fell. It is understood that past flood flow routes from the fells were in the direction of Boonwood, where it would split sending a proportion down to New Mill and a proportion down to Gosforth. However it was reported that the heavy rainfall on saturated ground that occurred during this event found an additional route across the fields down to the Mare Beck Tributary above Gillgrass Cottage.

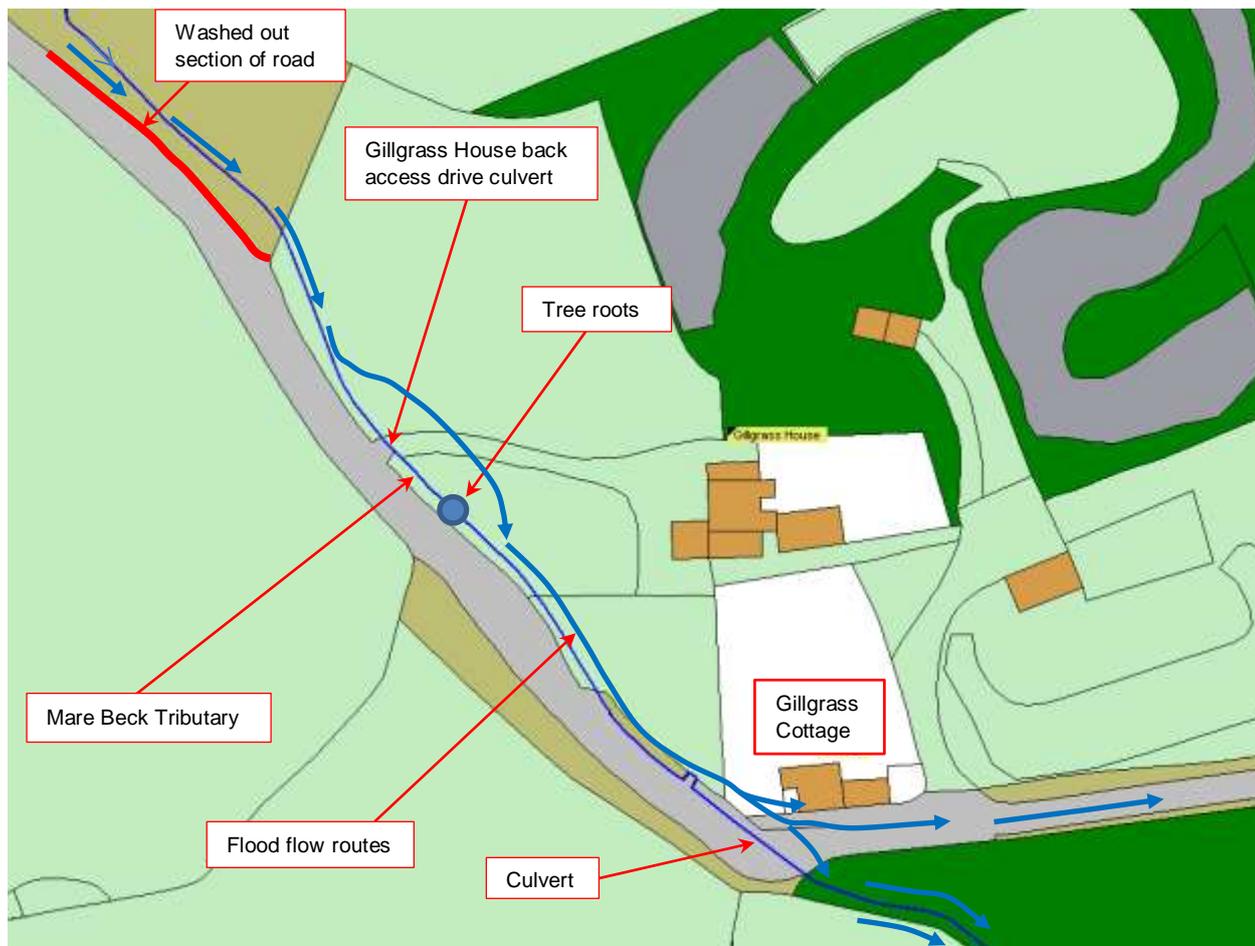
Figure 13. Flow Routes at Gillgrass Cottage

Records show that the head of the Mare Beck Tributary issues in a grassed area just across the road from Wind Hall, about 1km north-east of Gosforth (See figure 13) The beck runs along the north-eastern side of the road to Wellington. Until the extreme rainfall event of 30th August, it ran under a culvert at the back access drive to Gillgrass House and through the roots of a large tree (see Figure 12 “Flow Routes at Gillgrass Cottage”). The beck then continues down the side of the road until Gillgrass cottage where it then flows through a culvert into a steep sided gully.

Debris from washed out road section contributed to the blocking of the back access culvert to Gillgrass House and clogging up the roots of the tree on the edge of the beck. Flows then took an alternative route clockwise round the tree and washed out the access drive just north of its culverted crossing. Debris was carried down to the highway culvert outside Gillgrass Cottage which became blocked and partly washed out. Flows then overtopped the culvert and covered the road, flooding the ground floor of the cottage on the way. Some of this flow re-entered the beck downstream of the culvert causing damage to the road and embankment, with the remainder the flow continuing down to Wellington.

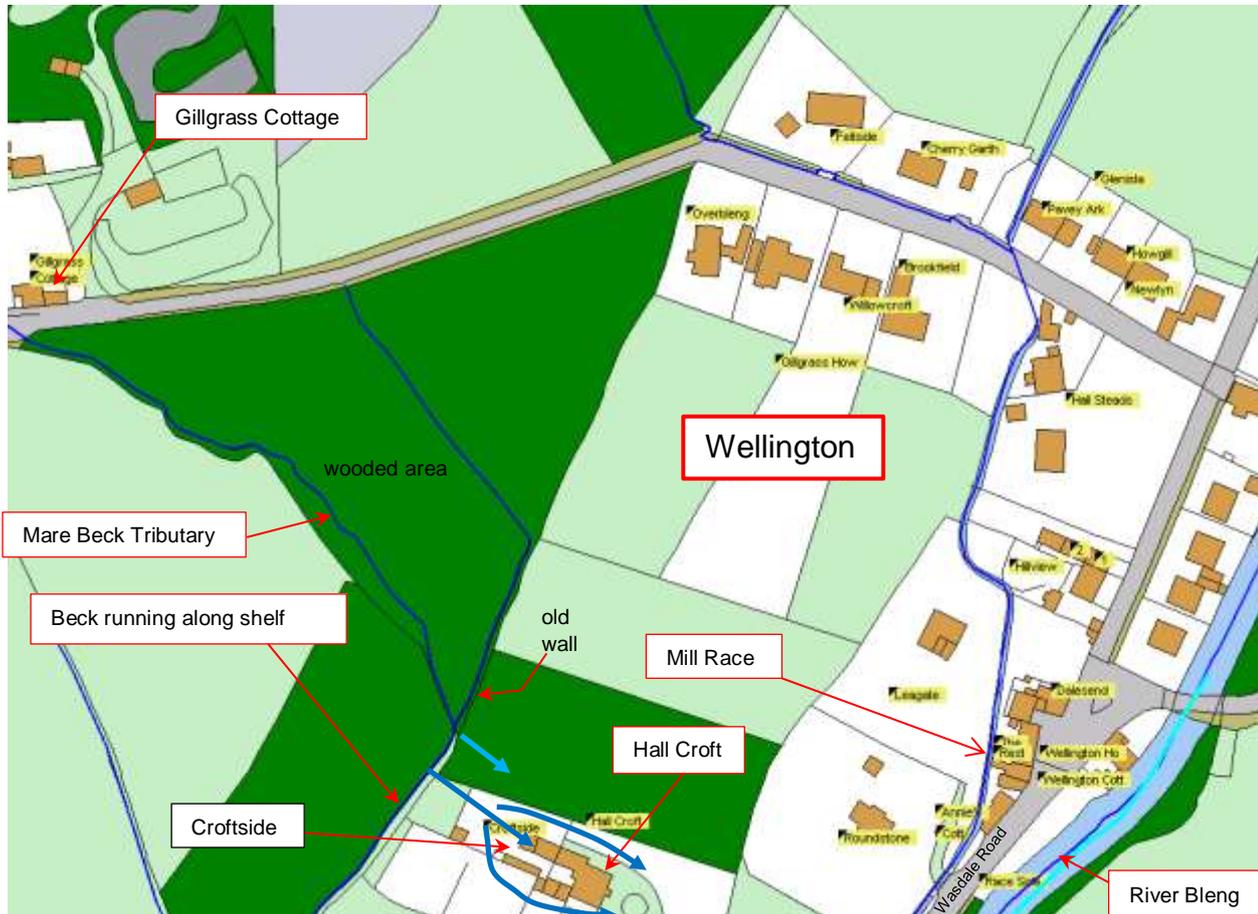
Figure 14. Flow Routes at Wellington

It was reported that floodwater from the Mare Beck Tributary flowed into the front door of “Croftside” and floodwater completely surrounded “Hallcroft”. The beck at this location is above the surrounding ground.

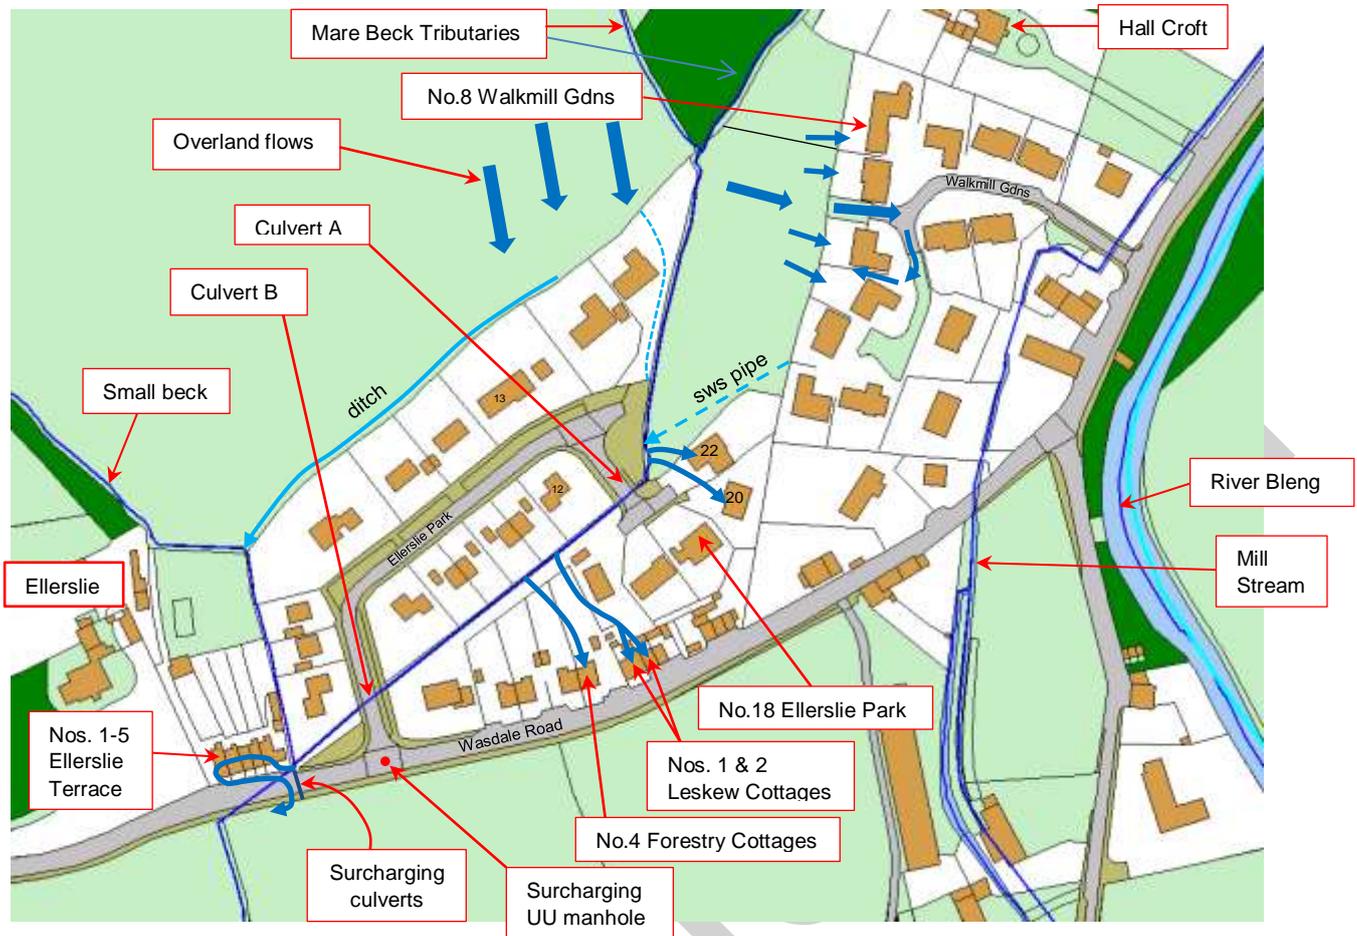
Figure 15. Flow Routes at Ellerslie Park and Walkmill Gardens

About 300m downstream of Croftside is Ellerslie Park and Walkmill Gardens (see Figure 15 “Flow Routes at Ellerslie Park and Walkmill Gardens”). The Mare Beck Tributary burst its banks adjacent Walkmill Gardens where it flowed across the field, but the flow was unable to return to the beck because of a spoil heap and so caused flooding to back gardens. Feedback reported substantial damage externally to 8, 10, 15 and 17 Walkmill Gardens.

The beck crosses under the estate road in a twin 600mmØ culvert (Culvert A), where it surcharged and flooded the garages of Nos. 20 and 22 Ellerslie Park. The beck then burst its banks on the other side of the culvert, flooding gardens as well as flooding internally Nos.1 and

The silting up of the beck in Ellerslie Park caused the highway drainage outfalls to block, resulting in the highway drainage to surcharge out of the road gullies. The start of the highway drainage in Ellerslie Park is at the turning head. Gullies located next to No 18 and no 1 Ellerslie Park were constricted by slit and debris blocking the outlets from the gullies to the beck.

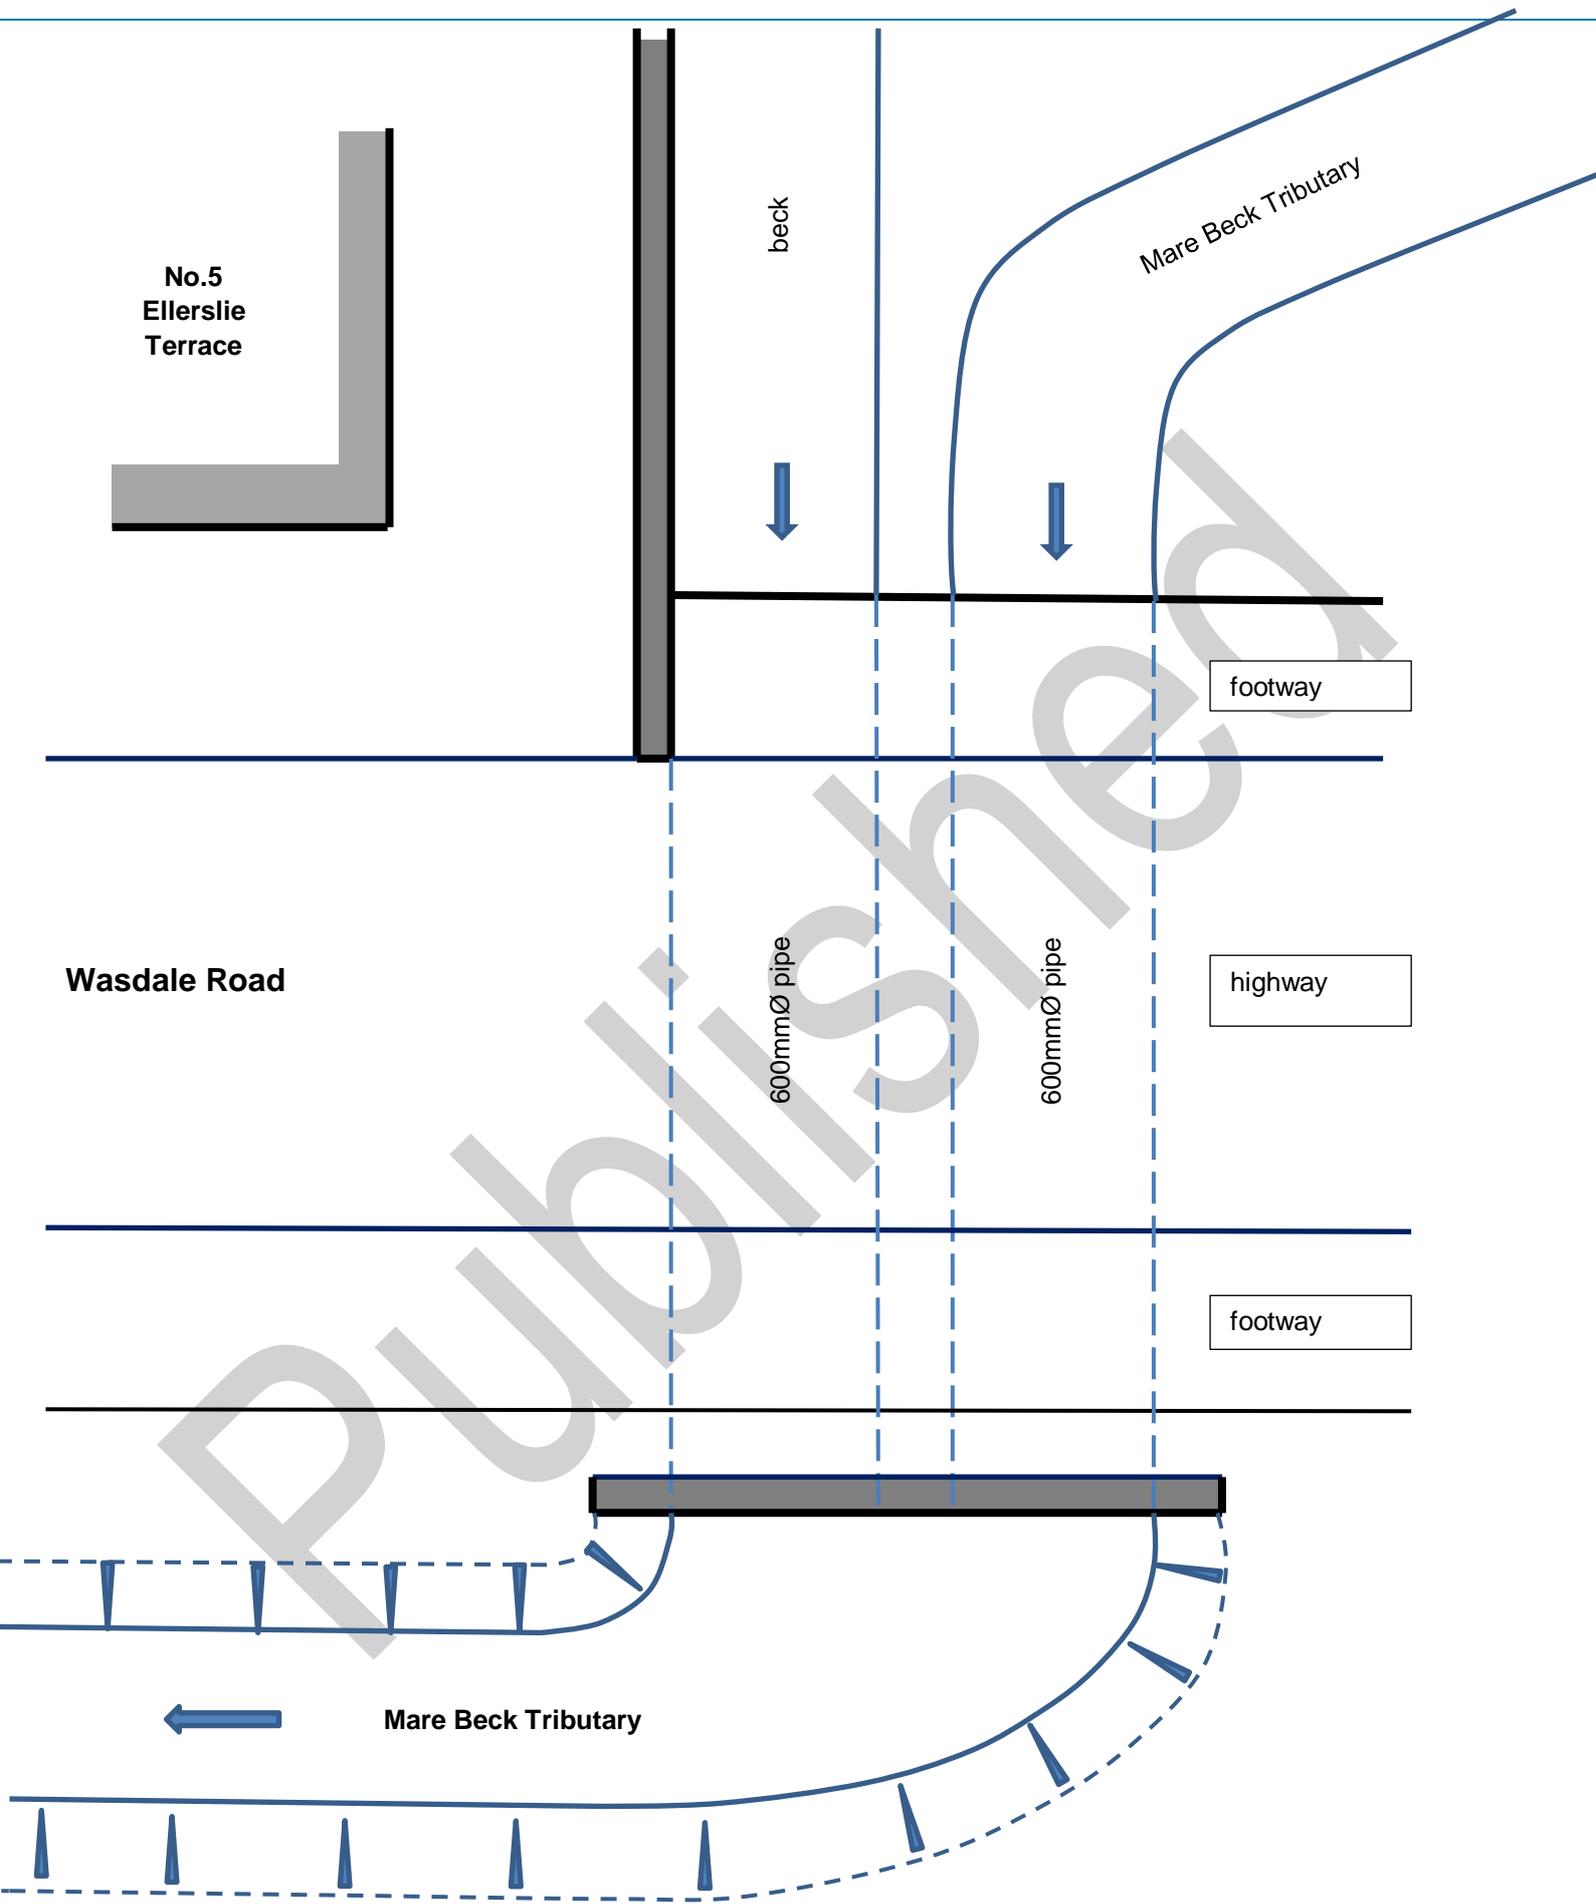
Figure 16. Wasdale Road Culvert Layout

Culvert B crosses Ellerslie Park road into a ditch that runs parallel with the unknown beck before crossing Wasdale Road outside No 5, via separate twin culverts.(see Figure 16). Both culverts surcharged and overflowed causing flooding internally Nos.1 to 5 Ellerslie Terrace. A United Utilities combined sewer manhole at the junction of Wasdale Road and Ellerslie Park also surcharged out of its cover, contributed to the flooding in this location.

On emerging from the culvert pipes on the southern side of the Wasdale Road, the Mare Beck Tributary turns 90° to the southwest and runs parallel with the road for about 30m. It then turns 90° southeast.
