Calder Bridge

Flood Investigation Report No. 52

Flood Events 2012

This flood investigation report has been produced by Cumbria County Council as a Lead Local Flood Authority under Section 19 of the Flood and Water Management Act 2010.

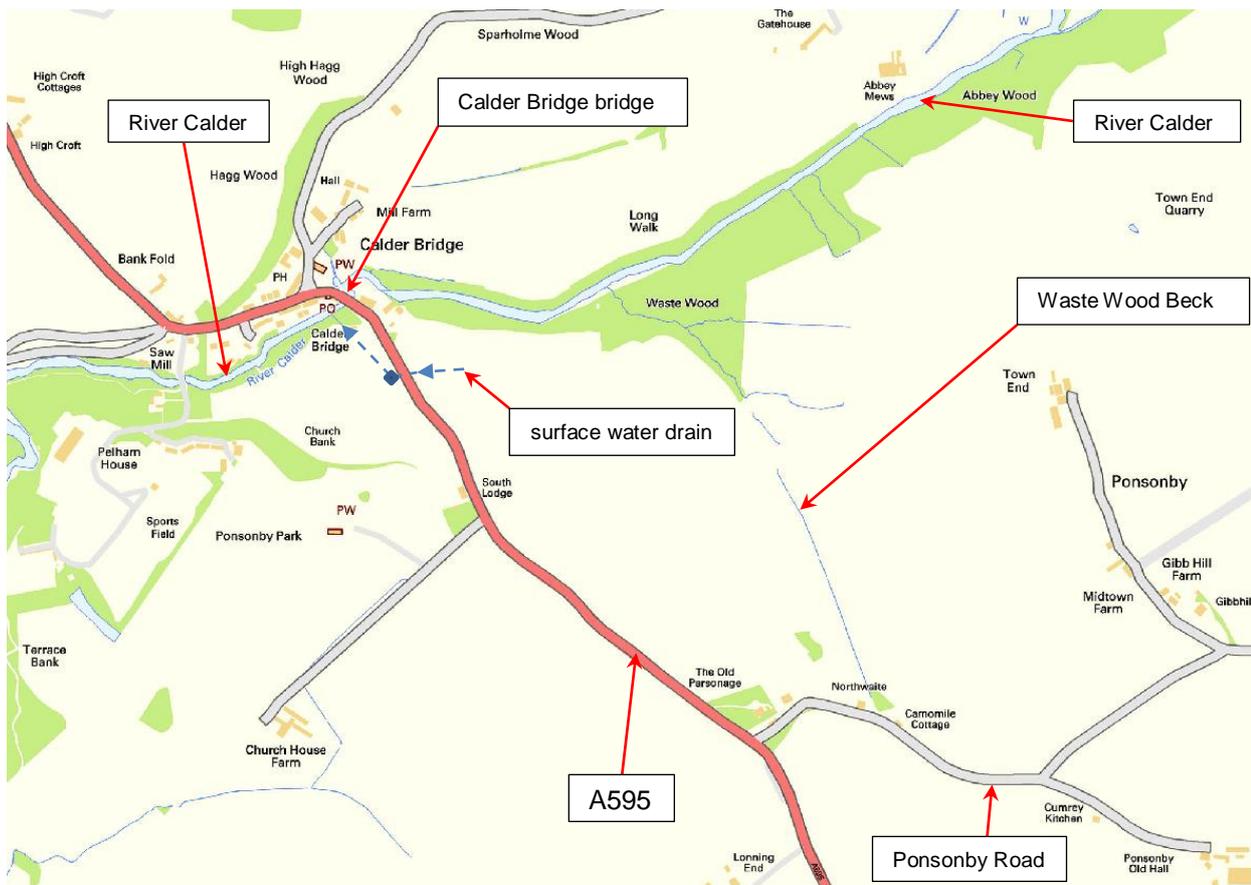
Figure 2. Calder Bridge Surrounding Area Plan

The village of Calder Bridge is on the A595 (see Figure 1. “Location Plan”), at the westerly most corner of the Lake District National Park. It is about 6km southeast of the town of Egremont and about 3½ km northwest of the village of Gosforth. The River Calder is crossed by a bridge on the A595 at this location. About 1km south-east along the A595 is Ponsonby Road, which leads to the settlement of Ponsonby (see Figure 2 “Calder Bridge Surrounding Area Plan”) that consists of farms, cottages and Ponsonby Hall. Figure 3 “Calder Bridge Village Plan” shows the location of the properties involved in the flooding.

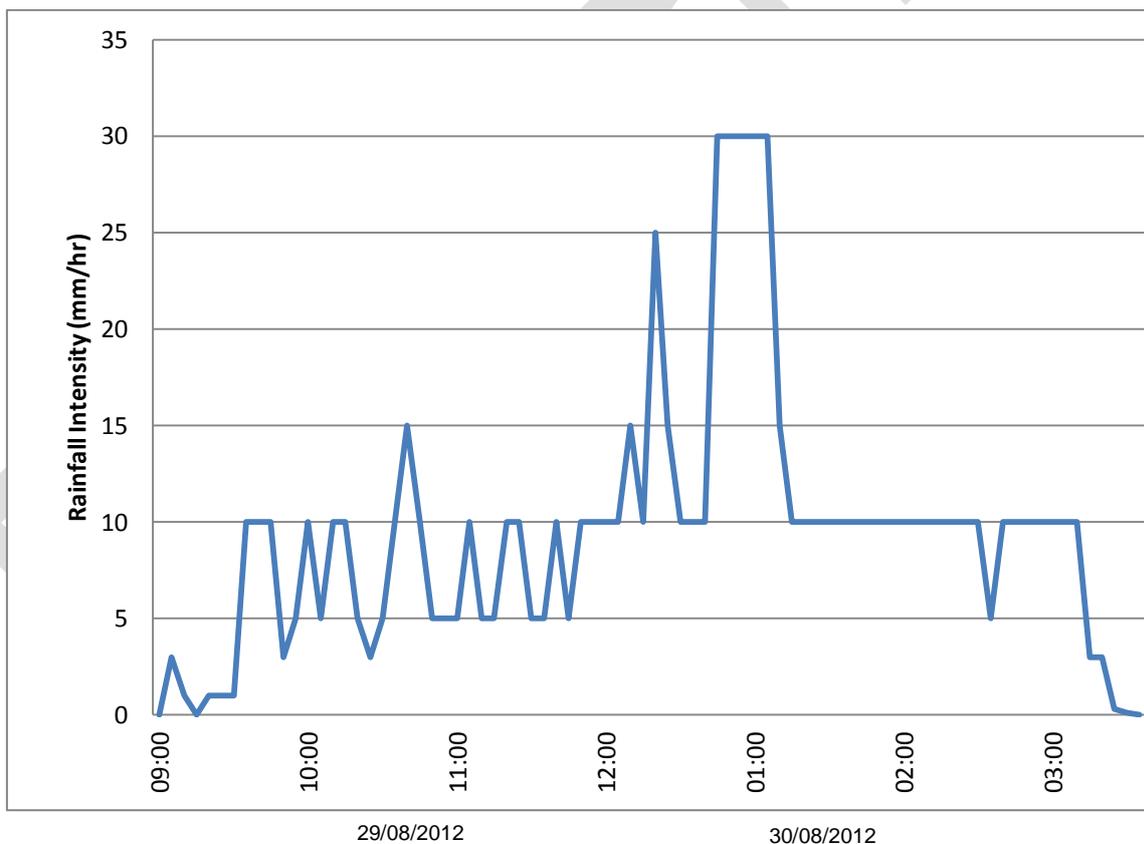
Figure 4. Rainfall Data

Rainfall radar records indicate that at about 9:00pm on the evening of the 29th August, it started to rain heavily and did not stop until about 3:30am on the 30th August (see Figure 4: “Rainfall Data”). This rainfall event peaked approximately between 12:45am and 01:05am with an intensity of up to 30mm/hr.

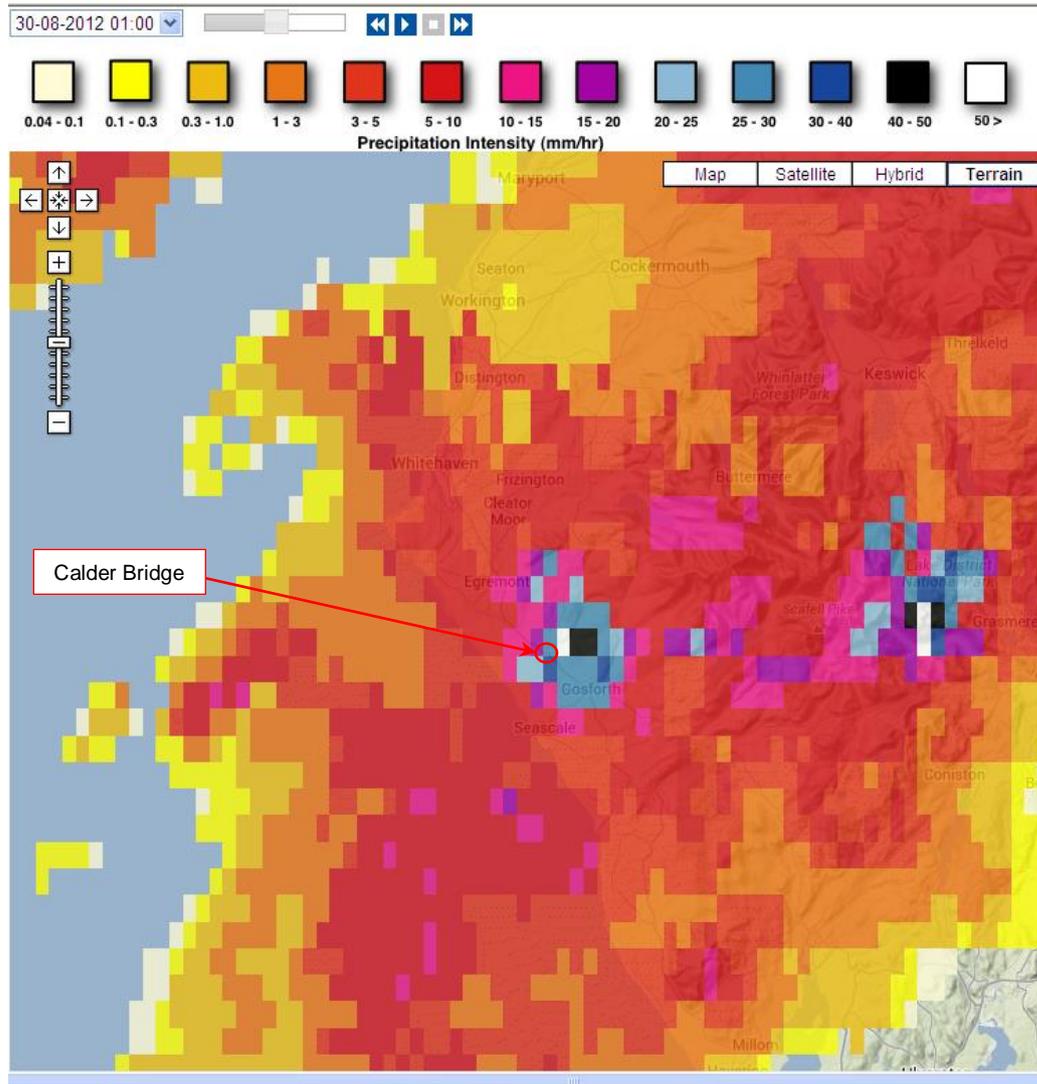
Figure 5. Radar Picture of Rainfall at Calder Bridge at 1am on 30th August 2012

The radar picture shown in Figure 5 “Radar picture of Rainfall at Calder Bridge at 1:00am on 30th August 2012”, illustrates that as well as significant rainfall on Calder Bridge, there was an extreme intensity of rainfall on the fells above the village. Intensities in excess of 50mm/hr. can be seen on this picture. Intensities above 20mm/hr. are considered to be heavy rainfall.

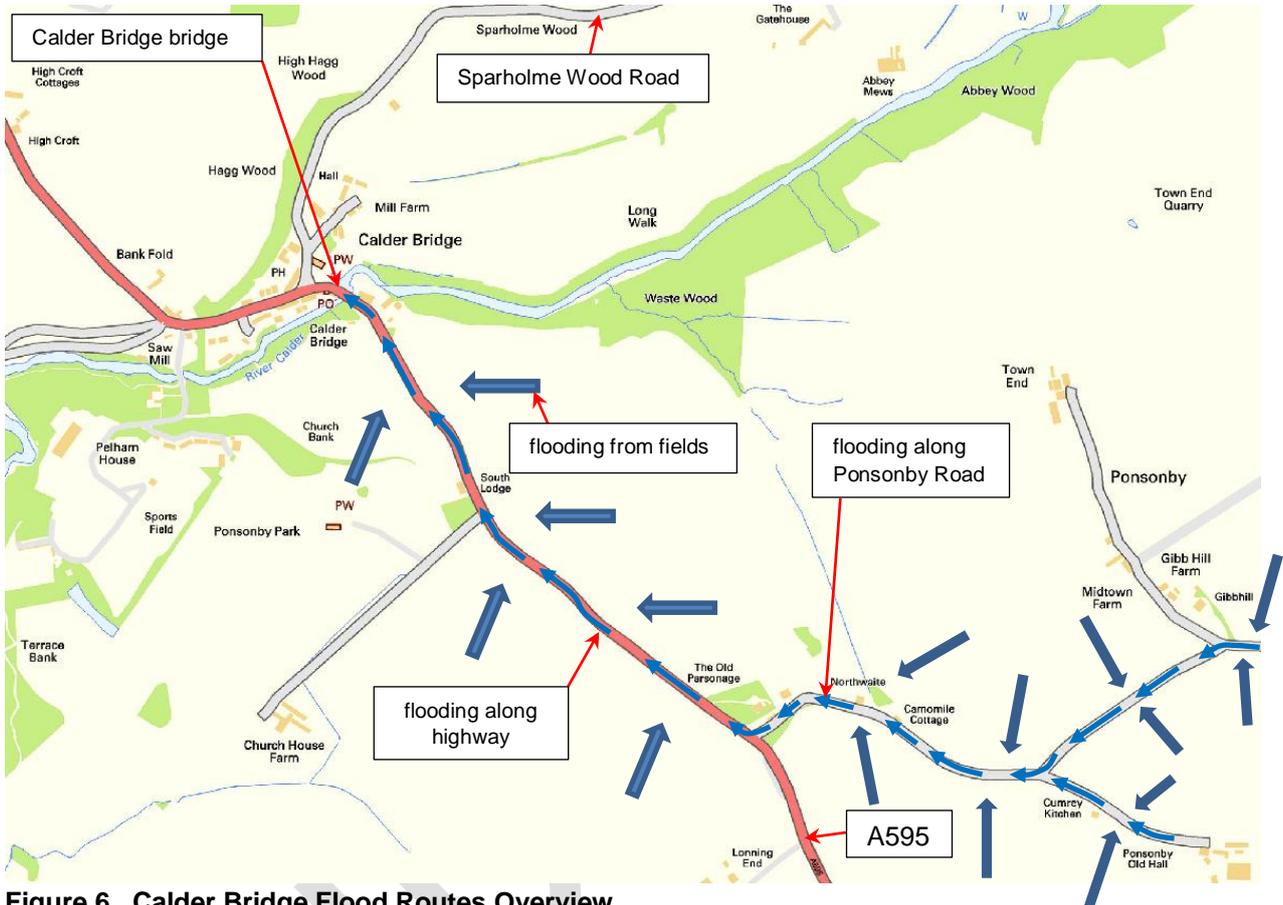
Figure 6. Calder Bridge Flood Routes Overview

Although there was considerable flooding of the highway throughout the village, the worst of the flooding occurred on the north side of the River Calder bridge, outside three cottages. Some of the runoff came from the Sparholme Wood Road (see Figure 6 “Calder Bridge Flood Routes overview”), the junction of which is across the A595 from the cottages, but the main body of the flood came down the A595 from the south. Flood waters poured off of the fields onto the highway, bringing with it silt and debris, inundating the highway drainage. There was a considerable amount of runoff coming off of the Ponsonby Road onto the A595. ‘The Old Post Office’ and ‘Allona’ were flooded internally (see Figure 7: “Calder Bridge Flood Routes and Flood Extent”).

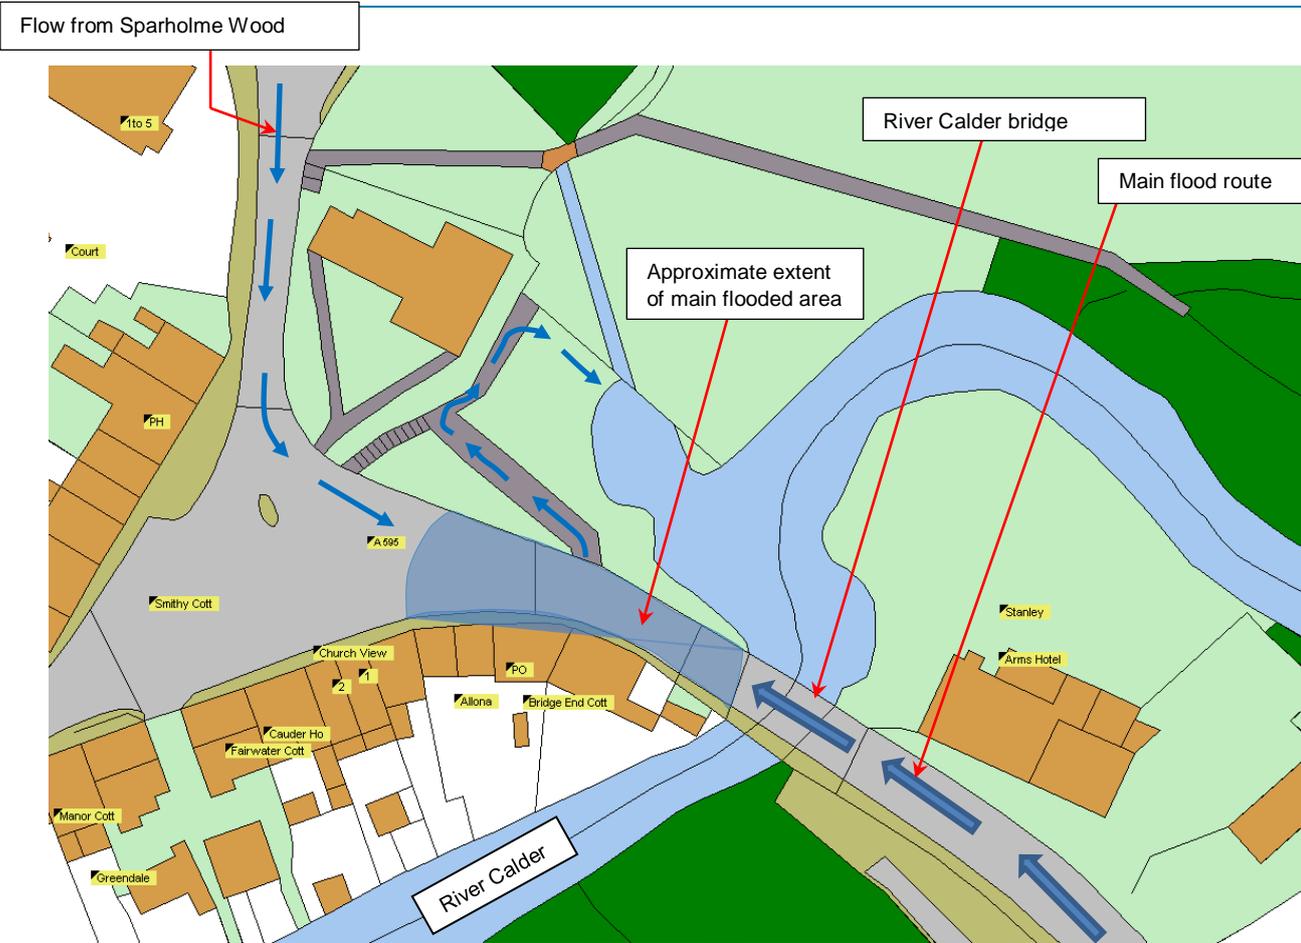
Figure 7. Calder Bridge Flood Routes and Flood Extent

Subsequent to the August 2012 flooding, the owners of ‘Allona’ have carried out some resilience measures with flood doors being fitted. Also County Highways carried out some intensive gully and highway drainage maintenance. Grips were installed in order to shed extreme flooding off of the highway before the flow reached the village. However there have been seven flood incidents since August 2012, including one as recent as February 2013 and although ‘Allona’ and ‘Bridge End Cottage’ remained unscathed by the flooding, ‘The Old Post Office’ suffered flooding again. Once again water poured off of the fields onto the A595 and the highway drainage was overwhelmed.

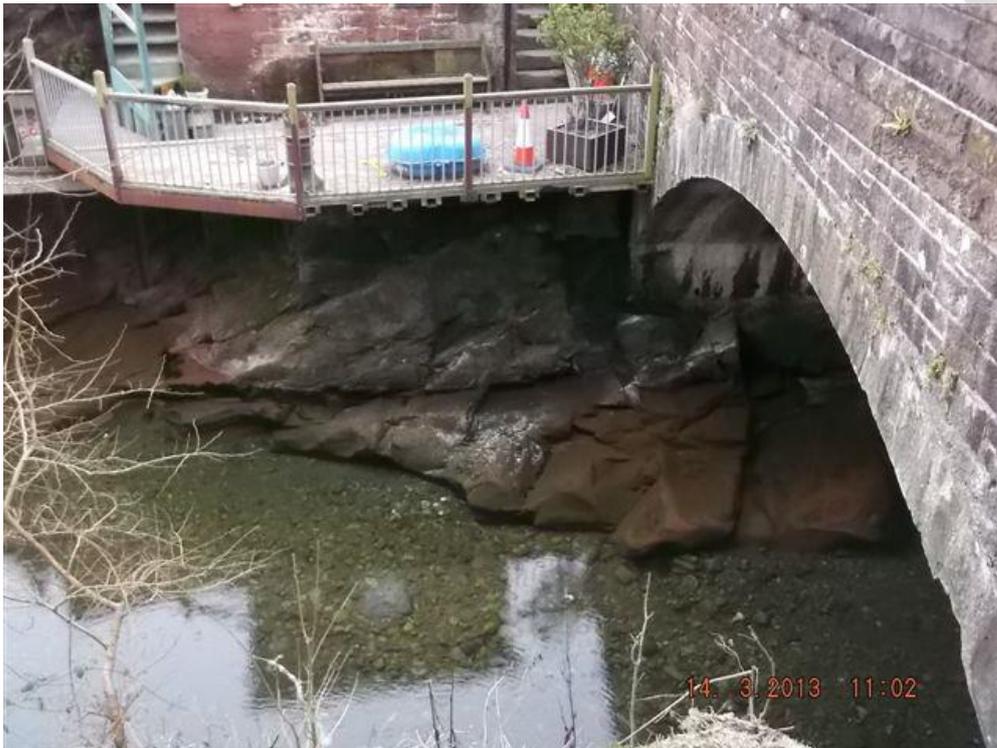
Figure 8. Site of Calder Bridge Highway Drainage Outfall

Since the February 2013 flood event, Cumbria County Council Highways have further investigated the causes of the flooding. It was already known that the highway drainage outfall pipe into the River Calder, which runs across the garden of 'Bridge End Cottage', was undersized and not fit for purpose but access to remedy this was not permitted (see Figure 8 "Site of Calder Bridge Highway Drainage Outfall").

Following legal proceedings, this existing 150mm dia. outlet was replaced by a 225mm dia. pipe in April 2013. Holes that had been put into the bridge parapet upstream were insufficient to cope with the runoff and so two 150mm dia. pipes were fitted as overflow outlets to a new 500mm dia. catchpit in the highway. The catchpit was fitted with a grated cover and the pipes discharged through the downstream bridge parapet wingwall enabling the highway drainage to discharge directly into the river. Two 225mm dia. pipes have also been installed in the wall extension to the upstream side of the bridge parapet, to provide escape routes for exceedance of the highway drainage system by storm water coming down the A595 highway from the Ponsonby Road junction direction.
