How Man

Flood Investigation Report 28

Flood Event 30/8/2012

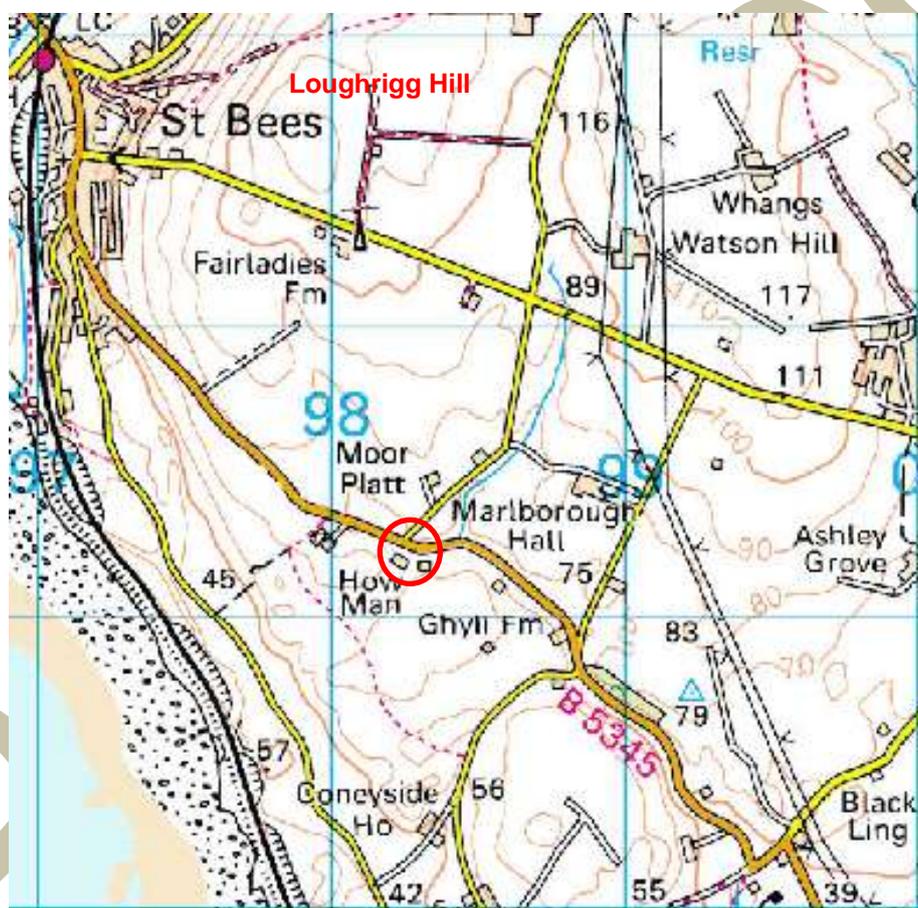
Figure 1 illustrates the location of How Man which was flooded on 30th August 2012 following extreme and sustained heavy rainfall. Less extreme events have caused flooding both before and since. Much of the water originated from the slopes to the north of How Man. These are part of an un-named hill which has been named in this report as Loughrigg Hill for consistency with report number 37 into the flooding of the same date in nearby St Bees. The summer was the wettest in England since records began and so surrounding fields were unable to absorb any new rainfall.

Figure 1. Map showing location of How Man flooding area.

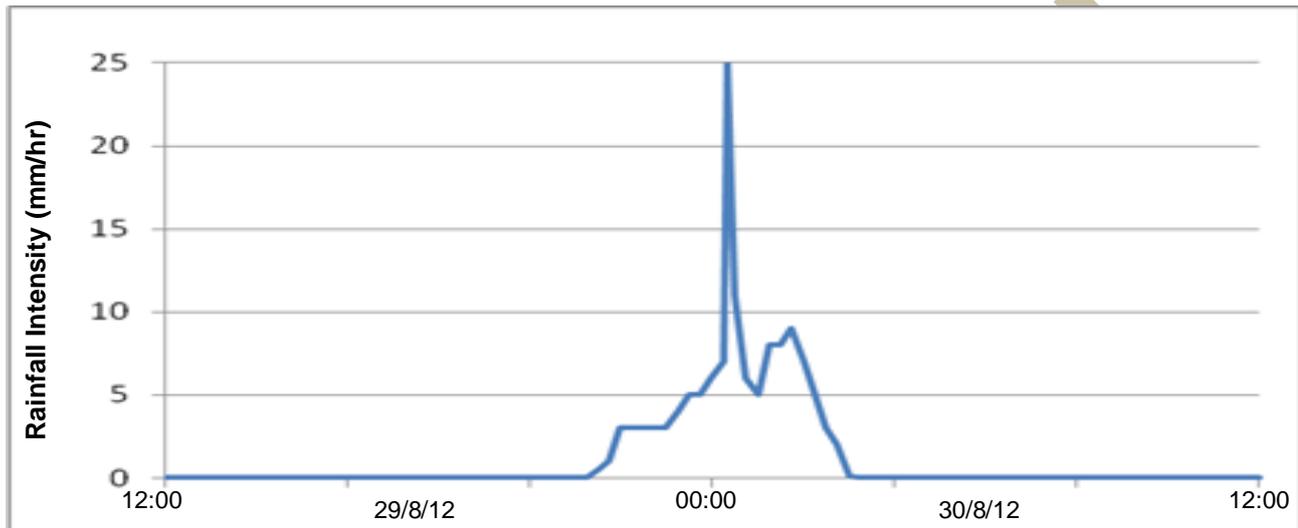
Radar data taken from weather provider records for the area over Loughrigg Hill show peak rainfall was 25mm/hr and occurred at about 00:20am. The rain started at 9:00pm and finished at 3:00am with 28mm in 6hrs.

Figure 2. Rainfall data from 29-30th August 2012

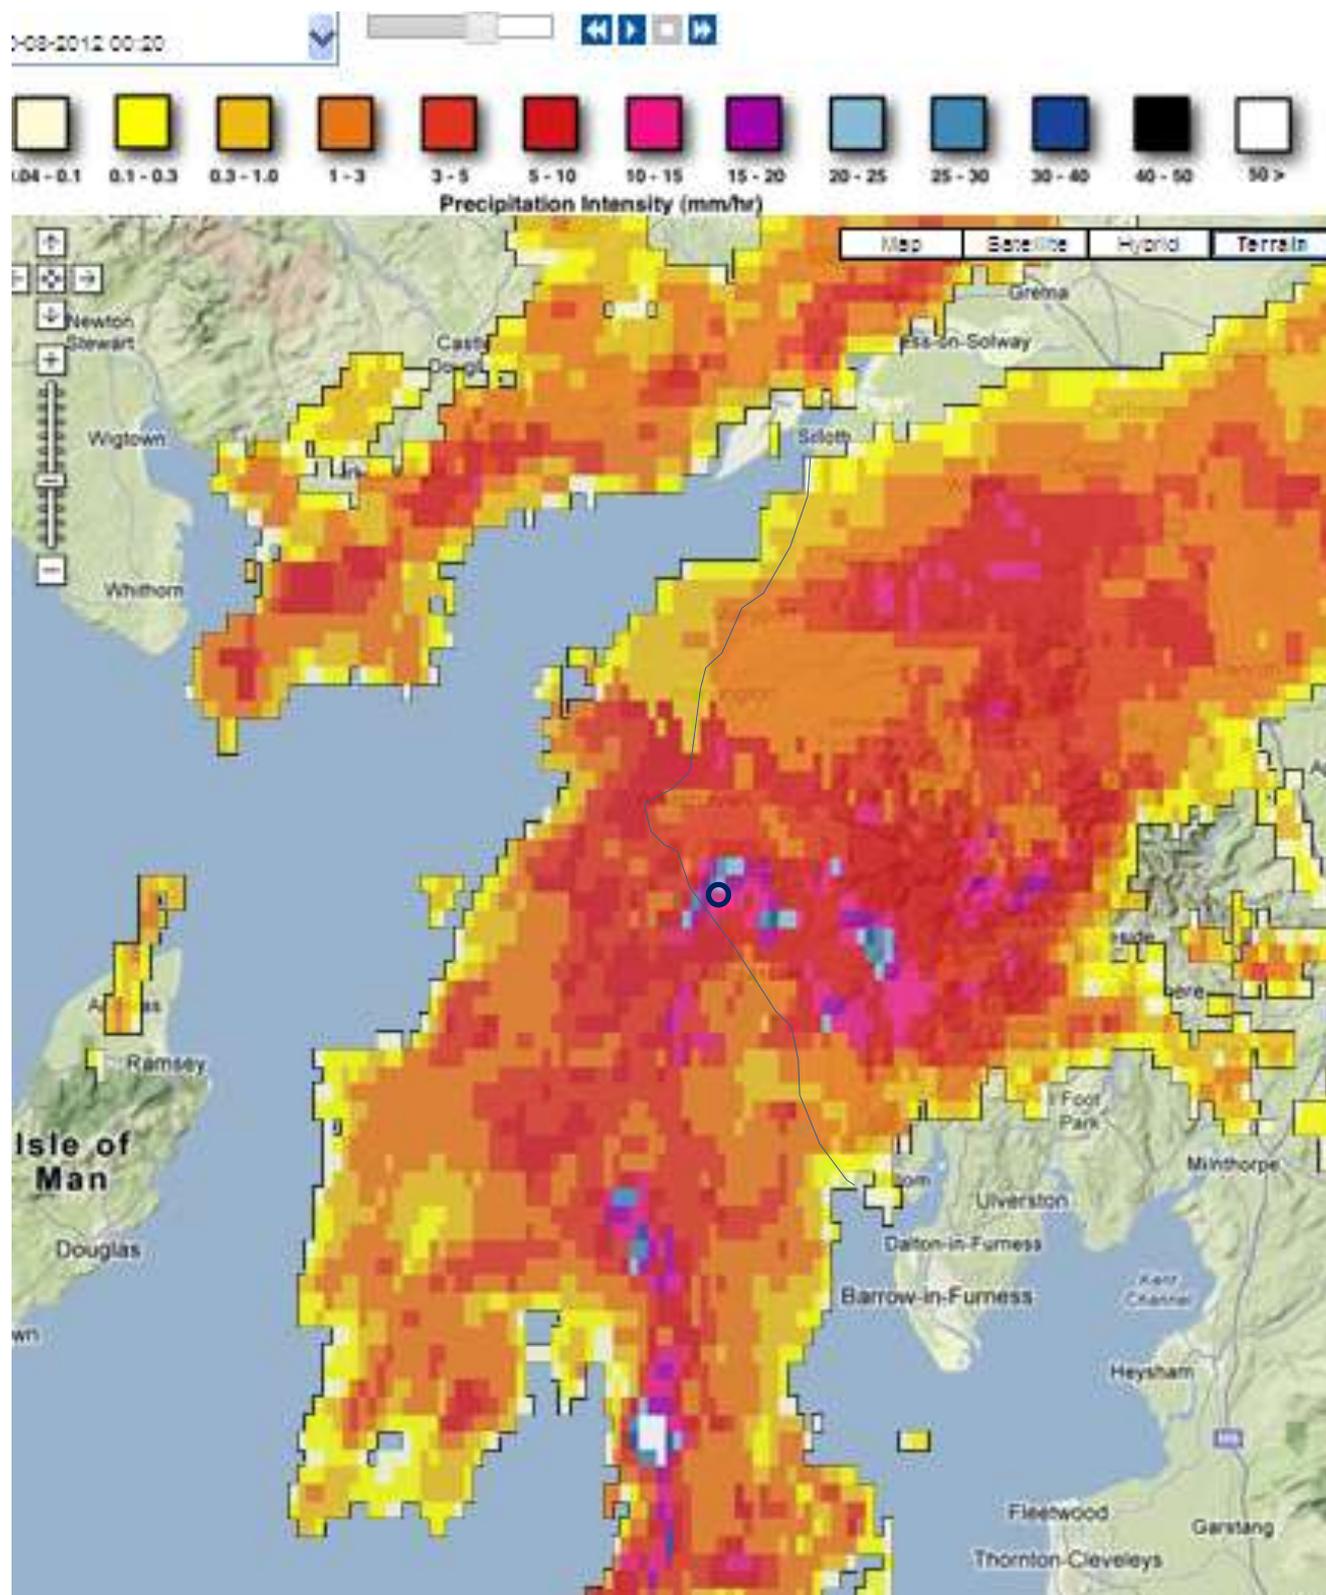
Figure 3. Rainfall radar image 30th August 2012. A snapshot of the storm over How Man (circled).

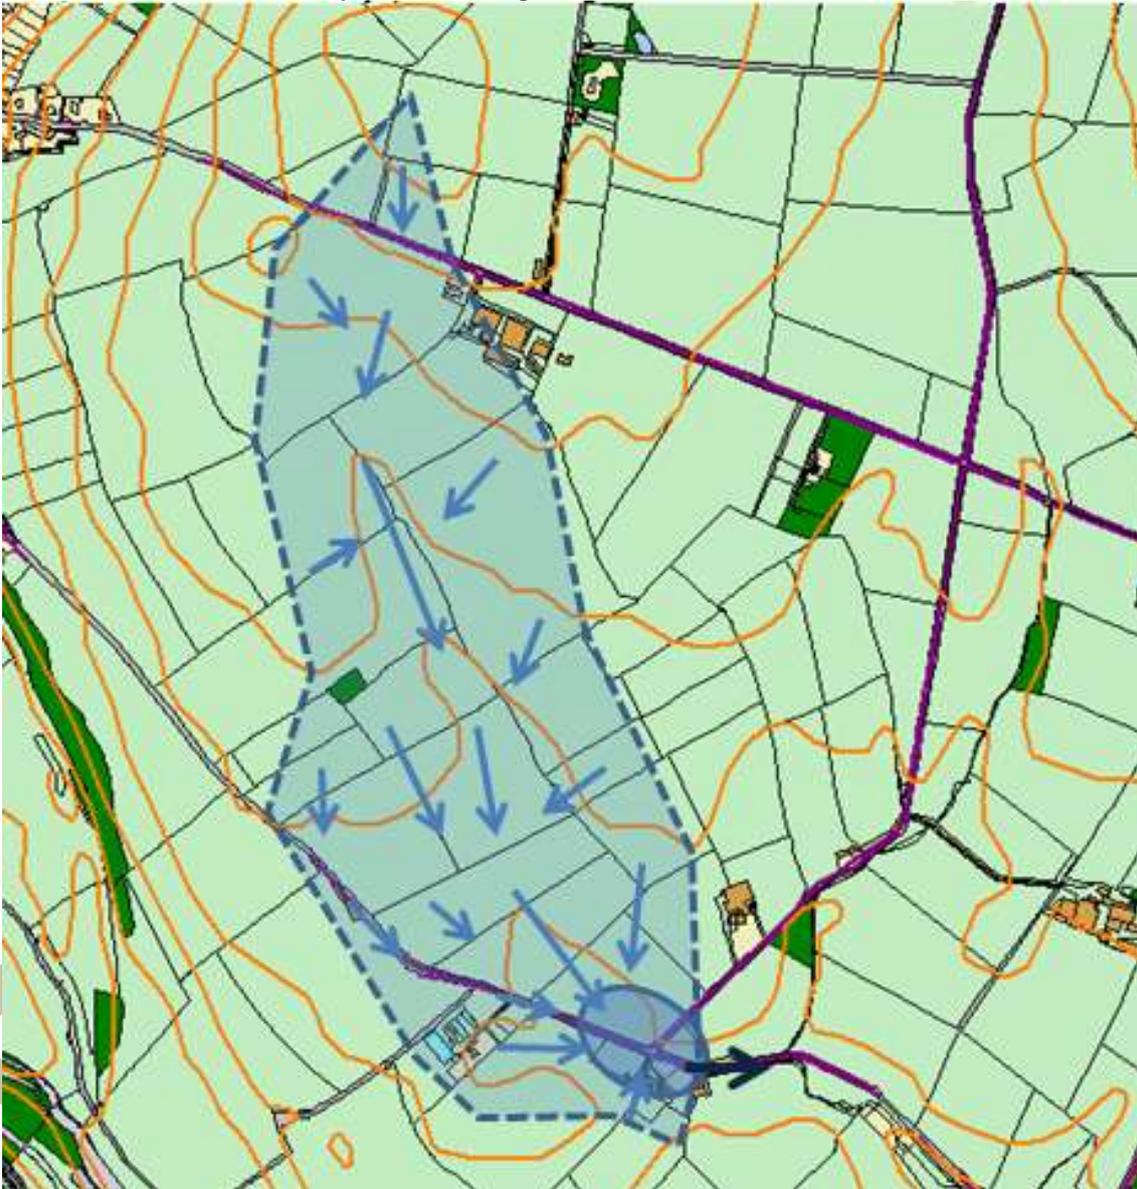
Because of the wet summer, there would have been very little opportunity for rainfall to infiltrate into the soil. By 29th August 2012 there had already been six days recorded in August where over 10mm of rain fell at St Bees. All of the water which fell within the shaded area shown in Figure 5 below, would eventually pass through the flooded area at How Man.

Figure 4. Flow routes towards the flooded area at How Man

At How Man surface water collects and pools in the field on the other side of the road to the north of the property. Excessive water draining off the field overloads the drainage system which is entirely piped in this area. When the water exceeds the capacity of the drainage system the pool of water in the field builds up until it flows out of the corner of the field, flooding onto the highway. As these flows continue, floodwaters from the road enter the garden and then the house at How Man.

The water collects on this section of highway because the road alignment rises slightly towards Ellergill Beck, the watercourse draining the runoff to the east. The lowest point is adjacent to the house.

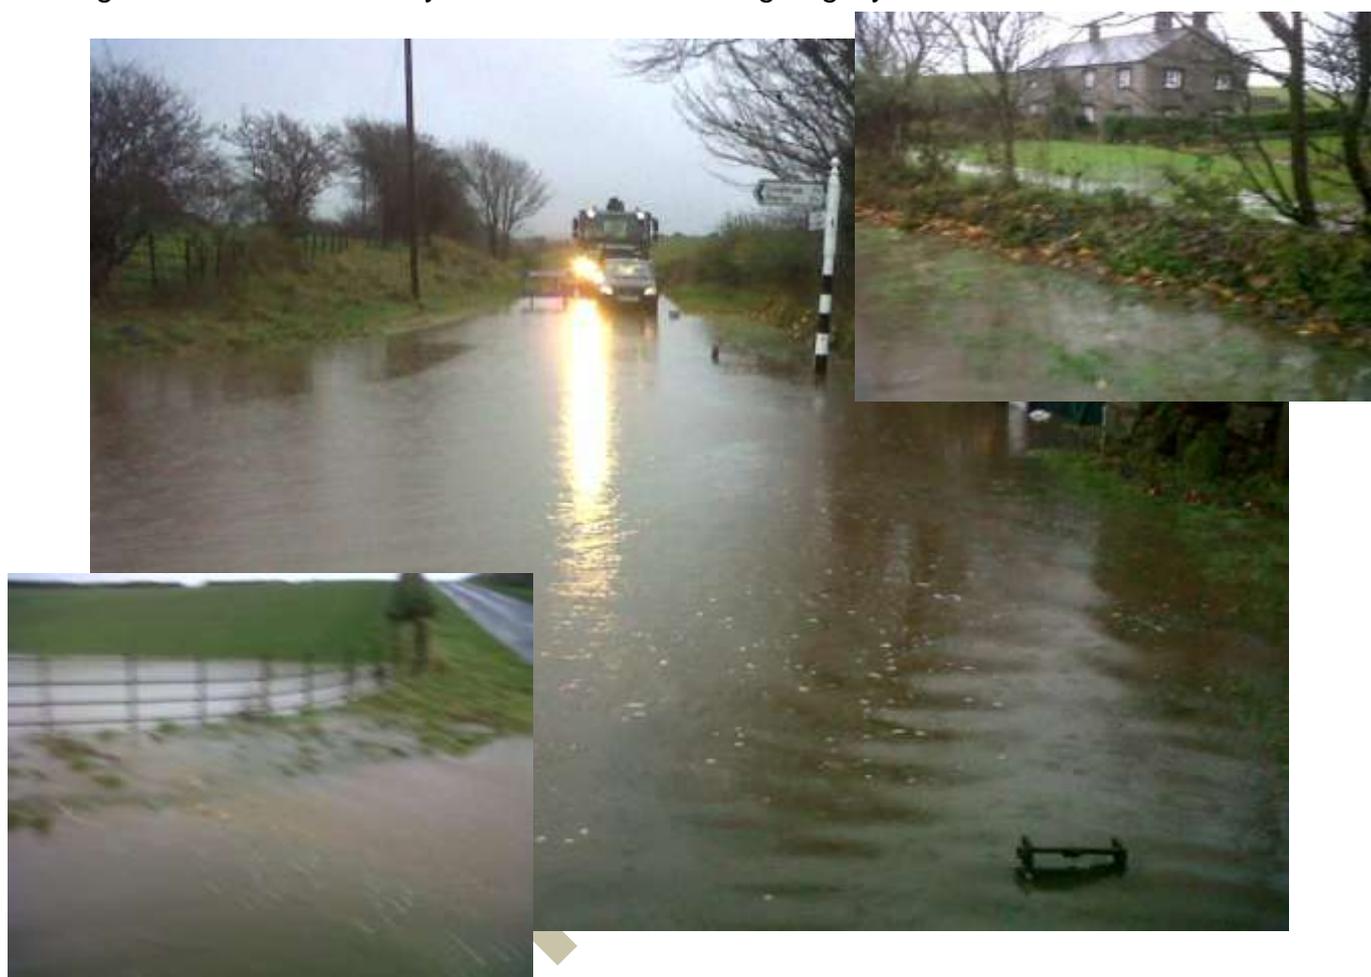
The flooding is further compounded because of traffic using the B5345. Even when cars drive slowly through the flood water, bow waves cause flooding in the house, even if the main body of water has not reached that far. As well as the property flooding, the pool in the road may also present a danger to life as cars fail in the floodwater and are abandoned. This results in drivers walking in the road where they are unaware of dislodged gully and manhole covers.

Figure 5. Flood water flowing out of the corner of the field (bottom inset) and flooding the road where a dislodged gully grating shows above the water. Flood water had not reached the house (top inset). Photos taken 22/11/12.

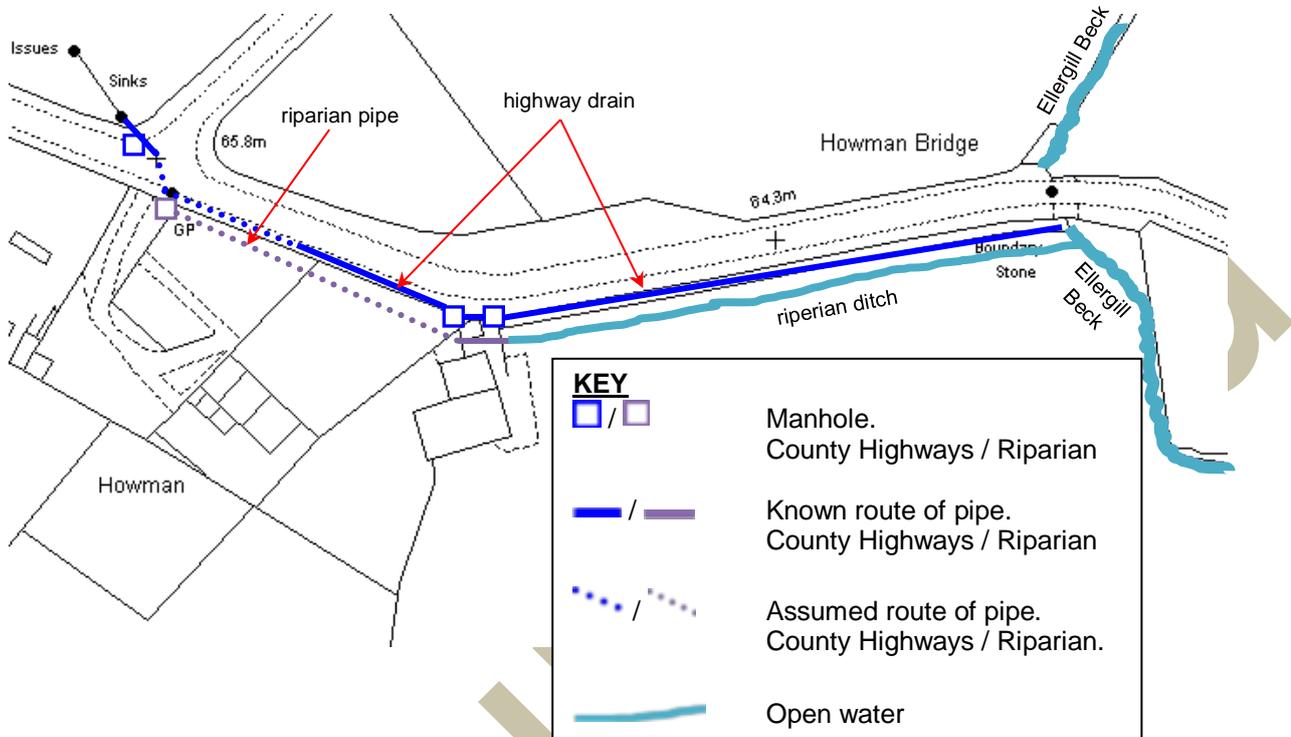
Before the 1970s, the owner of How Man understands that highway areas were drained by a road side ditch, but this was replaced by a gully and 150mm pipe system and the ditch was filled in. This significantly reduced the capacity for water to flow away from the area. Downstream from How Man the ditch still exists and connects to Ellergill Beck. A 300mm diameter pipe system outfalls into it from under the garden of How Man. This pipe is in riparian

ownership meaning that the owner of How Man has the responsibility to maintain it. The LLFA had no powers to investigate the state of this pipe during its investigations. After a more recent flooding event County Highways installed a 300mm dia. pipe to replace the 150mm dia. pipe highway drainage system. This runs parallel to the riparian pipe and ditch and was extended to outfall into Ellergill Beck directly. This pipe would have provided six times more capacity for conveyance when it was installed but unfortunately flooding has continued.

Figure 6. Plan of drainage system around How Man (gullies not shown).

CCC as Lead Local Flood Authority, when carrying out this investigation observed both systems running. The part of the system owned by the Highway Authority was inspected. It starts as a broken pipe in the field providing some land drainage, vulnerable to blockage, and not in control of the Authority. It was expected that the system would be restricted with silt and debris but there was no evidence of this from manhole inspection. The main manhole adjacent to the field has no catchpit arrangement but the system was clear.

Action by	Recommended Action	How
County Highways	Check highway drainage is functioning	Jetting, gully cleaning, COMPLETED.
County Highways	Identify any defects in highway drainage so that system can be repaired and work at full capacity.	CCTV survey, repairs if necessary.
County Highways	Reduce risk of flooding to How Man and danger to life for motorists using B5345.	Work with the Police Authority to identify criteria and process for closing road when in flood.
Riparian Owner (How Man)	Identify any defects in riparian drainage so that system can be repaired and work at full capacity.	CCTV survey, jetting, gully cleaning, repairs if necessary. COMPLETED
Land Owners	Reduce the volume of run off that reaches the B3545.	Trial soil improvement measures. Rural SUDs
Land Owner	Allow water to flow into the drainage system rather than over the surface.	Improve the connection between the field drainage and the highway drainage.

Riparian Owner (How Man)	Increase capacity of land drainage and intercept runoff above How Man	Convert the 300mm pipe system within How Man to open ditch.
County Highways	Increase capacity of highway drainage and intercept flood waters off B3545 above How Man	Restore the 300mm dia. highway drain to open ditch.
Property Owners (How Man)	As flood risk can never be eliminated, residents who know they are at risk of flooding should ensure any future flooding, in all areas, causes minimal damage.	Ensure own properties are protected by resilience measures.

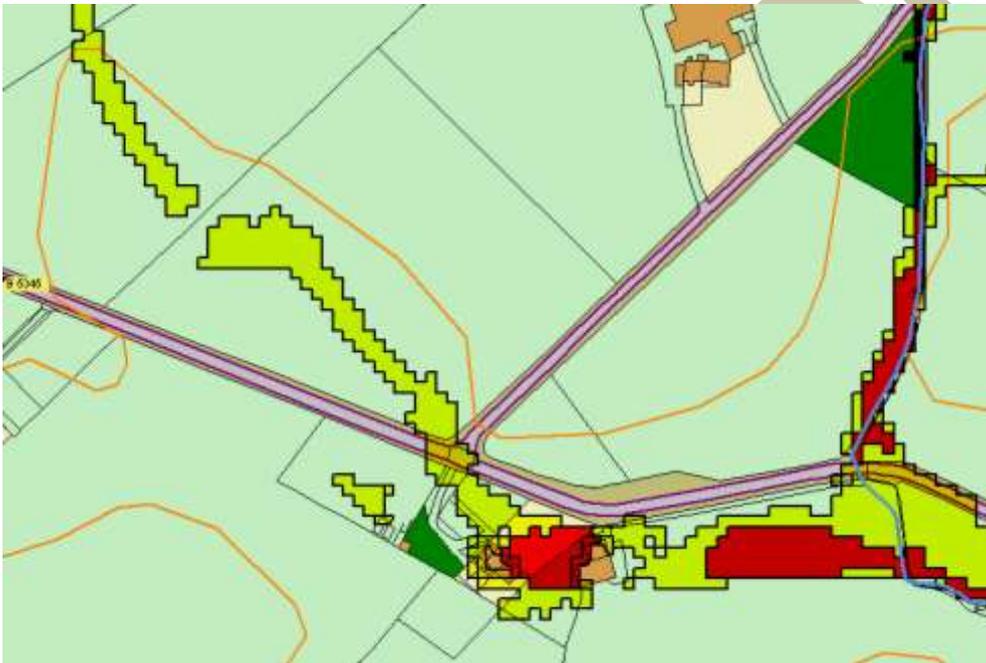
Figure 7. The Flood Map for Surface Water for a 1 in 30 year storm from the EA shows that How Man is expected to flood to a depth of at least 300mm (red). Surrounding areas will flood to at least 100mm (yellow).
