# New Mill

## Flood Investigation Report No.39

**Flood Event: 29<sup>th</sup>/30<sup>th</sup> August 2012**

This flood investigation report has been produced by Cumbria County Council as a Lead Local Flood Authority under Section 19 of the Flood and Water Management Act 2010.

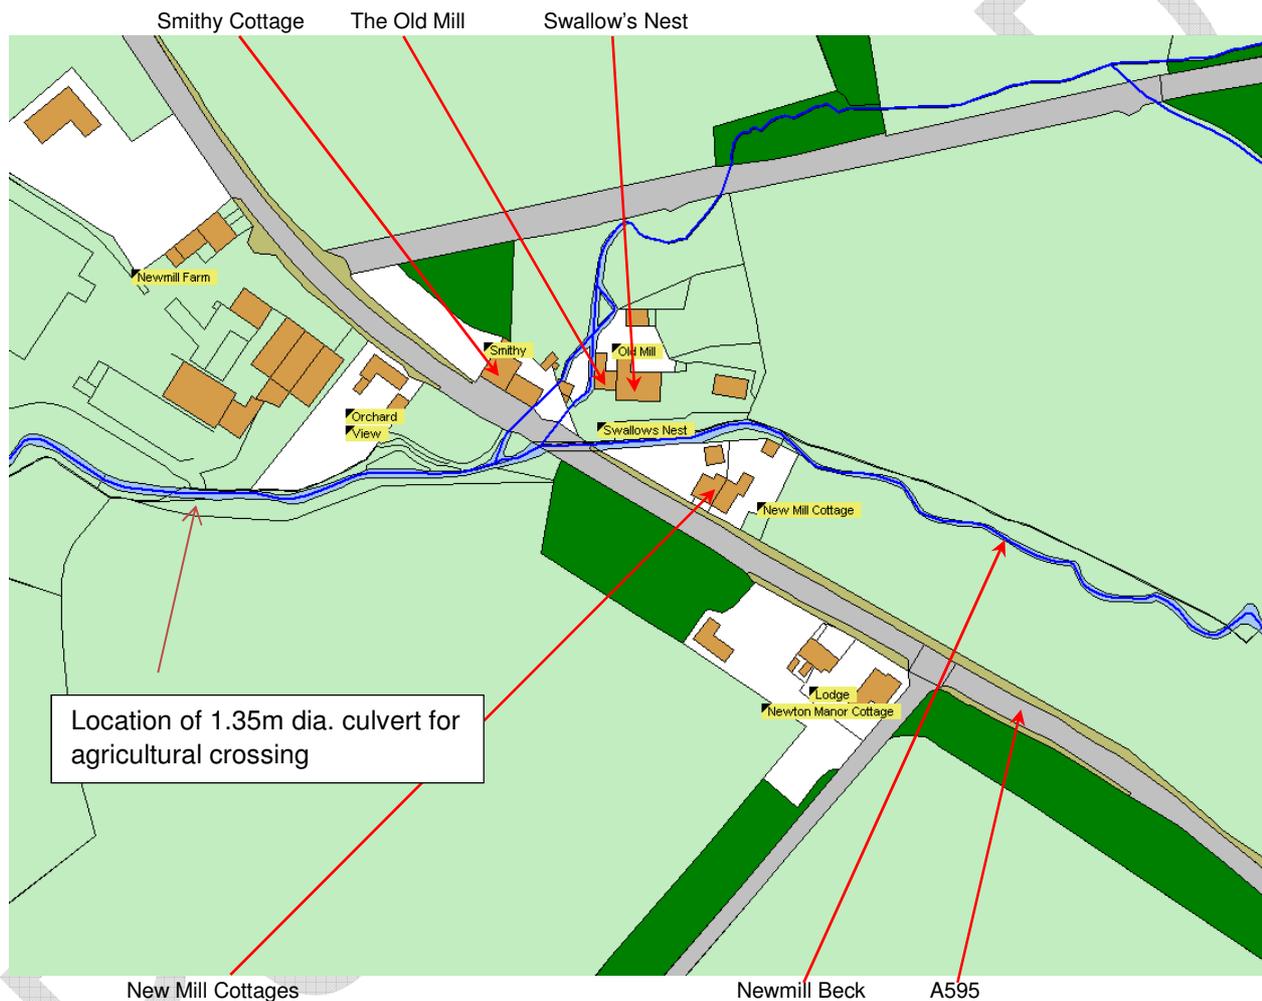
**Figure 4. Property locations**

Figure 4 "Property locations" shows the properties known to have had flooding problems as Newmill Beck burst its banks. The width of the flow increased (see Figure 5 "Flood routes") flooding Swallow's Nest and New Mill Cottages. Swallows Nest flooded internally and its access drive was broken up by the flood debris. A decking platform in the garden of Fussell New Mill Cottage was lifted and there was about 1.2m of water in a workshop. The cellar in Broadbent New Mill Cottage next door was also flooded. There is a danger that the outlet to the cottages' septic tank may become blocked by debris during such flood events. Further investigations revealed that the cellar of Orchard View flooded and substantial garden damage also occurred.

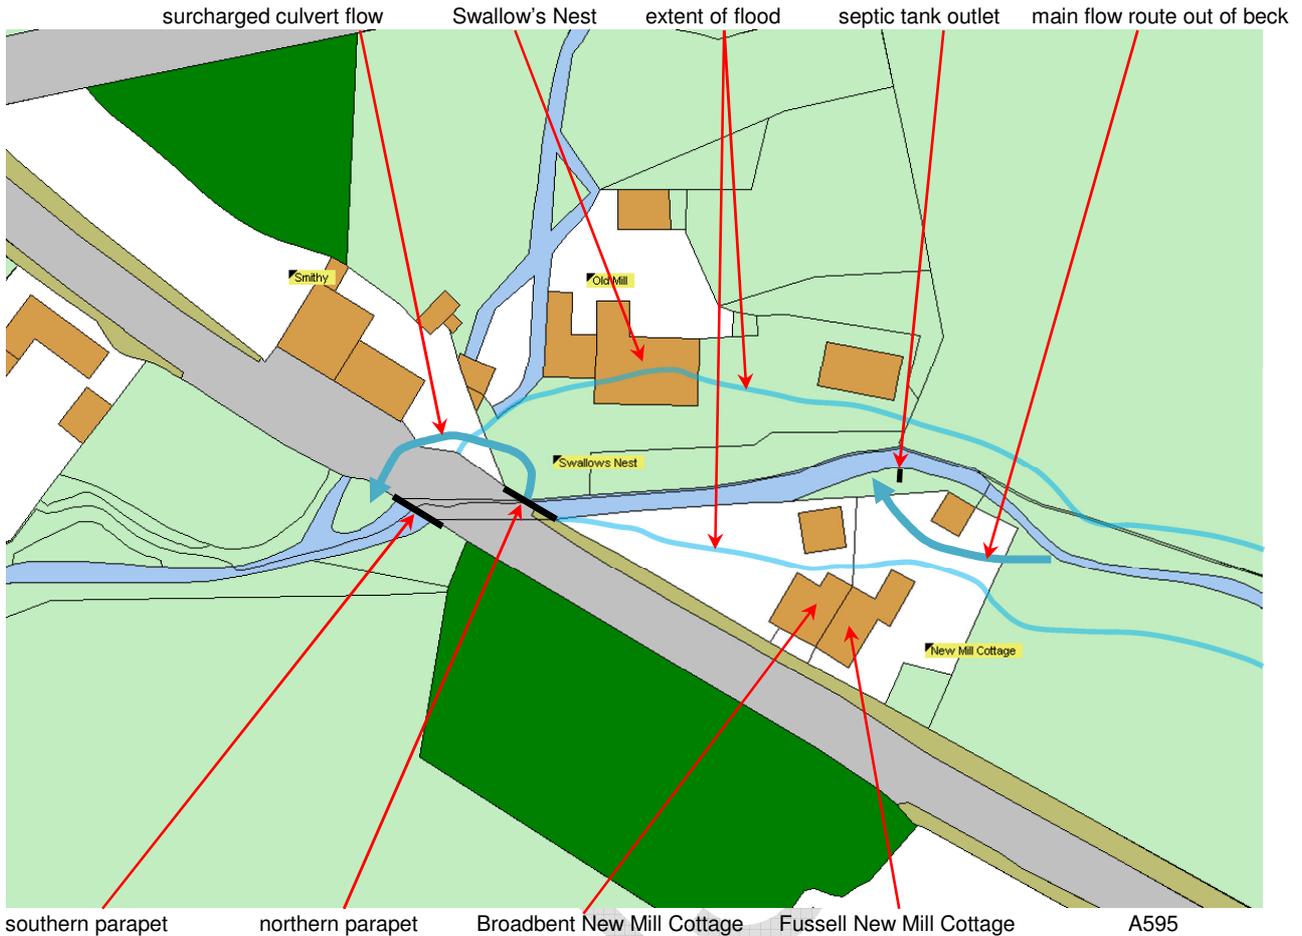
Figure 5. Flood routes

New Mill Cottages are in fluvial Flood Zones 2 and 3. It is understood that the Newmill Beck was in need of some maintenance and it was unable to contain the excessive flow. Also the culvert running under the A595 did not have sufficient capacity for the flow causing a surcharge flow over the highway to the north-west of the crossing.

Some of the surcharged flow from the culvert re-entered the Beck through a hole in the southern stone parapet wall. The northern stone parapet wall is continuous. It has been suggested that if a similar hole is introduced through the northern parapet wall, then a route could be provided for flood waters across the highway when the Beck is in flood. This could result in litigation claims if any road traffic accidents occurred as a result of highway flooding. A proposal to build a wall at Swallow's Nest to protect the property from future flooding could also increase the risk of future flooding to other properties adjacent to the Beck. The highway culvert is  $2.2\text{m} \times 0.8\text{m} = 1.76\text{m}^2$  in size at the upstream end and is  $2.0\text{m} \times 0.8\text{m} = 1.6\text{m}^2$  at the downstream outlet. This is further reduced by the angle of the wing wall taking the outlet to  $1.6\text{m} \times 0.8\text{m} = 1.28\text{m}^2$ .

Action by	Recommended Action	How
Residents	If affected by flooding, ensure that property is resilient to future flood events.	Consider whether flood protection is expedient. Seek advice from a competent flood resilience consultant.
Riparian Owners	Maintain flows in watercourses	Establish maintenance regime for clearing foliage and removing silt from sections of watercourses that fall within their area of responsibility.
LLFA	Encourage riparian owners to carry out their statutory duties in maintenance of their watercourses.	Provide advice. Liaise with the owners and process applications for Ordinary Watercourse Flood Defence Consent.
LLFA/County Highways/Landowners	Provide a route across culverts for exceedence	Review exceedence flood routes. Investigate potential for realigning the downstream wing wall of culvert under A595.
LLFA/ Landowners	Investigate attenuation or limiting flows upstream.	Investigate the catchment of the Newmill Beck upstream of the culvert at New Mill.

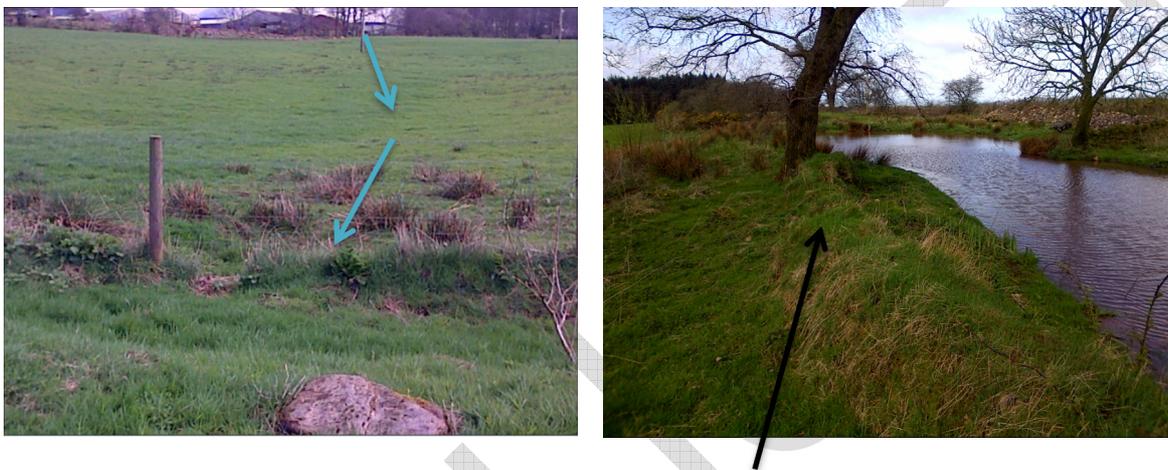
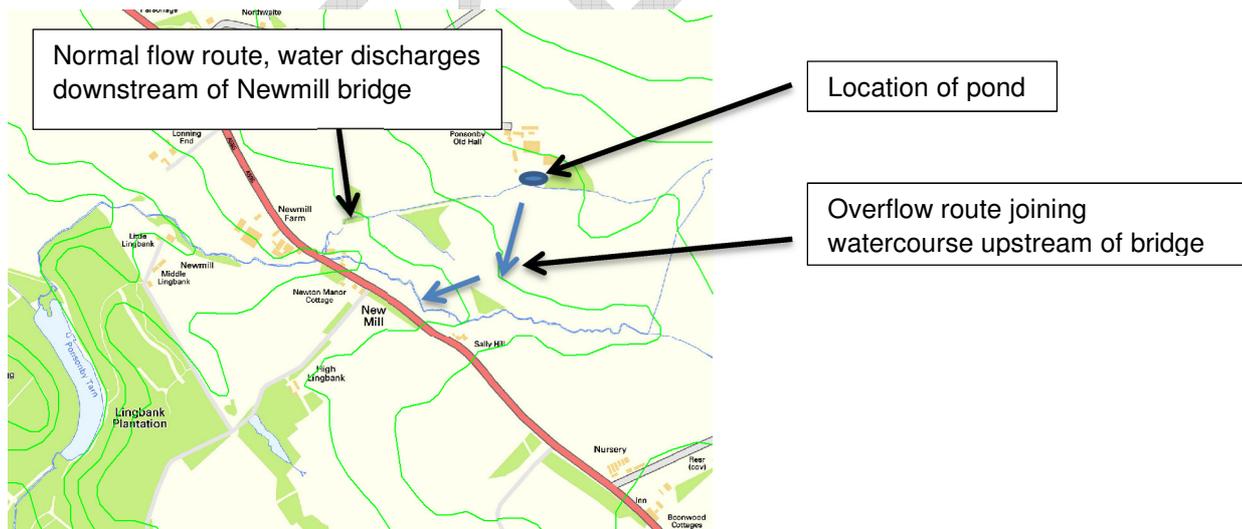
**Figure 6 Ponsonby Old Hall**  
Flow route during heavy rain

The LLFA officer from Cumbria County Council attended site following on from the delivery of the draft report during a heavy rain period and noticed water cascading from the Ponsonby Old Hall area. This water had not been recognised within the draft report.

While visiting the site it was noted that a bund at the higher pond in the grounds of Ponsonby Old Hall was being breached and that this water joined the watercourse upstream of Newmill bridge as opposed to its normal course through the old mill and discharging downstream of the bridge.

Bund to be raised

LLFA/ Landowner	Ensure bunding is adequate to stop overflow from Ponsonby Old Hall	Work must be carried out quickly and LLFA to ensure work is being carried out as agreed.

This anomaly has been pointed out to the landowner who is in the process of bunding the pond further so that all water goes back through the normal route and discharges downstream of Newmill bridge.

The work required has been added to the recommended actions on page 10.
