Braithwaite

Section 19

Flood Investigation Report

Coledale Beck, Braithwaite, Cumbria

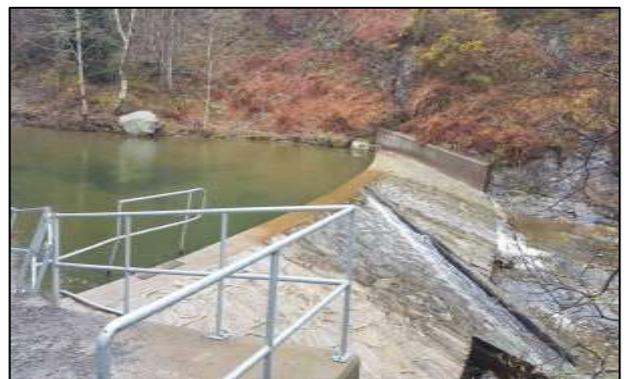
9th December 2015, NGR NY 23006 23615

Photograph 4: Current Gravel trap on Coledale Beck

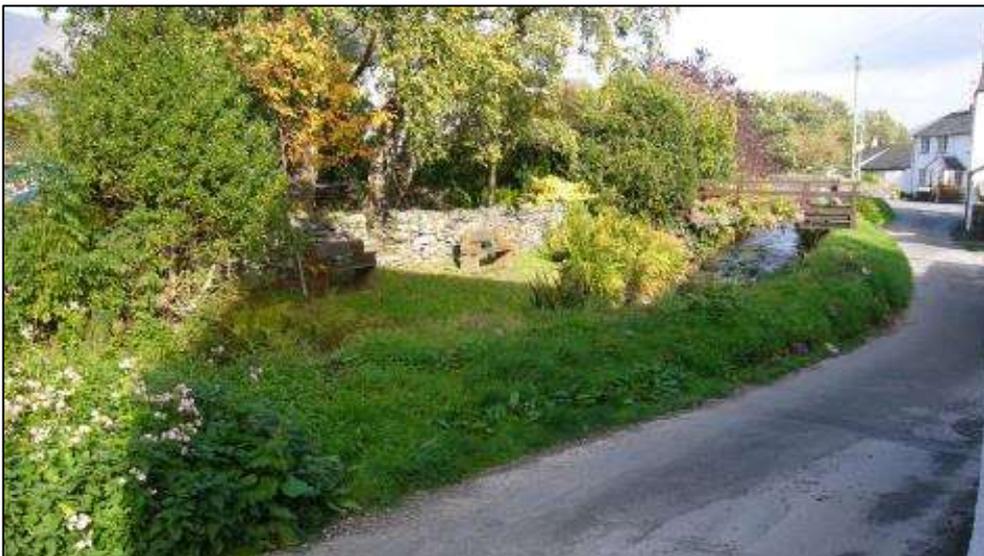
The flood defence embankment was overtopped, with sections washed away, during the 5th December 2015 flooding incident.

**Photograph 6: Embankment covered with turf after completion of the
refurbishment work in 2011, NGR NY 23133 23580**

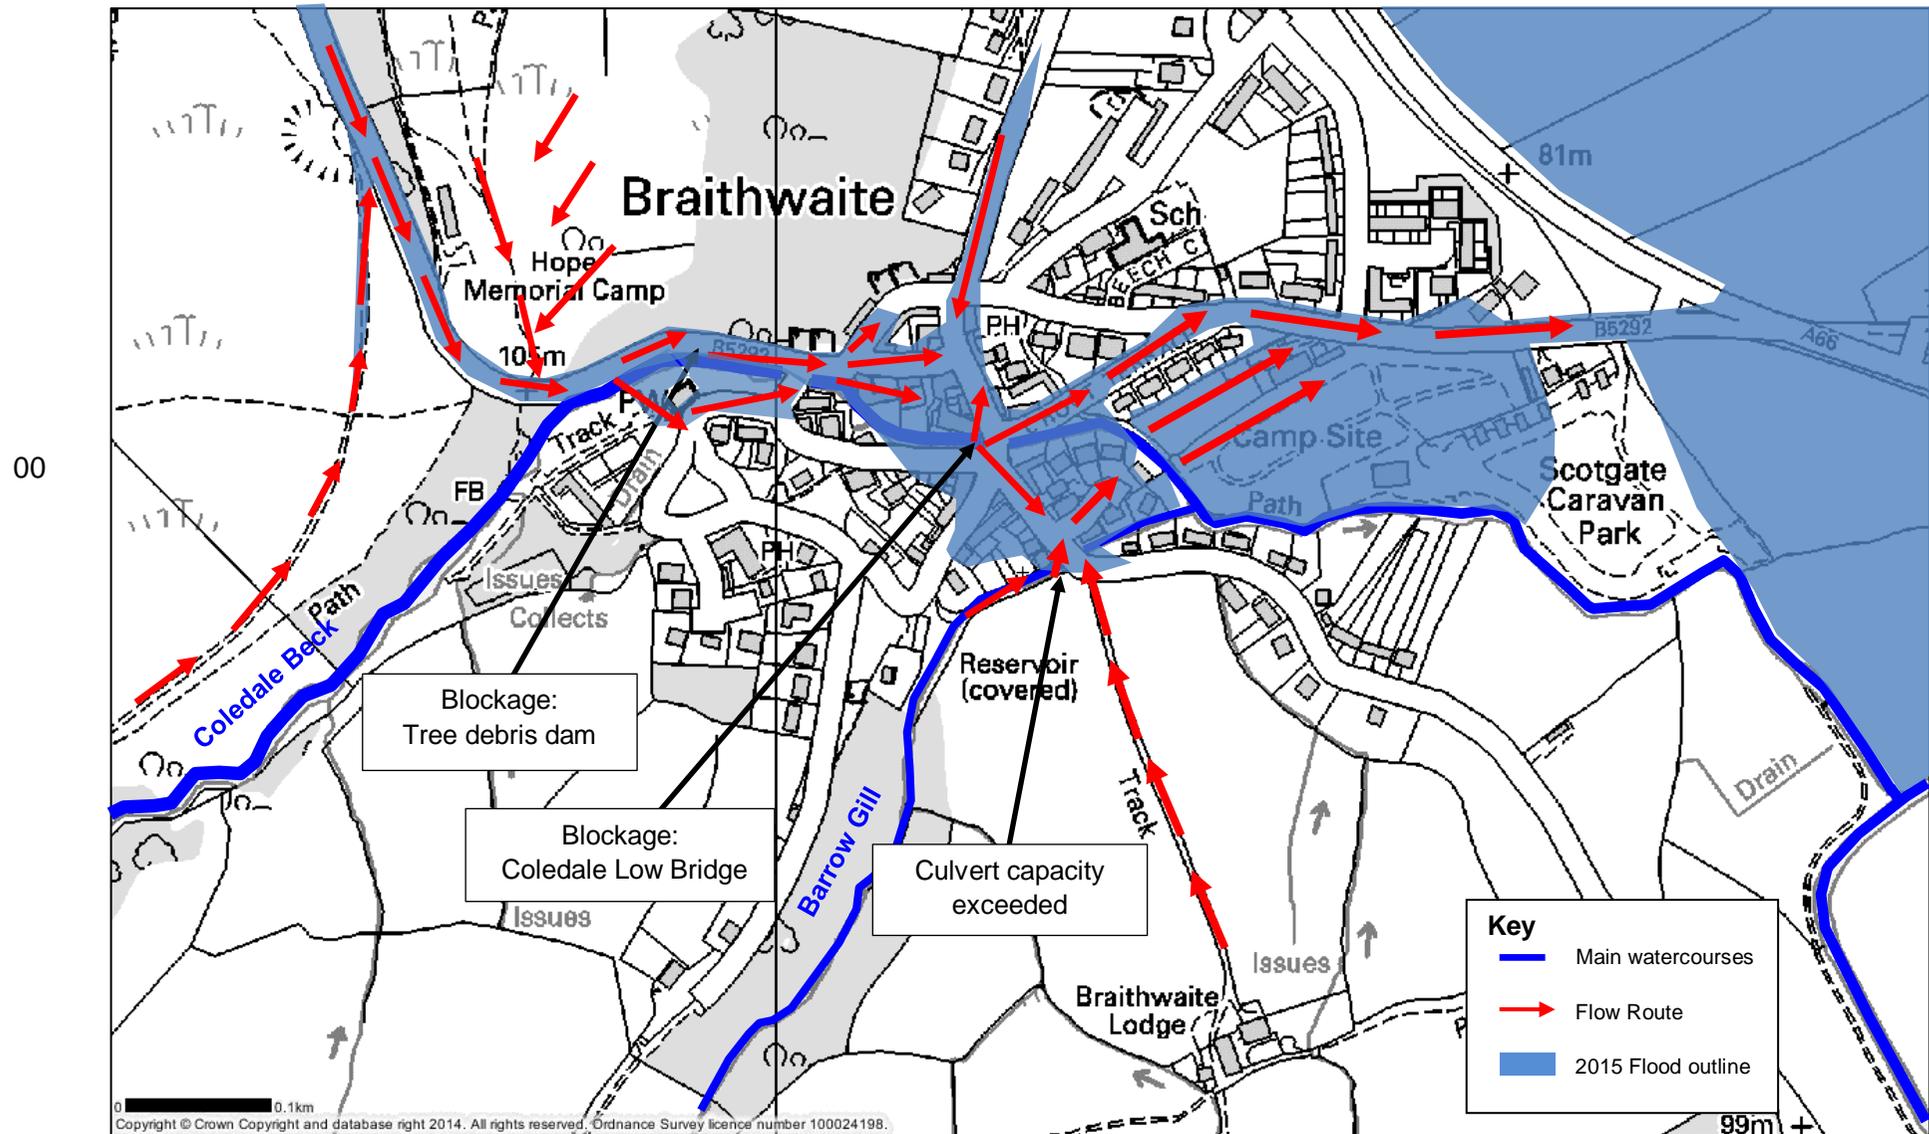
Figure 6: Map of flood flow routes

There were a number of flooding flow routes during the event, **Figure 6**, sourced from multiple locations. The details of these flow routes and the associated impact are discussed in further detail in the following section of this report.

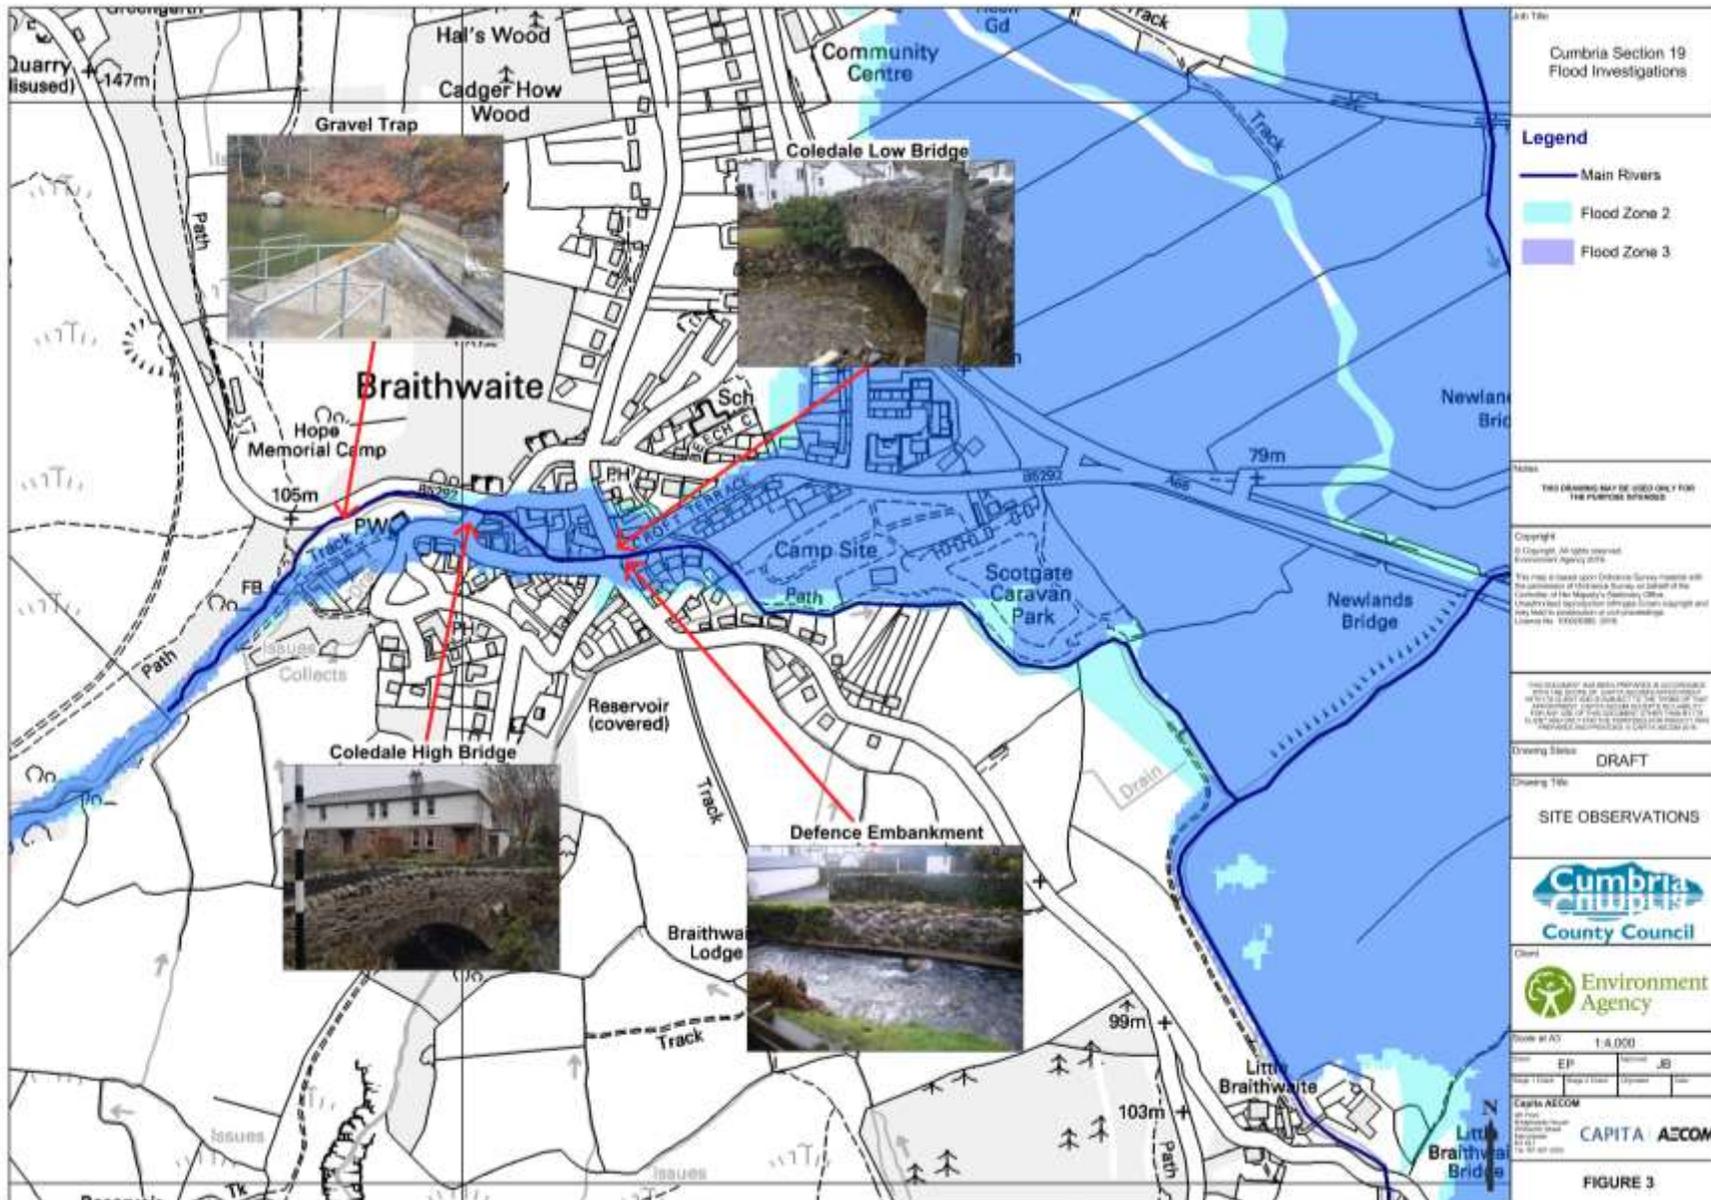
Figure 7: Key observations

A site visit was undertaken by the Capita AECOM survey team incorporating the areas seen in **Figure 7**. Key features, observations and photographs were observed and recorded.

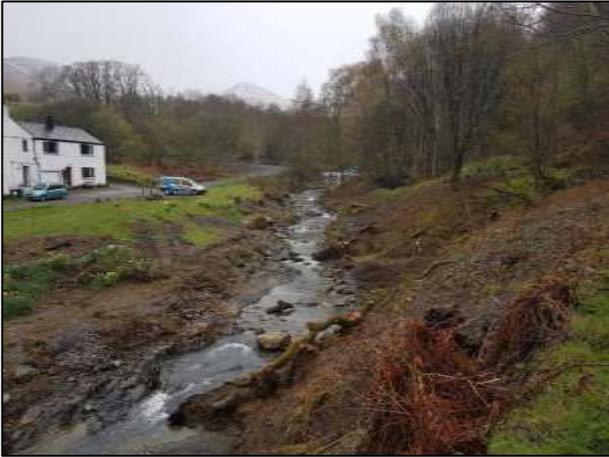
30th April 2015, NGR NY 22941 23637

The survey team commenced the site visits with a visual inspection of the upper reach of the Coledale Beck, the B5292 and the gravel trap which is located 200m north of the Higher Coledale Bridge. The Coledale Beck river channel showed signs of extensive vegetation clearance and the post-flood recovery works which were undertaken in December 2015, **Photograph 23**. The B5292 appeared to have suffered damage as a result of scour and undermining from the Coledale Beck, **Photograph 24**. The adjacent highways gullies were observed as being completely full of silt.

Photograph 23: Coledale Beck after the post-flood emergency recovery works, looking upstream towards the gravel trap

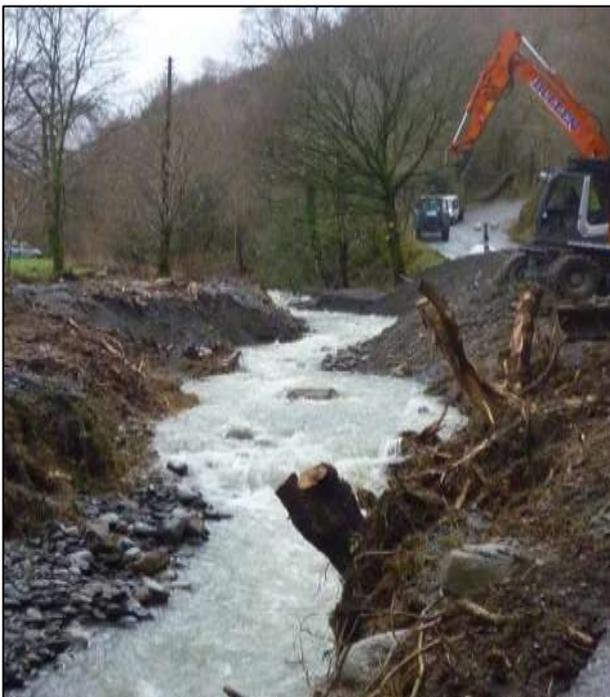
9th December 2015, NGR NY 22894 23627

Photograph 29: Emergency works to re-engineer Coledale Beck upstream of the Coledale High Bridge

- The Environment Agency began emergency works on the 9th December 2015 to remove the high volume of trees, gravel and debris from the Coledale Beck upstream of the Coledale High Bridge, **Photograph 29**. These works improved the conveyance of flow by reforming the shape of the river channel in this reach. Debris was also removed from the adjacent B5292 road.

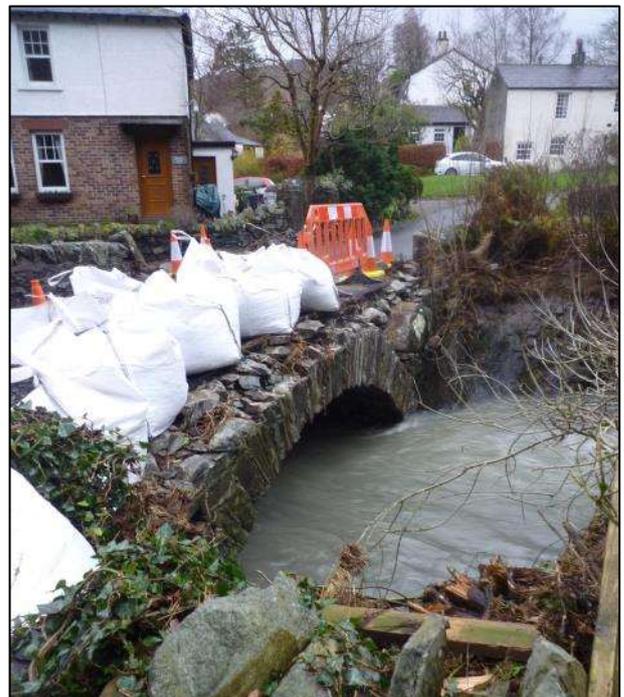
Photograph 30: Partially destroyed access bridge over the Coledale Beck

- Cumbria County Council cordoned off the Coledale Upper Bridge, **Photograph 30**.
- The damage to the flood defence embankment on the right bank of the Coledale was temporarily filled in. Demountable defences were later deployed on the 26th December by Army Engineers working with the Environment Agency. Both measures can be seen in **Photograph 31**.

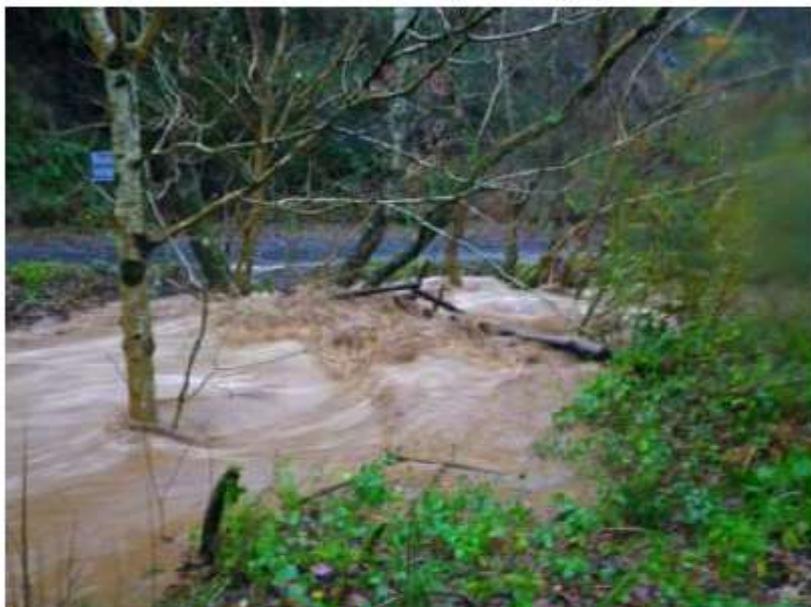
- 36. 14:41 – Water up to Chicken Bridge but still intact
- 37. 14:48 – Chicken Bridge Down but still held upstream by trees

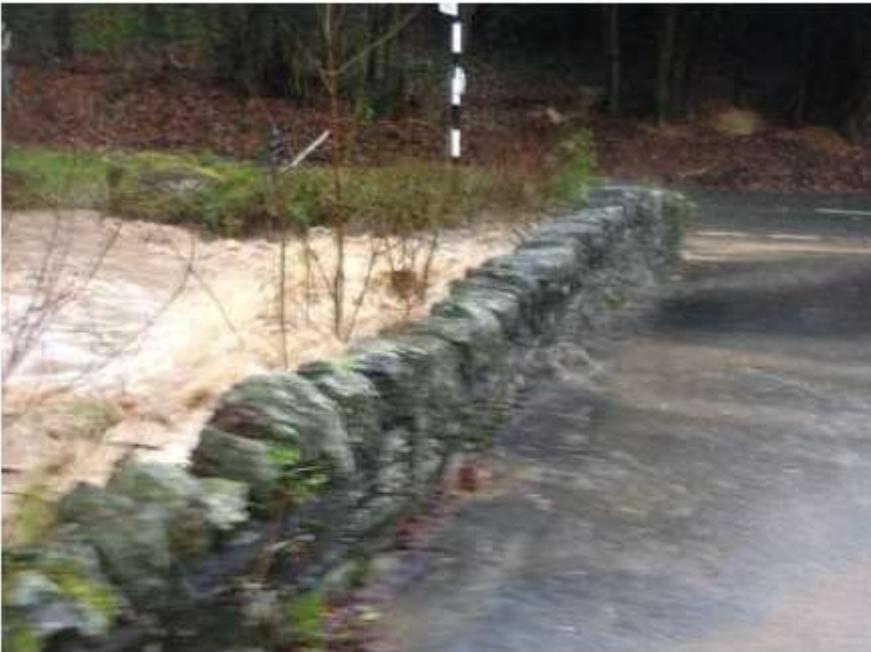
41. 14:57 Water at top of High Bridge, parapet under stress

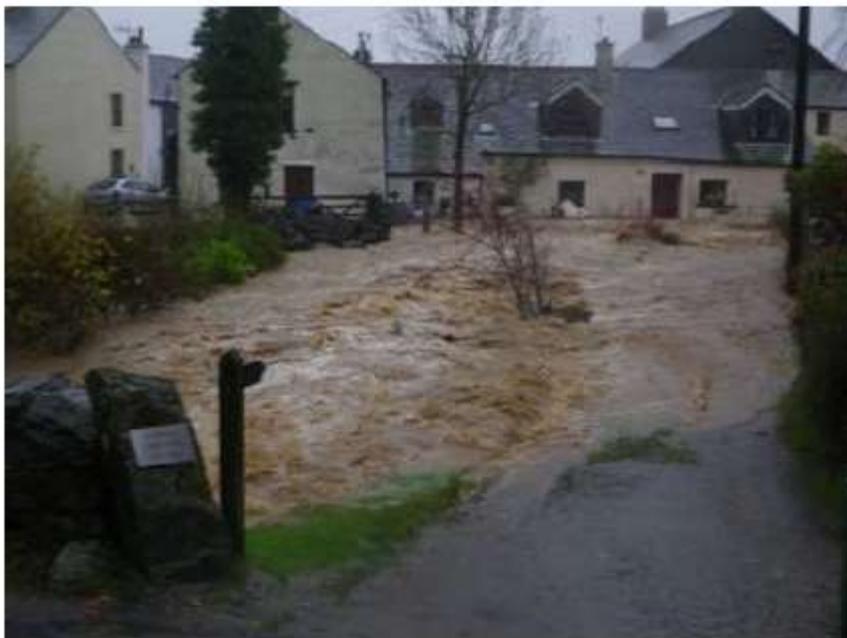
42. 15:00 – Beck had already broken its banks on both sides downstream of High Bridge

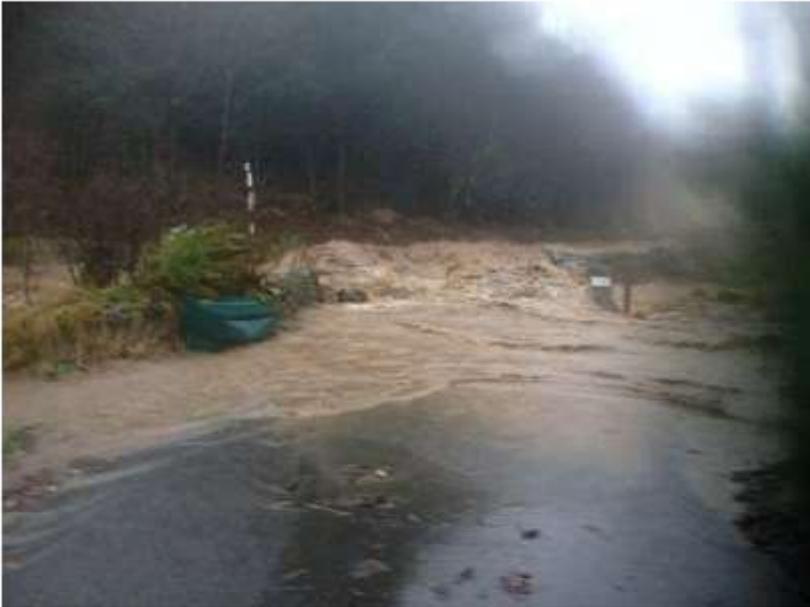
45. 15:16 – Surge from Land slip at Force Crag Mine and/or jammed tree debris downstream from gravel pit pushes water out of its channel

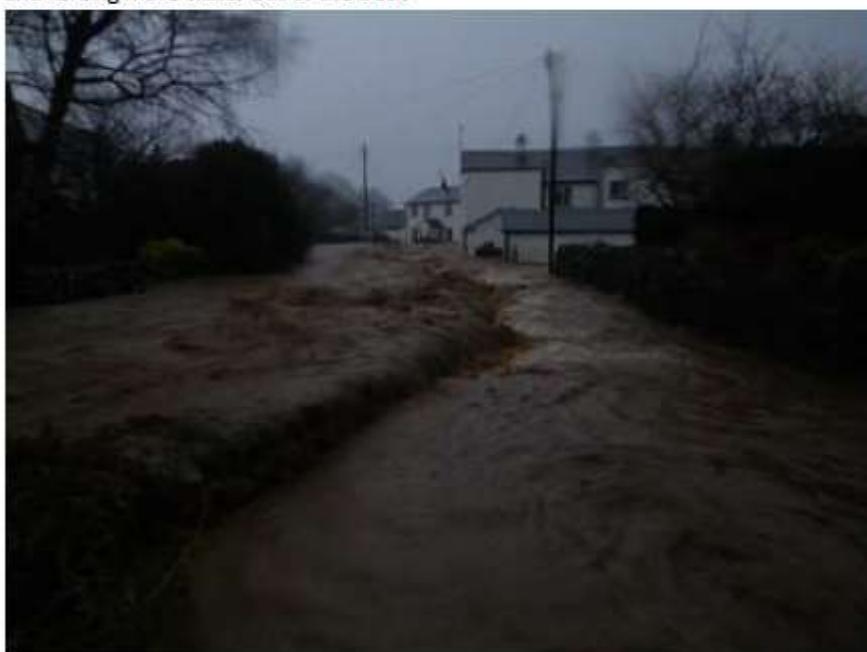
46. 15:38 All wooden upstream of Low Bridge are shown as down and totally blocking Low Bridge and forcing more water out of the beck

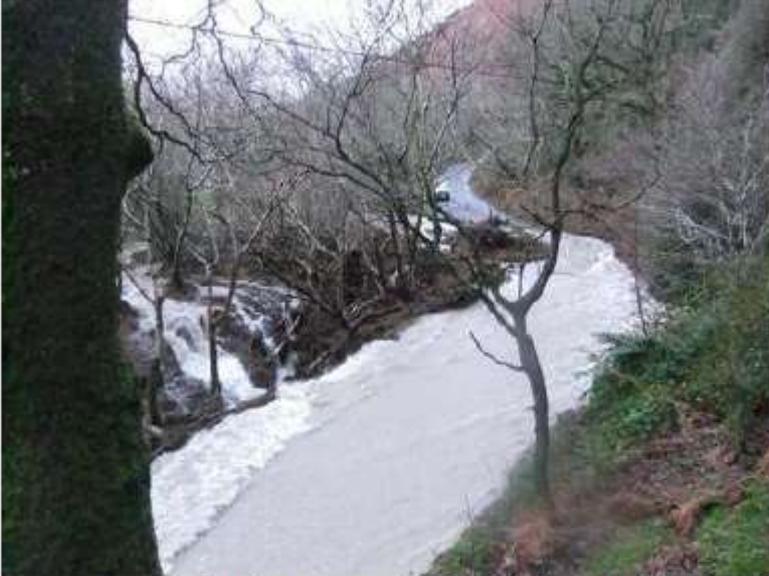
65. 09:39 – Tree Debris forcing water from Beck down Whinlatter Road

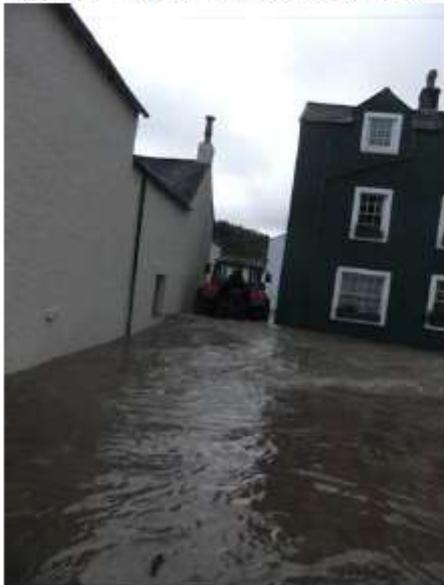
69. 10:03 – Village continues to be flooded by water coming down the Whinlatter Road

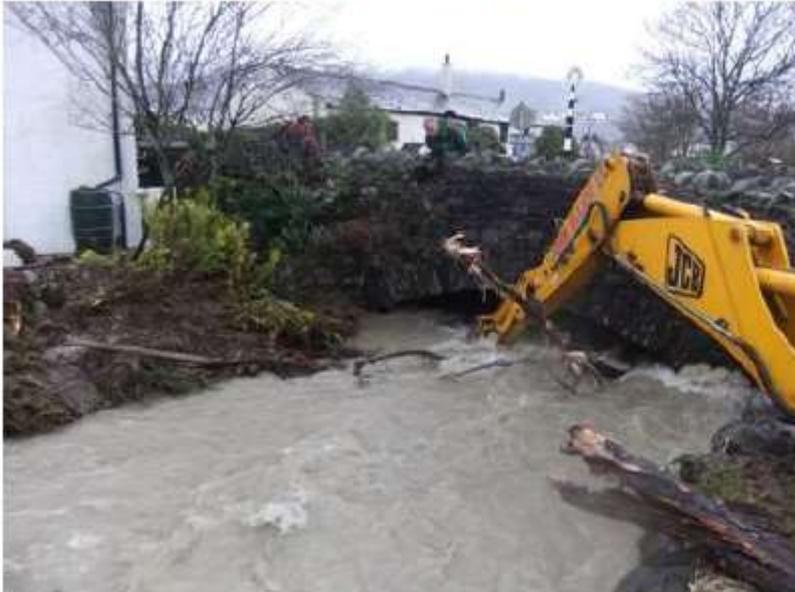
71. 11:17 – Work continues to clear Low Bridge of tree and wooden bridge debris
