Section 19 Flood Investigation Report Ellen Grove, Maryport

Flood Event Saturday 15th October 2022

Cumberland Council as a Lead Local Flood Authority under Section 19 of the Flood and Water Management Act 2010 have produced this flood investigation report.

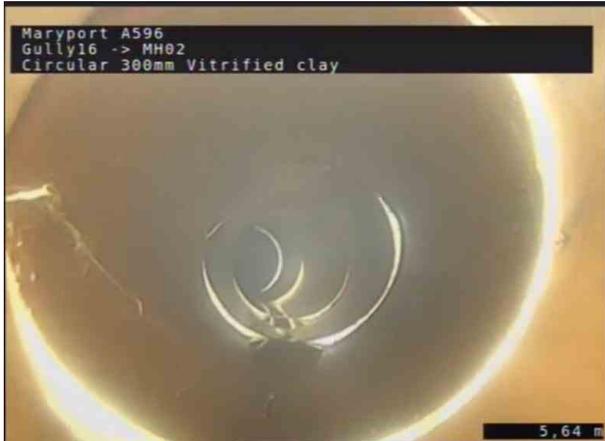
Section Pictures - 08/12/2022 - Gully16X

1, 00:00:33, 5.75 m
Roots, fine at joint

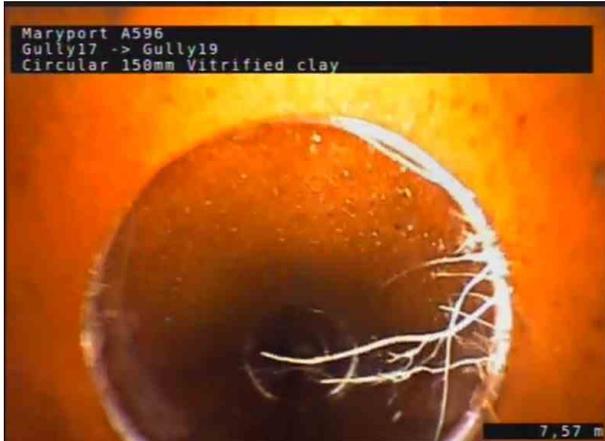
Section Pictures - 08/12/2022 - Gully17X

1, 00:01:03, 7.55 m
Roots, fine at joint, start

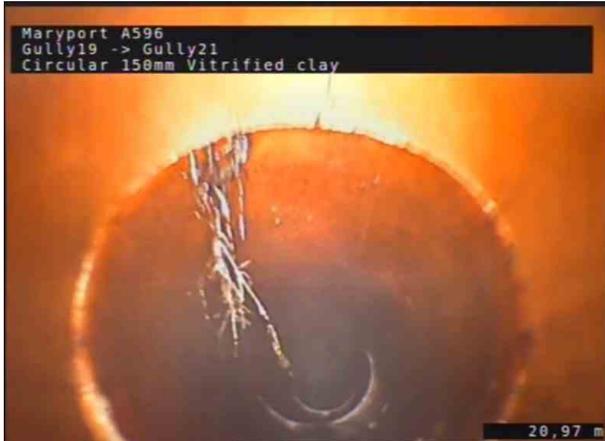
Section Pictures - 09/12/2022 - Gully19X

1, 00:01:22, 20.97 m
Roots, fine at joint

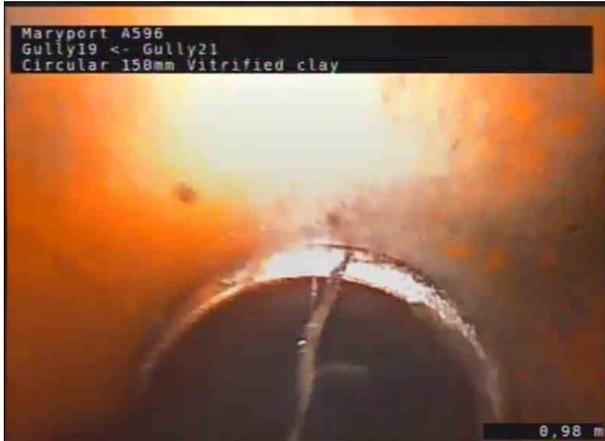
Section Pictures - 09/12/2022 - Gully19X

1, 00:00:25, 2.02 m
Roots, fine at joint, start

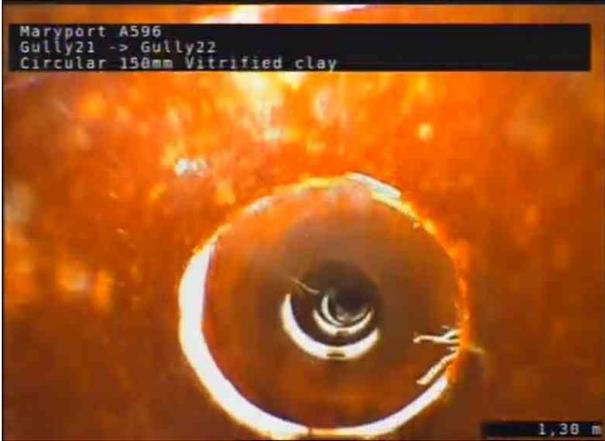
Section Pictures - 09/12/2022 - Gully21X

1, 00:00:35, 1.30 m
Roots, fine, start

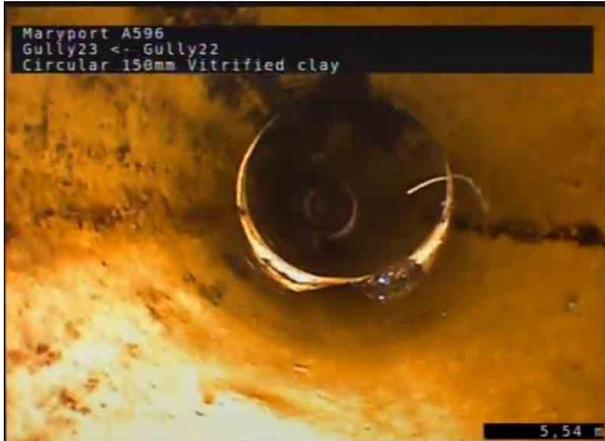
Section Pictures - 09/12/2022 - Gully23X

1, 00:01:13, 5.78 m
Roots, fine at joint, start
